# **A Brief History of the NRU Reactor Vessel Leak and Repair**

TRTR Conference

G.B. Wilkin

2010 September 19-24

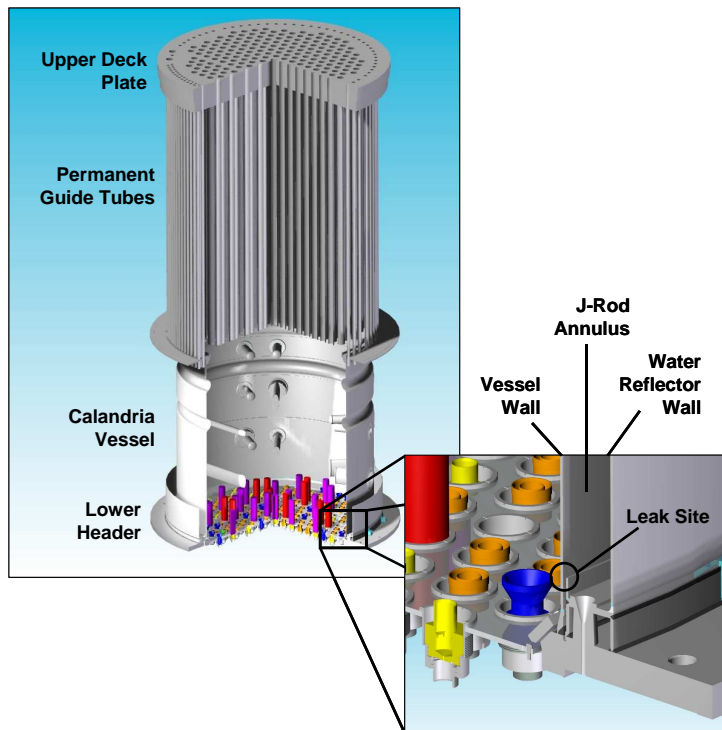
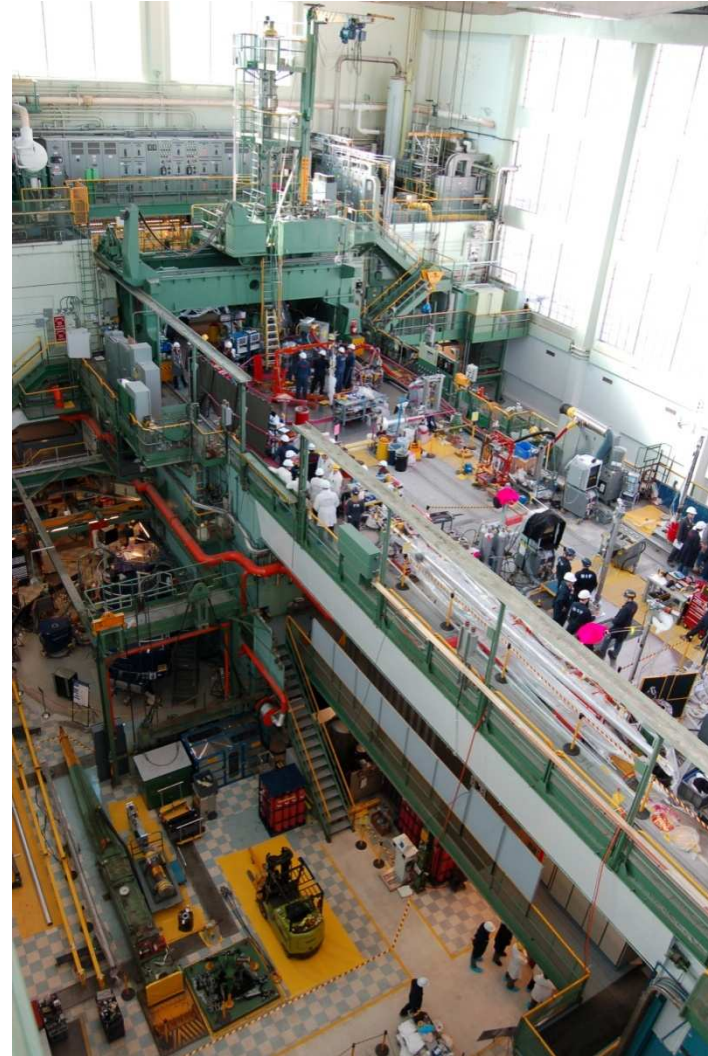
# Location of Heavy Water Leak

- Leak site is 30 feet below the deck plate at the base of the vessel
- Access through 4.75-inch dia. tubes
- High radiation environment

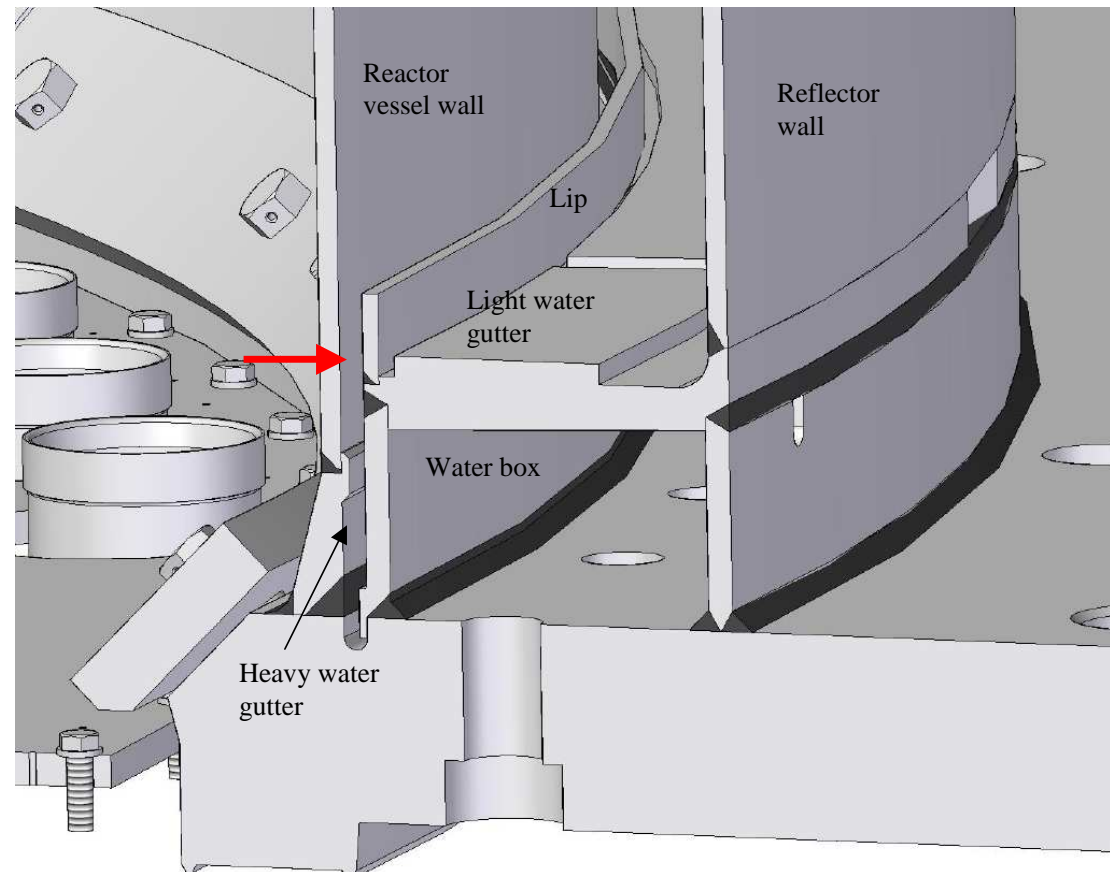
# Leak Site

- Detailed non-destructive examination of lower vessel wall performed
  - Leak location determined accurately
  - Corrosion widespread in the lower portion of the J-rod annulus

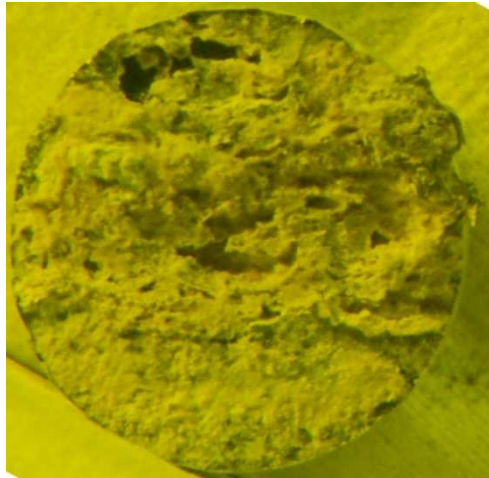
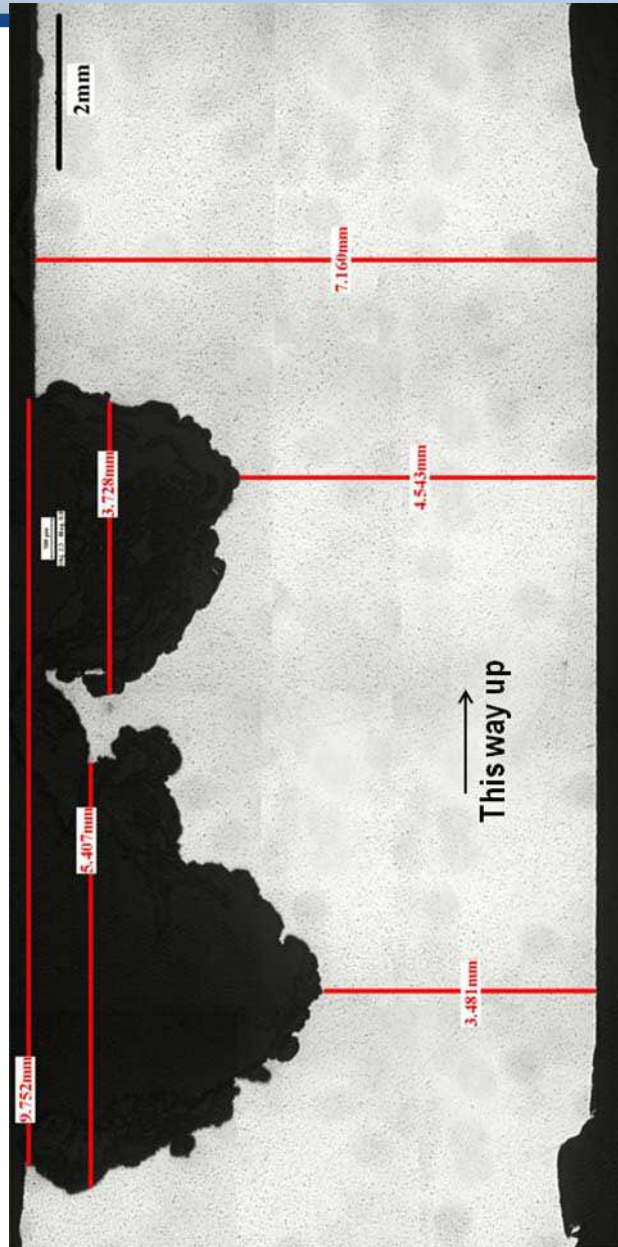
- J-rod Side

# Removed Coupon from Vessel Wall
