Technical Meeting on Research Reactor Ageing Management, Refurbishment and Modernization

EXPERIENCE OF TRR-1/M1 RESEARCH REACTOR FOR POOL REPAIRING

Thailand Institute of Nuclear Technology (Public Organization)
(TINT)

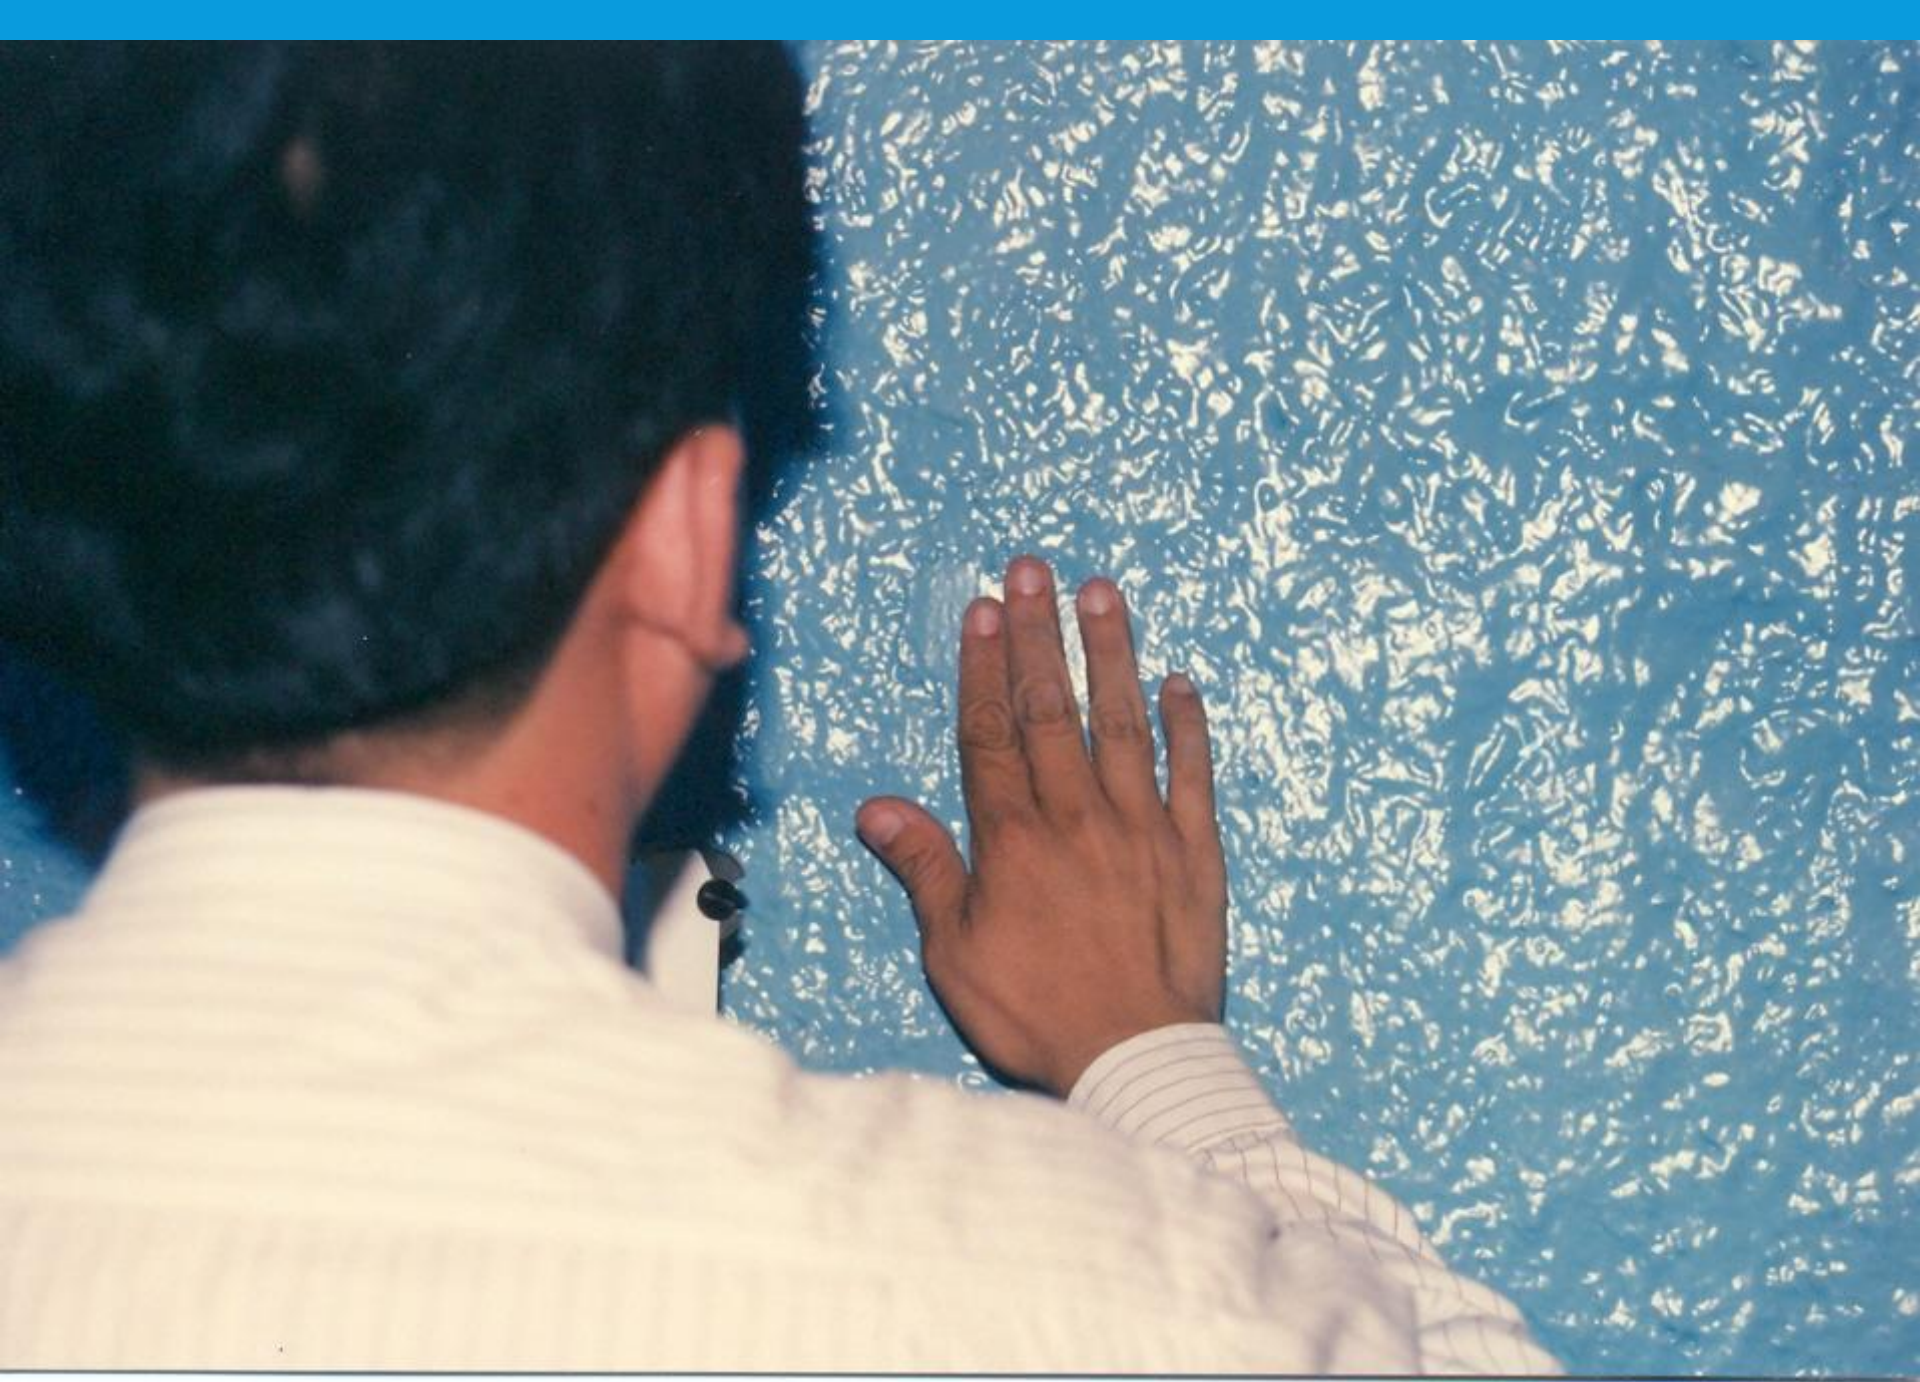
1992

**After finished
we found
bubble blow
out
from the wall**

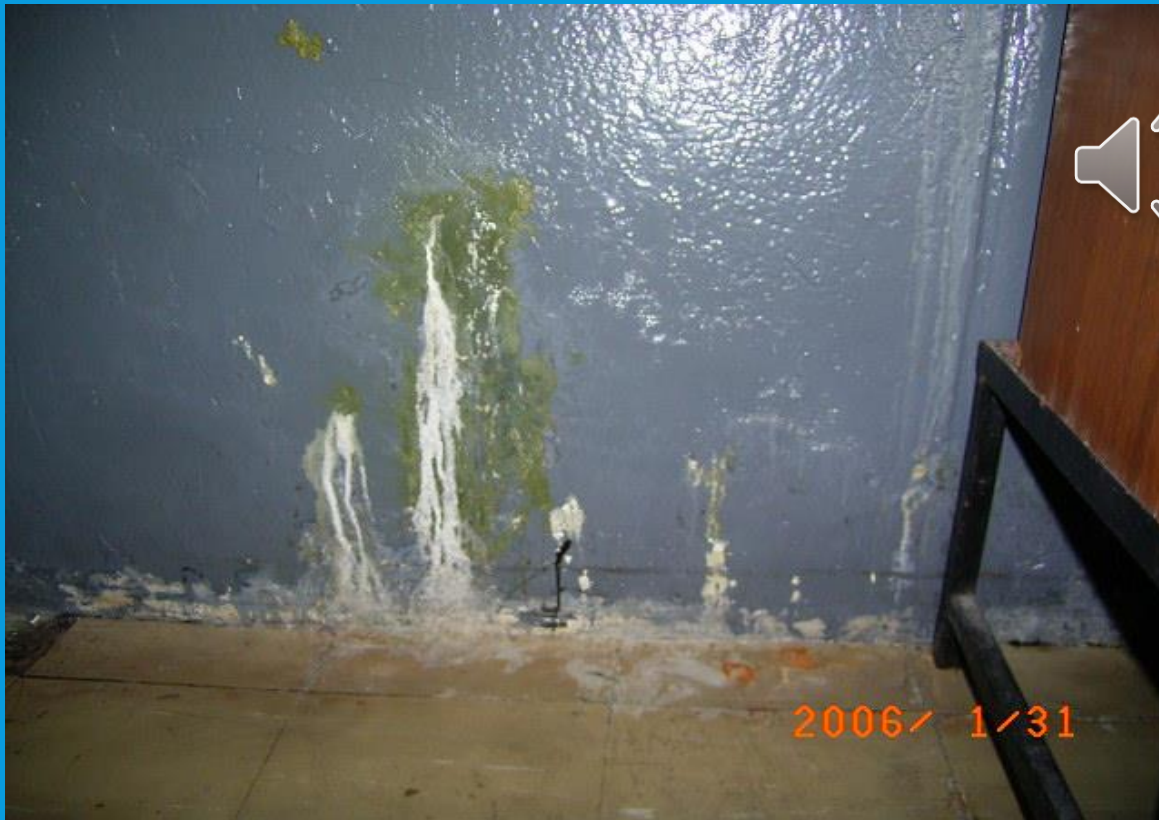
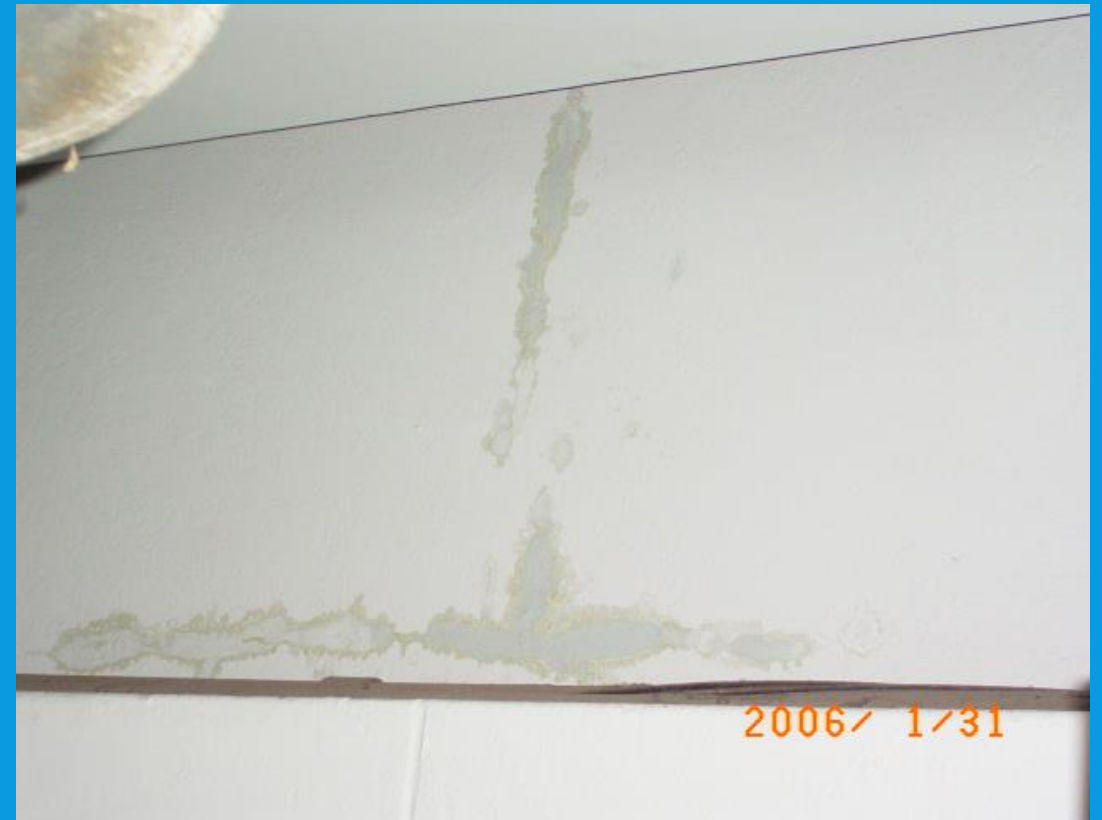
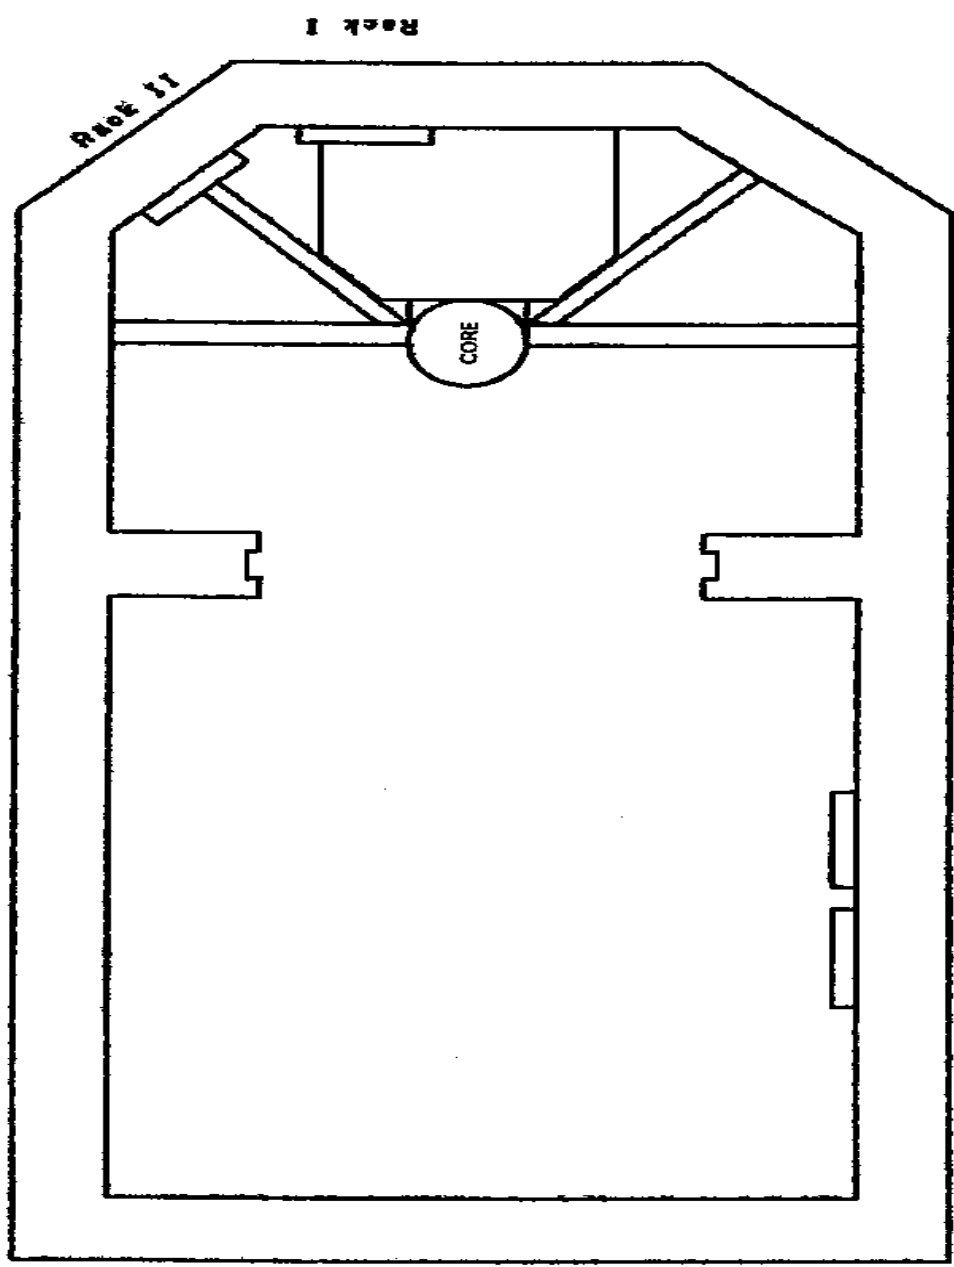
Leakages was found in the end of 2004 at the location near the leakages in 1992

(large portion of the pool)

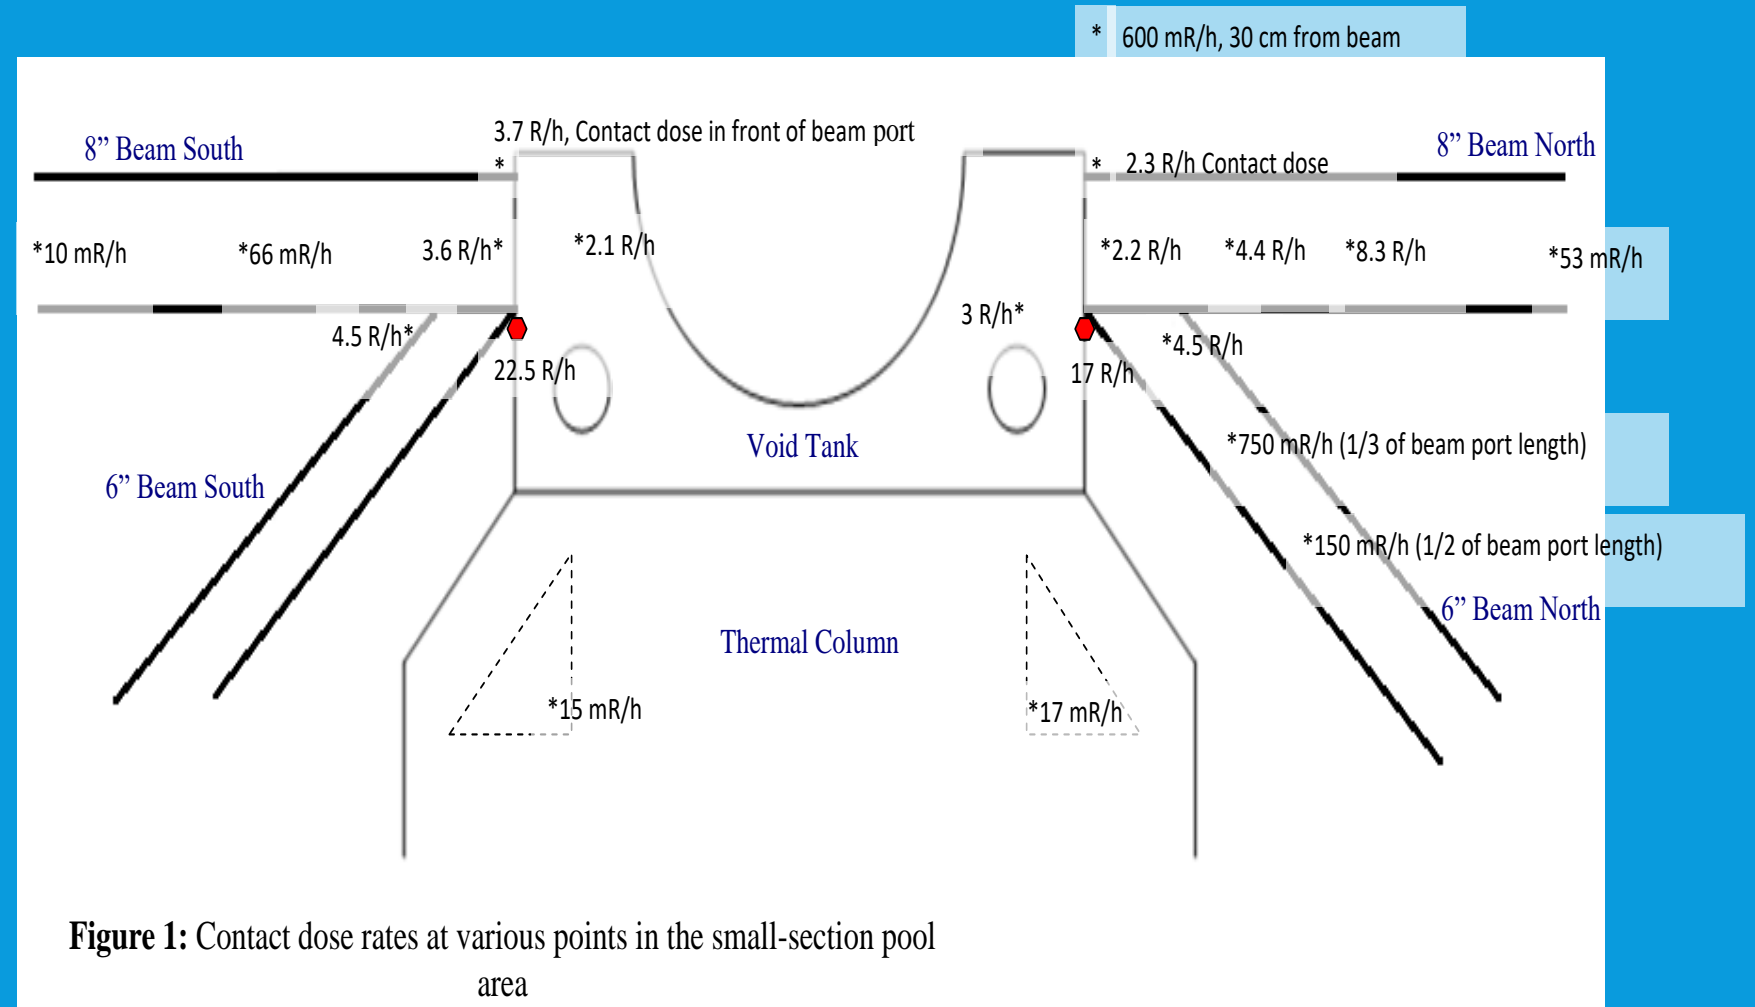
After we did “Dose Measurement” in 2011 we found some area have high Dose rate

The measured dose rate shows high radiation field in the in-pool area. There are two main hotspots (as shown in red) which have radiation dose of approximately 20 R/hr. These hotspots are from the bolts and nuts which align the void tank and neutron beams in their designed positions. It is believed that the bolts and nuts are made from stainless steel

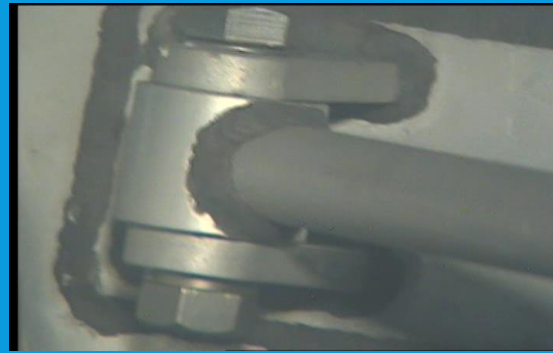
Top-South Location (#1)

all bolt-nut sets are in good physical condition except the bottom-south location which consists of rusty top washer. To minimize personnel contamination, the bottom-south location is the last of bolt-nut removal sequence.
