FRM II: LESSONS LEARNED FROM THE REPORTABLE INCIDENT “RELEASE OF C-14 ABOVE DISCHARGE AUTHORISATION”

F. JESCHKE, A. PICHLMAIER, R. SCHÄTZLEIN

Technische Universität München, ZWE FRM II

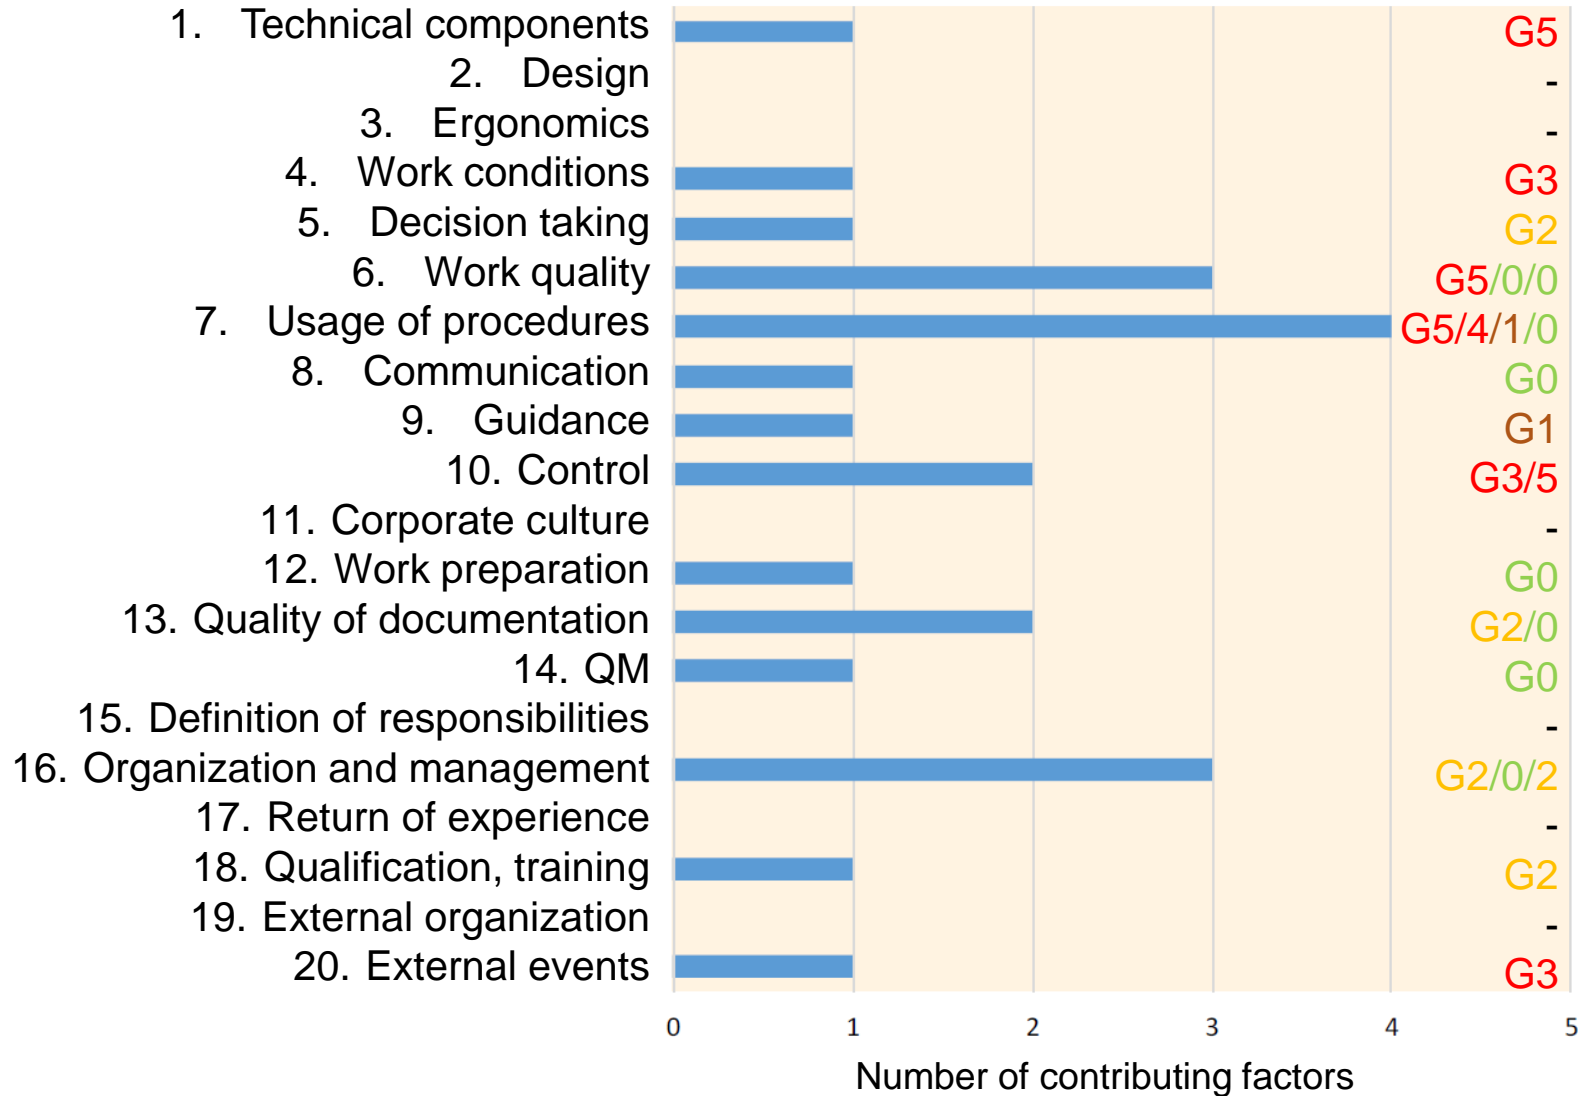
- Done with external support by professional service provider
- Duration of the analysis: December 2020 to March 2021
- Approach
 - 28 interview with 19 persons on all levels (from operator to upper management)
 - Divide event into small “construction blocks”
 - Identify the contributing factors
 - Weight the contributing factor from G0 (no contribution) to G5 (very important contribution)
 - Presentation of results
 - Define and execute the action plan

- Contributing factors and weight

weight

- Reactor operation suspended for more than one year
- Complete new construction of the C-14 removal device (ongoing)
- Root cause analysis was done, the main conclusions lead to:
 - Training of the personnel on communication and improved professional behavior (HPO, first and second round completed for 100 % of employees)
 - New construction of the C-14 removal device (cf. above, confirmed by the root cause analysis)
 - Several minor changes concerning e. g. review of the management system, handling of procedures, organization of recruitment.
