STATUS OF THE RESEARCH REACTOR FRJ-2 AT THE RESEARCH CENTER JÜLICH, GERMANY

J. Wolters

Central Division of Research Reactors and Nuclear Facilities
Forschungszentrum Jülich GmbH, D-52425 Jülich

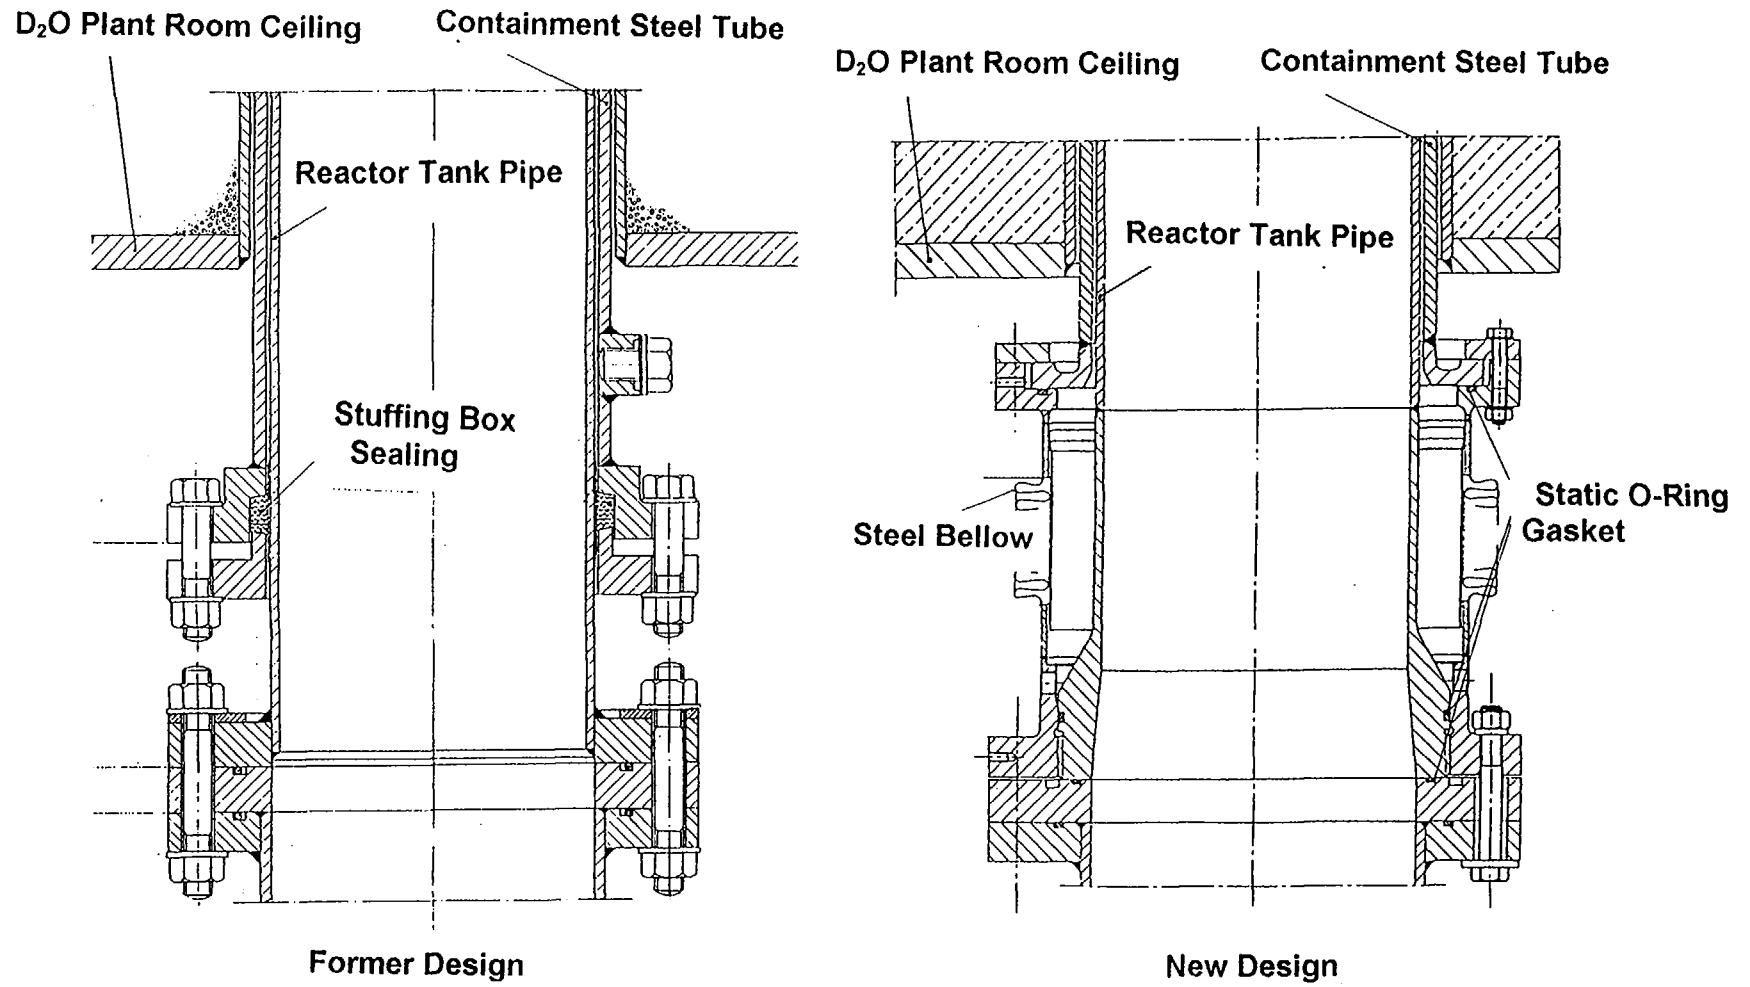
The sealing between the tank pipes and the liner tubes of the steel tank was provided by stuffing boxes as is shown in Fig. 2. The reason for this design was that the fixed point of the tank lies at the top flange so that the thermal expansion of the tank and its pipes requires a free movement of the tank pipes at the sealing.

In the past, leaks in two smaller pipes resulted in the ingress of heavy water into the graphite reflector and thus also into the gaps between the liner tubes of the steel tank and the reactor tank aluminum pipes. Of course, after the events had been detected the water was drained from the graphite reflector, but the moisture left in the bottom part resulted in corrosion of the steel tubes. The gaps were filled with corrosion products which became very solid during the course of time and hindered the movement of the tank pipes so that unacceptable stresses were caused in the bottom of the reactor tank.

The problem became obvious when the movement of the tank pipes against the steel tubes was measured and was found to be inadequate for all pipes. After having realized that the problem required a fundamental solution, it was decided to replace the stuffing-box design by a new design using steel bellows and O-ring gaskets (Fig. 2). The lower part of each unit of steel and aluminum tube was cut in two steps using a compass saw and a milling cutter device. The radioactive corrosion products were removed from the gaps and new flanges were welded to the steel tubes and new nozzles to the aluminum pipes. Tritium release during welding was almost totally avoided by heating the aluminum material used before welding.

Fig. 2: Sealing between the Reactor Tank Pipe and its Containment Steel Tube at the Outside of the Biological Shield

The new design represents an improvement of the plant since all the aluminum pipework is now enclosed by stainless steel and the sliding seal has been replaced by a static one.
