## **Wear Inspection for Fuel Channels in HANARO**

*Sang-Ik WU, Yeong-Garp CHO*

HANARO Applications Research, Korea Atomic Energy Research Institute

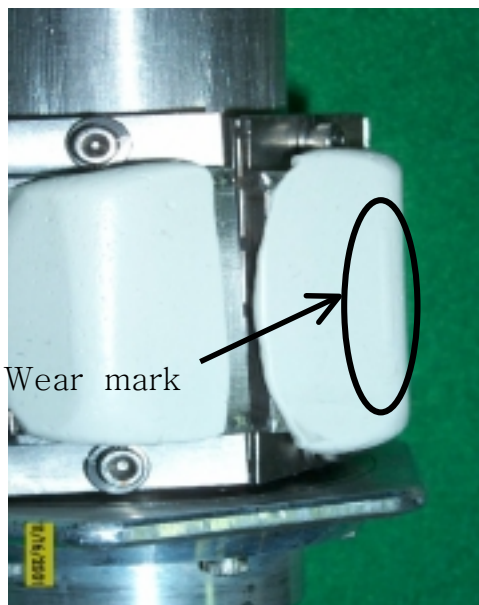
Figure 5. Wear mark by bottom guide  
(0.2mm height X 20mm)

channels and one cylindrical channel that are judged to be in the group of the worst channels based on the statistics of the fuel inspection. The results show visible wear mark on one of the hexagonal flow tubes at the positions of the top guide and the bottom guide of the fuel assembly. Figure 5 shows a typical wear marks caused by the zirconium bottom guide of the fuel assembly shown in figure 6. But the wear damage is very slight, 0.2mm maximum depth measured by a precision dial gauge, in comparison with the thickness of the fuel channels (1.6mm). No visible wear mark has been found in the cylindrical flow tube so far. The wear inspection is being continued for all the remaining fuel channels to get valuable results for estimation of the lifetime of the fuel channels.

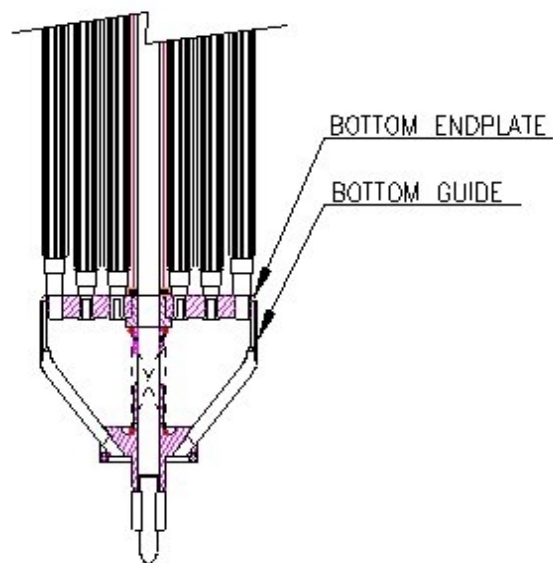
Figure 6. Lower part of fuel bundle
