EXPERIENCE ON MAINTENANCE OF THAI RESEARCH REACTOR “SMALL-POOL” SECTION

C. TIPPAYAKUL*

*Reactor Management Section
Thailand Institute of Nuclear Technology (TINT)
16 Viphavadee Rd. Bangkok, Thailand 10900*

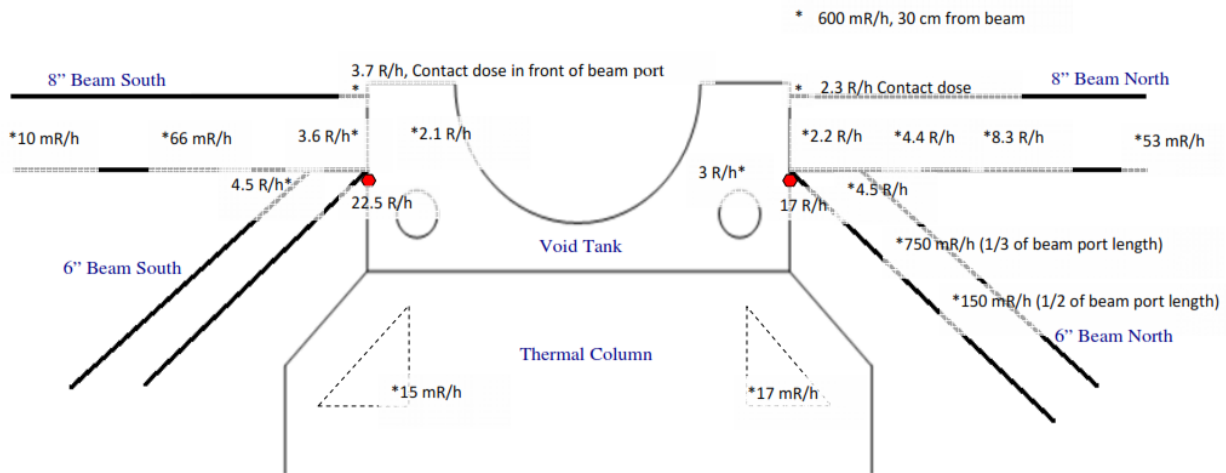
Fig 2. Radiation dose rate at various positions in the small-section area

From the radiation survey, three hot spots were identified. The first two areas were on the left and right side of the void tank. It was found then that the high dose rate was caused by 4 sets of bolts and nuts supporting the void tank. These bolts and nuts were made of stainless steel as supposed to aluminum alloy. However, it was also found that one of the washers was corroded suggesting that this particular washer was made of galvanized steel rather than stainless steel. The last hot spot was near the middle of the 8" north neutron beam. It was believed that there was also stainless steel acting as a structure inside the beam. Spectrum analysis of the radiation detected Co-60 as the main nuclide in these hot spots.

The strategy to execute the project was discussed at the inception of the planning. It was decided to remove the bolts and nuts and to replace with the new ones before entering the area in order to reduce the radiation dose rate. The removed hot items were to be placed into a shielded container and to be transferred to the large-section pool for temporary storage during the re-painting operation. Two methods to remove the bolts and nuts were discussed. The first was to remove them under water with special tool and the second was to drain the water completely and to remove them in air using normal tool. The first method had the advantages that the radiation dose rate in the working area would be much less but it needed to take longer time since it was much more difficult to conduct the work from far distance and special tools had to be prepared. The second method, on the other hand, would take much shorter time and no special tool had to be prepared but the radiation dose rate in the working area would be higher. It was finally decided that the execution strategy was to adopt the first method since the risks from unexpected situations could be better controlled and minimized.

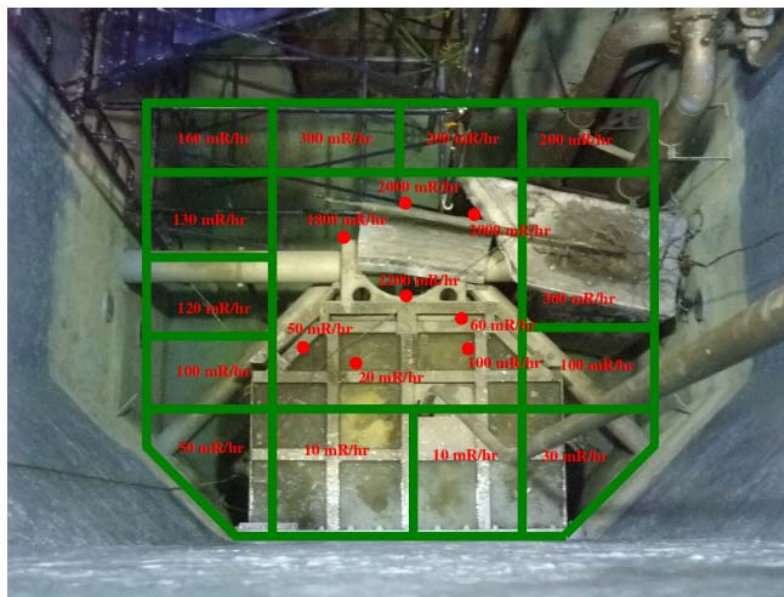
Fig 3. Radiation dose rate map of the reactor pool when completely drained

The radiation dose rate map showed that the area in the line of sight from the north beam had relatively higher dose rate than other area. Workers to perform the coating were advised to avoid or spend minimum time in the area. Strict radiation control such as time limit, equipping all workers with digital dosimeters for real-time monitoring, daily exposure record, contamination monitoring was enforced. The coating activities were finally completed according to the planned schedule. The exposure to all personnel in the project was found to much less than the target limit – the maximum exposure was 1.1 mSv and the collective dose for the whole project was 8.4 man-mSv.
