# AGEING MANAGEMENT AND PREVENTIVE MEASURES FOR REACTOR POOL LINER AND BEAM TUBES AT THE DALAT RESEARCH REACTOR

NGUYEN NHI DIEN\*, NGUYEN MINH TUAN AND TRANG CAO SU

*Nuclear Research Institute, 01 Nguyen Tu Luc Street, Dalat City, Vietnam*

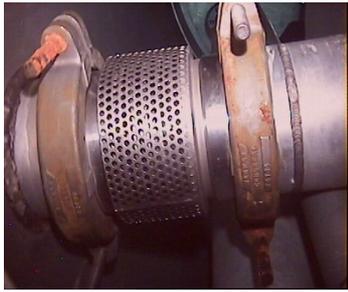
- As previous results, the most concerns were with the beam port No #4 because two of four steel bolts to tighten-up the flexible joint (the bellows assembly flange of beam port) were rusted and the results indicated that this rust was slowly developed and the electrochemical corrosion may happen with these bolts. However it was difficult to explain clearly because only two of four bolts are rusted, but other two bolts still have a shining color of stainless steel (Fig. 3).

**Fig. 3a.** Four bolts to tighten-up the flexible joint of the beam port No #4 (down side).

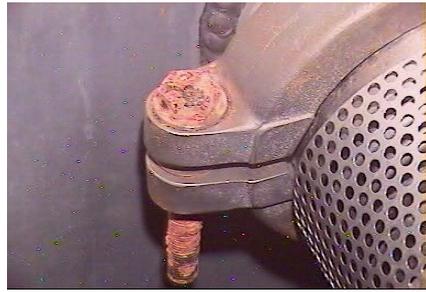
**Fig. 3b.** One steel bolt at beam port No #4 (reactor pool wall side).

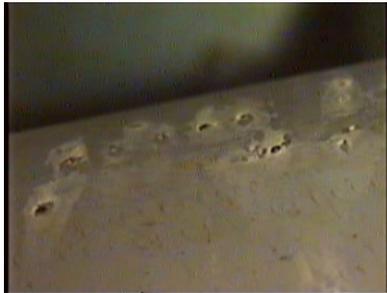
- There were some pitting corrosions with 2-3mm in diameter on the outside surface of beam port No #3. It may be due to surface scratches or mechanical defects happened when the re-installation of reactor structures done during the years of 1982-1983. Based on the pictures taken during last five years, it can be concluded that corrosion phenomenon still happens but slowly develops (Fig. 4).

**Fig. 4a.** Pitting corrosion on the upper surface of beam port No #3.

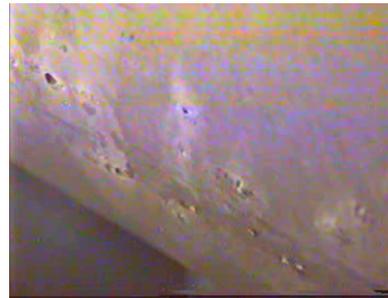
**Fig. 4b.** Pitting corrosion on the side surface of beam port No #3.

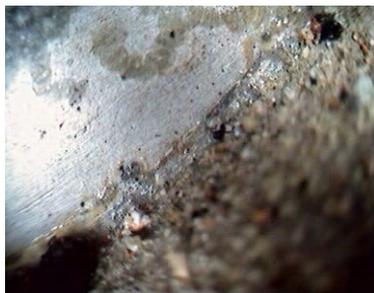
It was the first time from TRIGA reactor construction, all its four beam tubes have been carefully opened, cleaned and visually examined by the designed camera system. Some pictures are shown in Fig. 5 and Fig. 6. Based on the results obtained it can be concluded that the status of all four beam tubes of the DNRR are still in good condition and the reactor can be continuously safely operated without water leakage happened.

**Fig. 5a.** Inside surface of beam tube No #1 before cleaning.

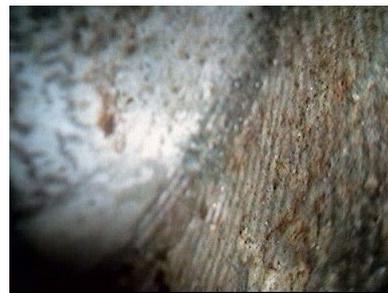
**Fig. 5b.** Inside surface of beam tube No #1 after cleaning.

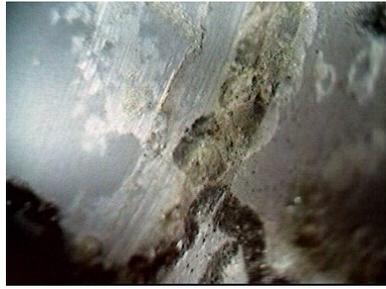
**Fig. 6a.** Inside surface of beam tube No #2 before cleaning.

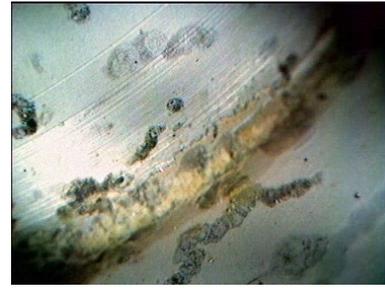
**Fig. 6b.** Inside surface of beam tube No #2 after cleaning.
