Modification and Continue Monitoring of Kartini Reactor Tank Liner for Long Term Safe Operation

Puradwi I.W.¹, S.Nitiswati², T.Tjiptono¹, Umar S¹.Tri Nugroho¹

¹Center for Accelerator and Material Process Technology – BATAN, Yogyakarta - Indonesia

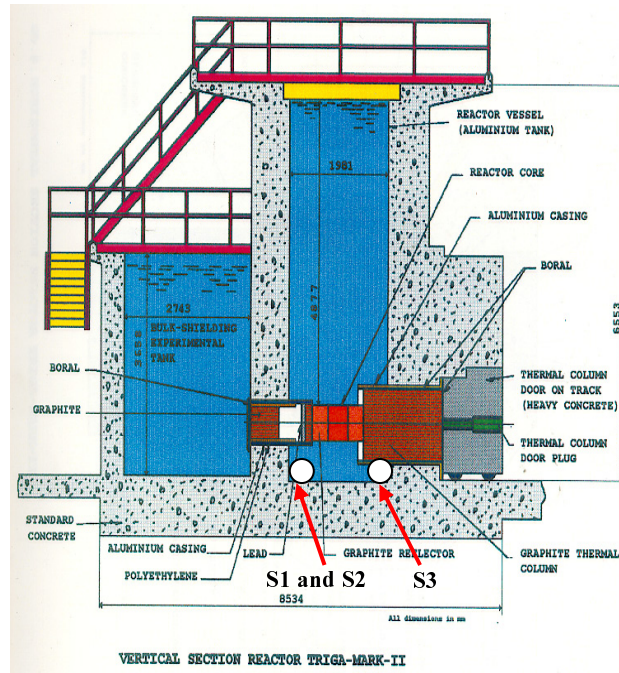
The two swellings features seen on the bottom of the tank observed under thermalizing column indicated as S1 and S2. These swellings could not be examined in more detail due to shortfalls in equipment capability. At that time they were not considered to be a serious issue for future safe operation.

Inspection result in 2007, another swelling feature on the bottom of tank observed under thermal column, indicated as S3. By using the same technique, profile measurement of S3 has been conducted. In S3 were obtained 5 dimples, such as 2 dimples with 2 mm in diameter, 2 dimples with 3 mm in diameter, and 1 dimple with 4 mm in diameter approximately[5].

Fig.1. Cross section of Kartini reactor and swelling locations[5]

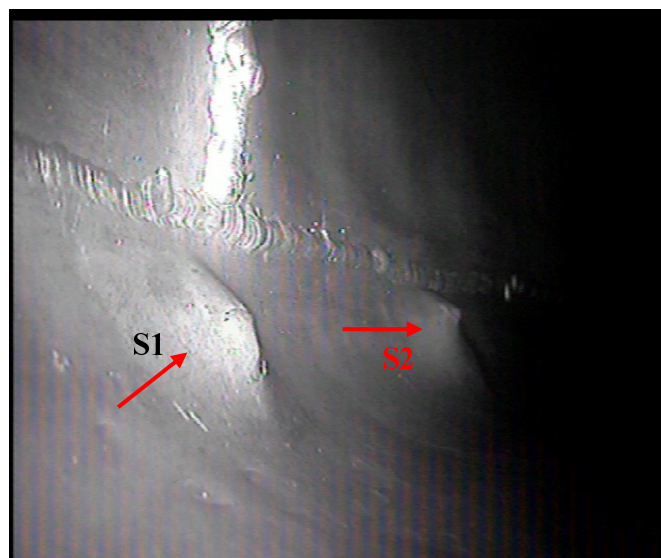
Result of inspection in 2004 utilized visual technique obtained as same as condition in 2001. The two swellings feature observed under thermalizing column. To obtain the swellings profile, such as height and areas of swellings, replication technique utilized putty was applied. Detailed measurement of the swellings profile can be obtained by measuring the height and area of the swelling replica impression utilized a height meter. In peak of S1 appeared 2 tears and 2 dimples. Lengths of tears were 14 mm and 5 mm approximately, dimple diameters were 2 mm and 3 mm approximately. In peak of S2 appeared 2 tears, they were 10 mm and 2 mm of lengths. Thickness measurement on the swelling areas of S1 and S2 on the bottom tank were obtained to be between of 5.3 mm – 5.5 mm indicated that the metal thickness in the areas of swelling were similar to the reactor tank wall thickness and to the original metal thickness[3].

Inspection results in 2005 were seen that S2 increased both in height and area. The thickness of reactor tank wall at various locations and thickness of swelling areas were still consistent in ranged between of 5.3 mm – 5.5mm[4].

Fig.2. Swellings profile of S1 and S2[5]

Lengths of the two tears in peak of S1 were 14 mm and 5 mm approximately, and diameters of the two dimples were 2 mm and 3 mm approximately.

Lengths of the two tears in peak of S2 were 10 mm and 2 mm approximately. In S3 were obtained 5 dimples, such as 2 dimples with 2 mm in diameter, 2 dimples with 3 mm in diameter, and 1 dimple with 4 mm in diameter approximately[12].

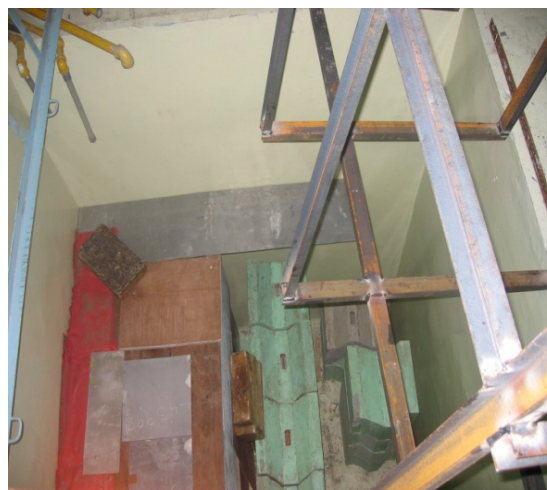
Fig.3. Modification activity of BSF[8]

In March 2008 a remedial action such as modification of BSF has been conducted to remove the conditions that are causing swelling. The BSF was dried and then half of BSF area which contacted to the thermalizing column was lined with aluminium supplied by local company to prevent future water penetration to the concrete. Modification activity of BSF are shown in Figures 3. Figures 4 and 5 are showing BSF before modification (before remedial action) and BSF after modification, respectively.

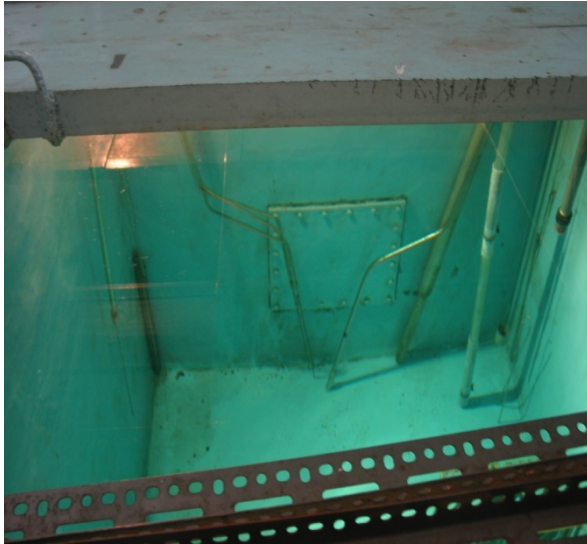
Root cause analysis of swelling problem has been performed in comprehensive by IAEA expert team during the time of inspection. Probable root cause of swelling is the seal of cover plate in BSF has deteriorated and allowed water in BSF entered both the thermalizing column and space between the aluminium reactor tank liner and the concrete. The water also saturated the concrete and has potential to corrode the steel reinforcement close to the surface of the concrete. It is believed that water leakage from the BSF has entered the area behind the aluminium tank liner and has saturated the concrete, and also believed the carbon steel reinforcement bar that were located close to the inner surface of the concrete pool backing has corroded. The expanding corrosion product (rust) has force the layer of concrete covering the steel reinforcement and subsequently pushing the aluminium bottom tank inwards and causing the swelling [6,7].

Under coordination of the IAEA expert team, in August 2007 the sealing plate cover the thermalizing column was removed and approximately 200 liters of water was drained from the thermalizing column. The first 200 mm thick layer of graphite was removed to allow examination of the aluminium behind the boron layer separating the graphite and thermalizing column. Examination the condition inside of the thermalizing column indicates that uniform corrosion has occurred on the inside of the thermalizing column. The painted surface of BSF concrete wall contained crack that have allowed water penetration[7].

Fig.4. BSF before modification[9]

The IAEA expert team recommended to modify BSF, such as surface area of the BSF concrete should be lined with aluminium to prevent future water penetration[6].

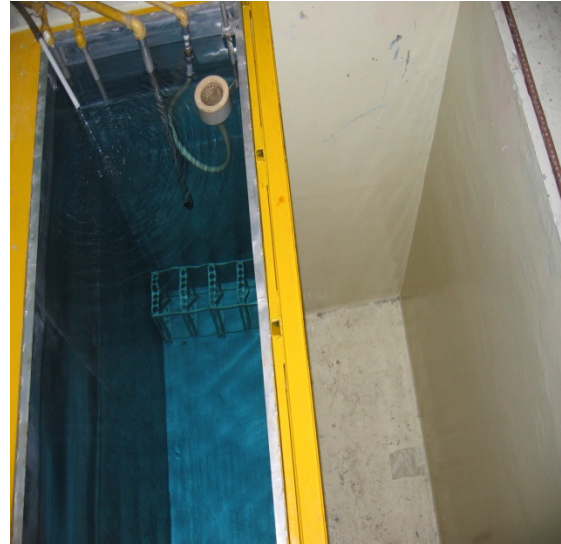
Fig.5. BSF after modification[9]

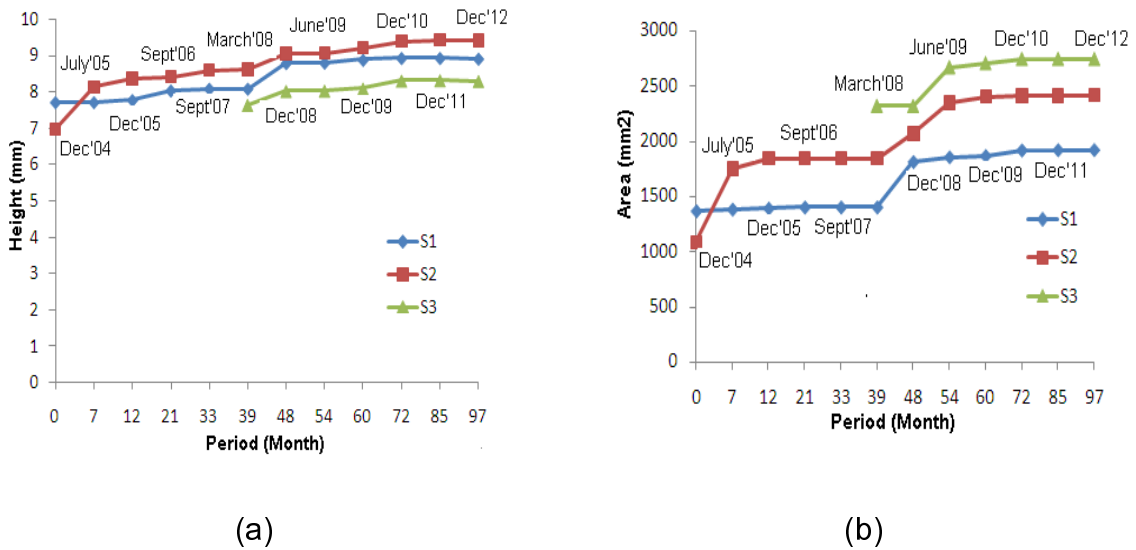
Fig. 6. The graph of swelling S1, S2, and S3, (a) height in mm and (b) area in mm²[12]

Data in the Figure 6 shows that the swelling height and area had grown slowly in size and became relatively stable from year 2009. Taking into account the remaining thickness of the aluminium at the swelling location could not be accounted by the formation of corrosion products from aluminium due to the low "pilling-bedworth ratio" for aluminium. The occurrence of the swelling as an ageing consequence.
