AGEING MANAGEMENT AND REFURBISHMENT OF RESEARCH REACTOR CIRUS

RAKESH RANJAN* & R. C. SHARMA

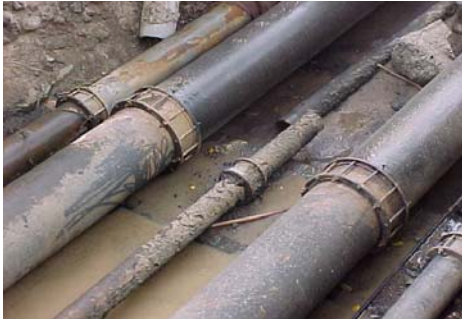
3.3 Primary Cooling Water (PCW) Pipelines: PCW system pipelines are made of carbon steel (A53 grade A) except the embedded pipe sections which are made of SS 304. A major chunk of pipe lines run subsoil about 4 m below ground level and are joined together by mechanical couplings called Dresser Coupling (DC) having elastomer seals. These couplings have features to accommodate thermal expansion of pipe sections as well as minor misalignment between the pipe sections. Outer surfaces of pipelines were provided with asphalt coating for weathering protection. One DC joint on core outlet line housed in an underground concrete pit developed leak during the 80's. As the leak rate was well within the make-up capacity of the system and leaky water was not going into sub-soil, DC replacement was postponed during refurbishment outage as the job involved core unloading. During refurbishment all underground pipe lines were pressure tested. The test pressure was limited to 110% of maximum operating pressure as per the guidelines of ANSI B-31.4. Leakage was observed from one more DC joint. In view of failure of two nos of DCs, all underground lines were exposed by excavation and elastomer seals were replaced. Old weathering protection was removed, external surface of pipelines was inspected and repaired by metal filling wherever required. Some smaller diameter pipelines which were subjected to varying internal environment condition were replaced as their thickness had reduced due to corrosion. For leakage detection in future by acoustic emission method, wave guides were welded to pipelines. Bore holes were installed near pipelines for checking of activity of sub-soil water near them.

DCs exposed.

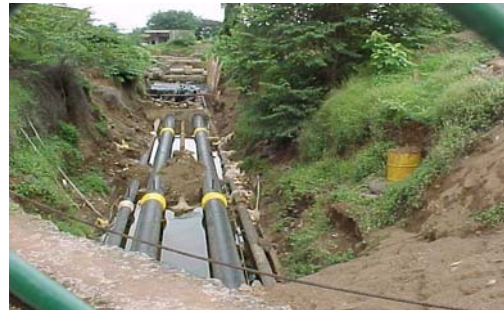
UG lines after weathering protection
