# Development of a Low Temperature Irradiation Capsule for Research Reactor Materials

## ABSTRACT

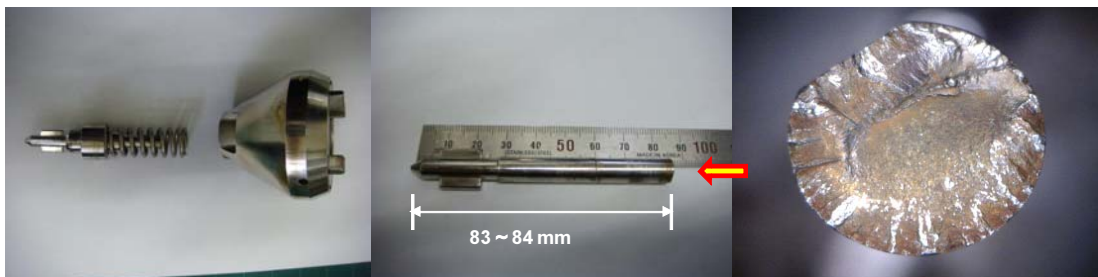
Owing to the internal flow of the coolant, the bottom part of the capsule was suspected to be susceptible to a vibration-induced fatigue failure. To strengthen the soundness of the bottom parts, the material of the rod tip was changed from stainless 304 to stainless 316L, and the welding method was also changed from TIG welding to an EB welding method.

An out-pile endurance test was performed on a 110% condition of a reactor coolant flow amount in the single channel out-pile test loop. As the rod tip of the out-pile testing capsule was failed during 7 operation cycles, as shown in Figure 5, continuation of the on-going irradiation testing of the capsules at HANARO was discussed based on an analysis of the failure [4].

Fig. 5. Failed rod tip of the 11M-19K out-pile capsule

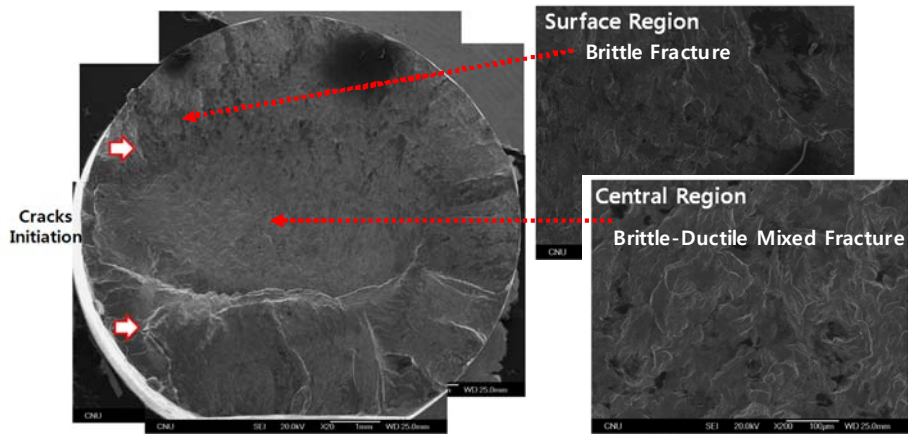
Figure 6 shows SEM micrographs of the fractured surface of the failed rod tip. It shows a typical appearance of torsion-induced fatigue fracture in the literature [5]. The fracture topography shows that cracks initiated at near the surface propagated into the central region and finally fractured, resulting in a brittle-ductile mixed fracture surface. Figure 7 shows that the out-pile test condition of 110% of a reactor coolant flow amount resulted in an increased directional coolant flow-induced vibration than a normal coolant flow condition of 100%. The amplitude of the vibration of the capsule was increased up to  $128 \mu\text{m}$  in the 110% coolant flow condition from  $73 \mu\text{m}$  of 100% coolant flow condition. The increased amplitude of vibration seems to be directly related to the failure of the out-pile test capsule. Based on the fractography and the increased amplitude of vibration of the capsule, the cause of the failure was attributed to a vibration-induced fatigue cracking. To clear the cause of the failure, the stress analysis and fatigue property of the failed part of the capsule are under examination.

Fig. 6. SEM fractography of the failed rod tip of the 11M-19K capsule

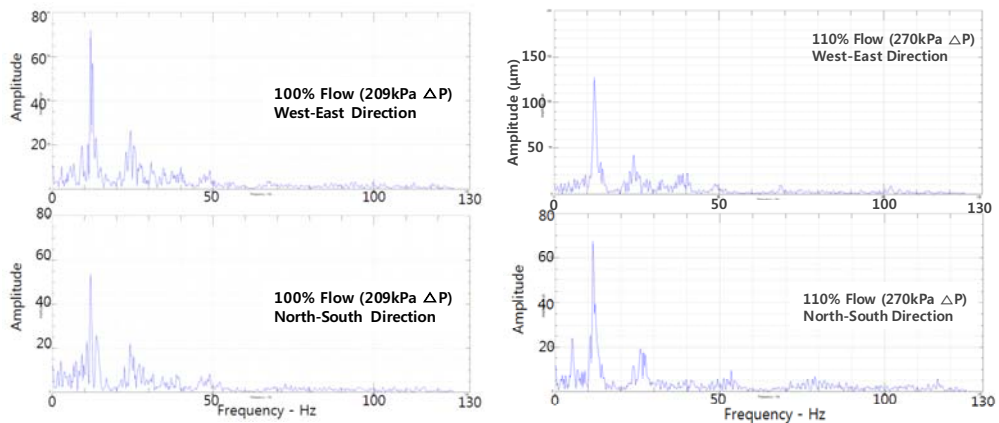
Fig. 7. Comparison of amplitude of vibration of 11M-19K capsule in 100% and 110% flow amount condition of reactor coolant

Based on the out-pile test results, two irradiation capsules of 11M-20K and 11M-21K were designed and fabricated [6]. Considering the increased amplitude of the vibration of the capsule during the out-pile endurance test of the 110% coolant flow condition, the capsule was estimated to be sound up to 7 irradiation cycles in HANARO of 100% coolant flow condition. Therefore, the irradiation capsules (11M-20K and 11M-21K) were loaded and irradiated in the CT and IR2 test holes of HANARO, respectively. Figure 8 shows a typical reactor core of HANARO with an irradiation capsule installed in the CT hole. The 11M-20K capsule was successfully irradiated for 4 cycles and transferred to a hot cell of IMEF. Figure 9 shows a variation of the temperatures of the specimens of the 11M-20K capsule irradiated in the CT Hole of HANARO (Cycle No. 83).

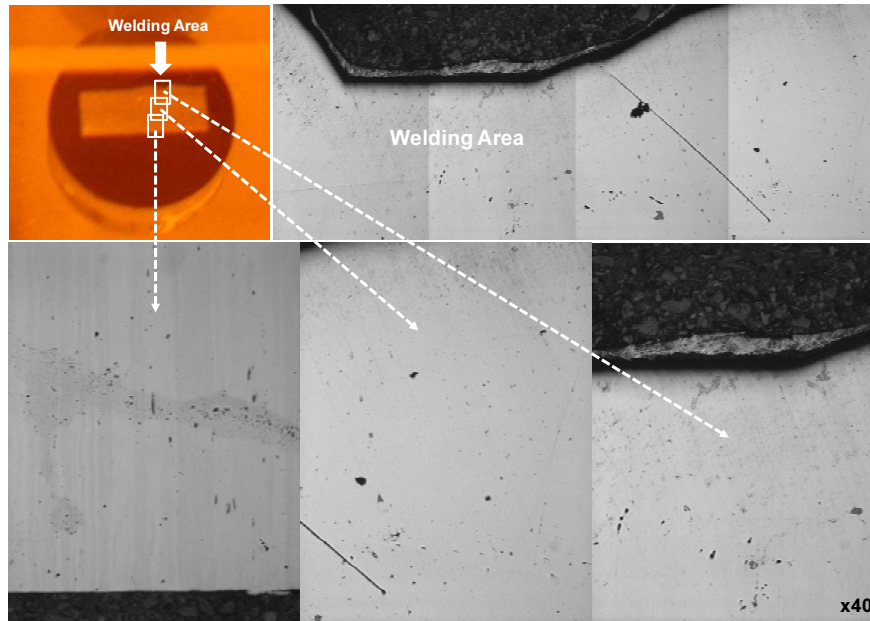
The rod tip of the irradiated capsule was sectioned into two parts, and the internal area was examined with an optical microscope and SEM to see an occurrence of fatigue cracks. Cracks or defects were not found in the rod tip of the irradiated capsule, as shown in Figure 10 and 11. Based on the soundness of the rod tip of the 11M-20K capsule, the irradiation of 11M-21K capsule that was already irradiated for 7 cycles in the reactor core will be extended to up to 8 cycles as required by the user.

Fig. 10. Examination of the welding area of the rod tip of the 11M-20K irradiated capsule with optical microscope

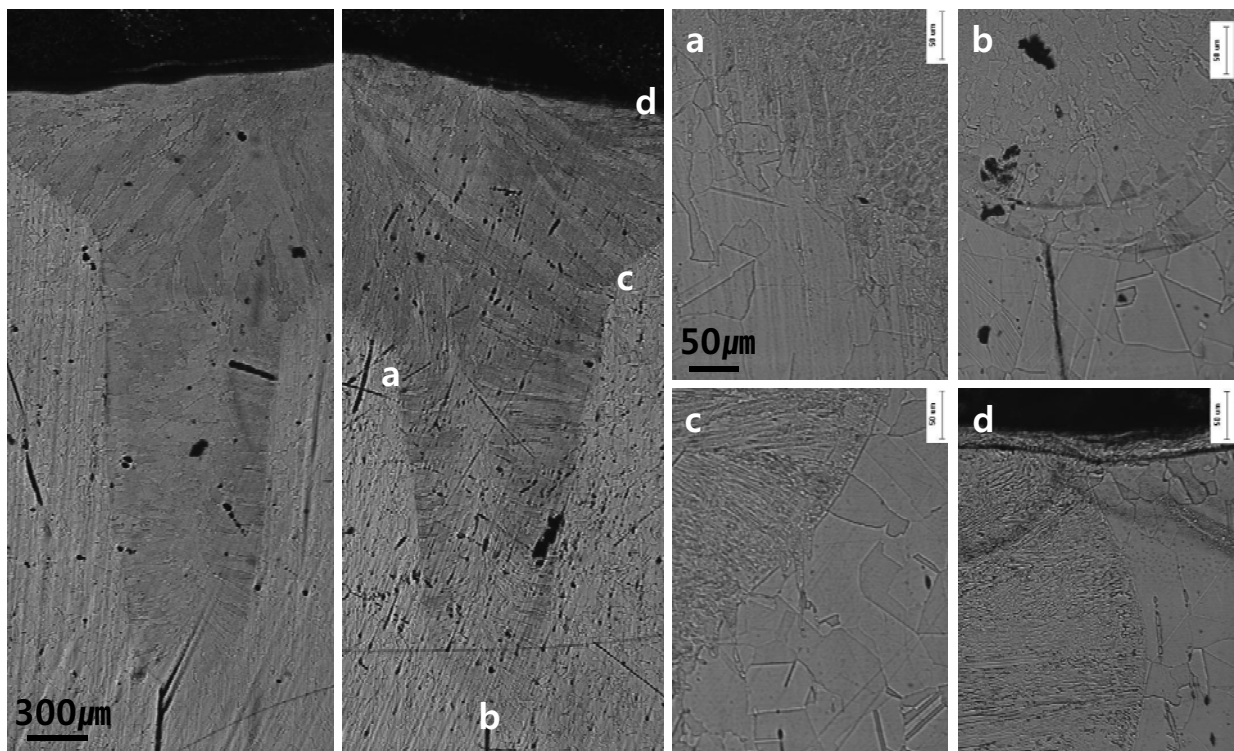
Fig. 11. Examination of the welding area of the rod tip of the 11M-20K irradiated capsule with SEM
