Current Status of JRR-3

Yoichi KASHIMA

Japan Atomic Energy Agency

2.1 Recovery works (1/2)

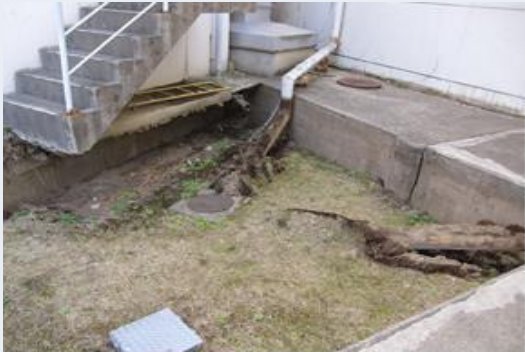
- Ground around reactor building sunk about 40cm
- Reactor building and equipment important for safe survival without getting serious damage.

Before	After
Ground sinking

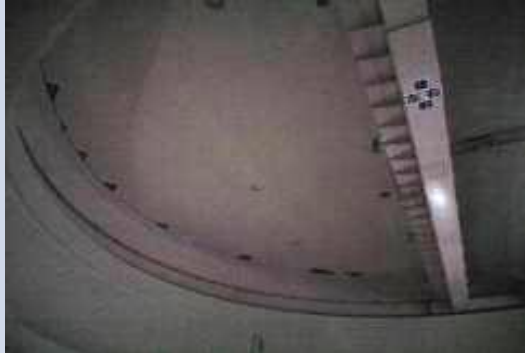
A close-up photograph of a damaged ceiling panel in a reactor building. The panel is cracked and partially detached, revealing the underlying structure.

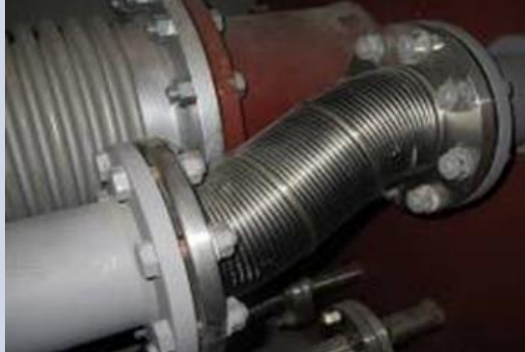
A close-up photograph of an emergency exhaust piping system. The piping is made of metal and has several flanges and bolts. It appears to be in a state of disrepair or incomplete assembly.

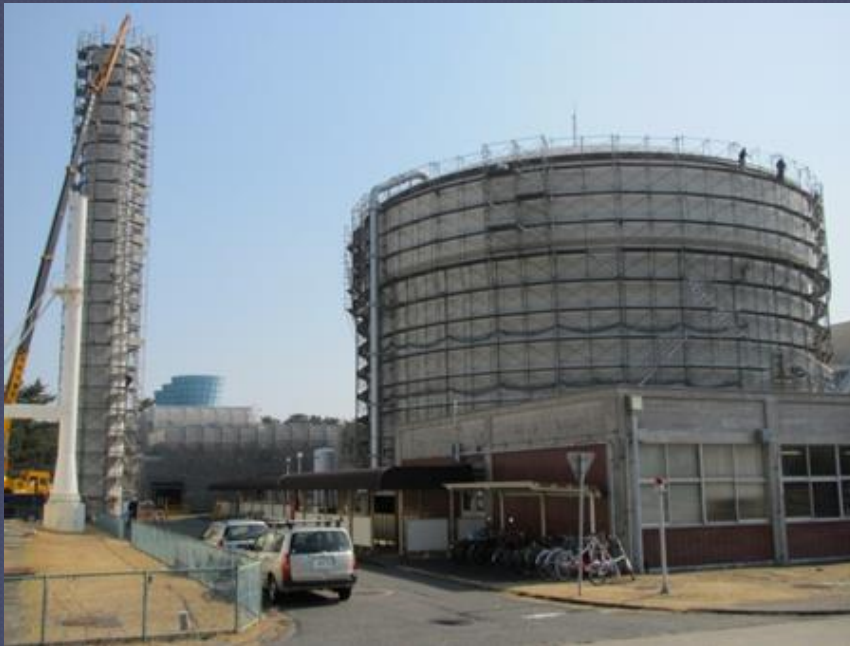
Reactor building

- Cracks of reinforced concrete structure were investigated with the installation of a scaffold.
- The cracks were mostly less than 1mm in width. Exfoliation or falling was not found.

All recovery works have already been completed.
