Secondary Cooling System Ageing Management and Refurbishment Activities at the OPAL Reactor

IAEA: Technical Meeting on Research Reactor Ageing Management, Refurbishment and Modernisation

Chris Humphrey OPAL Engineering

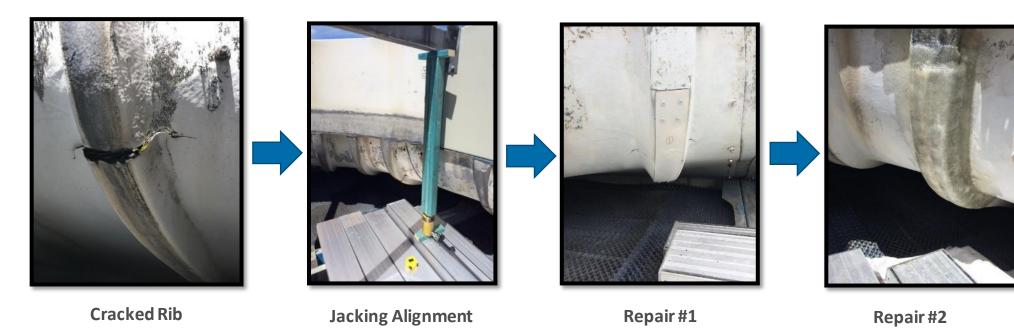
- In 2017, CT-A blades came into contact with fibreglass
- RCA found five tower support ribs were cracked and the tower was collapsing due to the 2 tonne mass of the fan assembly
- Modification Approved (Engineering Deviation Report):
 - Repairs were made to cracks and CT-A was returned to service
- Engineering commenced investigating a permanent solution

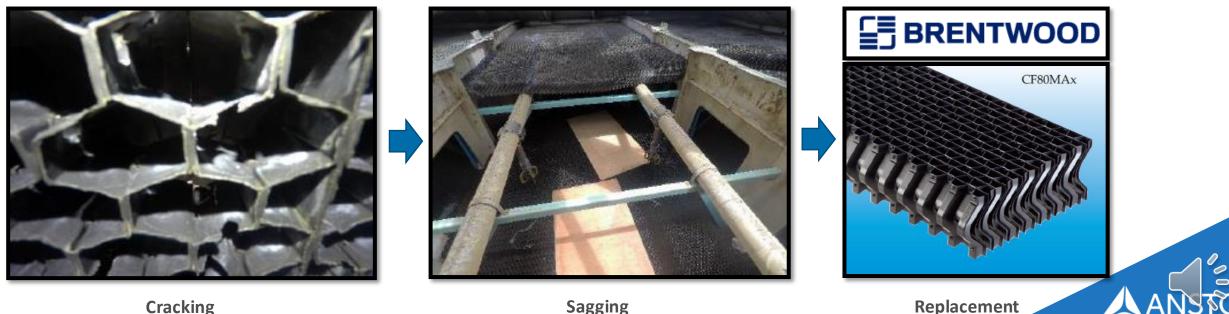
- Original drift eliminators were identified as in poor condition in 2017 and replacement prioritised due to:
 - UV damage, cracking and scale build-up, sagging due to loss of elasticity
- Australian standards required maximum drift loss of 0.002%, a safety barrier for prevention of exposure of people to legionella in water droplets
- In May 2018 new Brentwood CF80MAx drift eliminators were installed on all towers during installation of the 'load transfer frame'
- Modification approved (Component Replacement Evaluation):
 - Change to material (PVC from PP) with lower inherent flammability, stronger, improved drift loss 0.0005%

Cracking

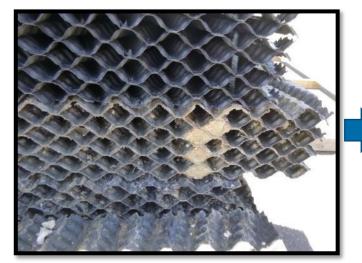
- Original internal fill or packing identified as in degrading condition in 2017 and should be replaced progressively over the next approximately 5 year period:
 - Cracking, fouling and scale build-up, sagging due to loss of elasticity, softening due to long term exposure to warm chemically treated water
- Spending is phased across financial years, so far two modules are completed with Brentwood CF1200MA:
 - Tower A: Aug 2019
 - Tower E: Mar 2021
 - Tower B, C & D: future
- Modification approved (Component Replacement Evaluation):
 - Change to material (PVC from PP) with lower inherent flammability, stronger, improved performance wettability

Fouling

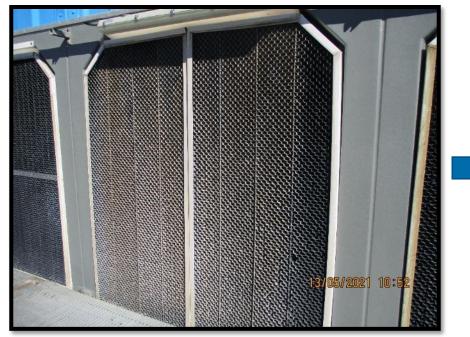
- Original air inlet louvre's were identified as in degrading condition in 2017 and should be replaced in the next 5 year period:
 - UV damage, cracking, fouling and scale build-up, sagging due to loss of elasticity
- In Mar 2021 the first 8 out of 76 removable air inlet louvres were rebuilt with Brentwood CL80, remaining
 panels will be replaced by the end of 2021
- Modification approved (Component Replacement Evaluation):
 - Change to thickness and material (PVC from PP) with lower inherent flammability, stronger, thinner with lower pressure drop

Old Air Inlet Louvre Panel

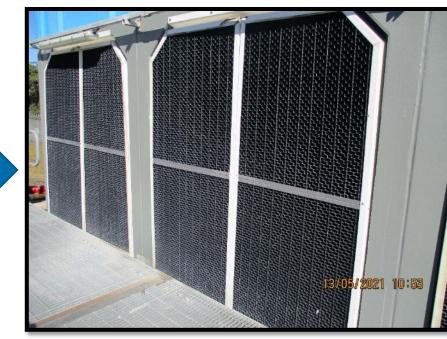
New Air Inlet Louvre Panel

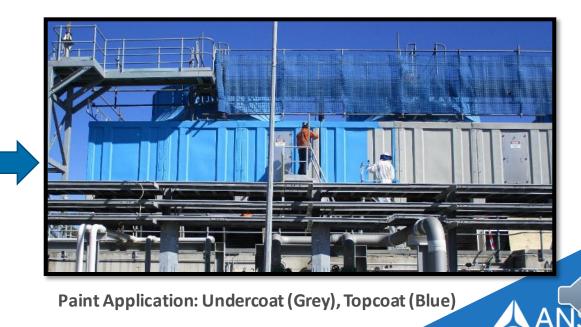
- Original fibreglass gel-top coat has lost its lustre and begun to chalk due to prolonged atmospheric weather and UV exposure.
- An epoxy painting specification was developed with DULUX industrial coatings to extend life by 15 years.
- The contractor commenced work in April 2021 involving: surface preparation, joint sealing, undercoat, topcoat.
- Modifications approved:
 - Installation of new stainless steel access doors (Component Replacement Evaluation)
 - Application of DULUX specified coating system (Engineering Deviation Report)

Original: corroded access door

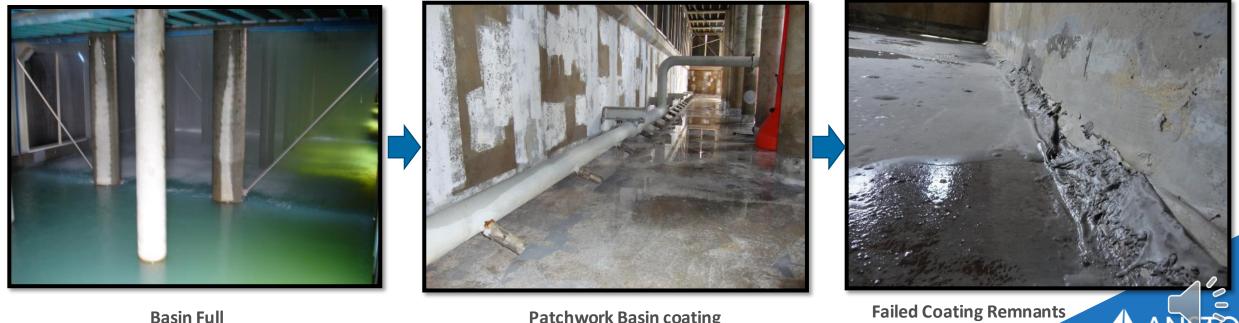
- Cooling tower basin is a concrete pool $\sim 35 \text{ m} \times 9 \text{ m}$ containing 700 kL of chemically treated water. The original waterproof lining inspected in 2010, 2012, 2014, 2016, 2019 has now completely failed.
- A long shutdown of 4 weeks is required to remediate (scheduled for June 2021).
- Modifications approved (change control submission):
 - Installation of a new concrete liner
 - Deployment of mobile cooling tower to enable completion with full basin empty

Patchwork Basin coating

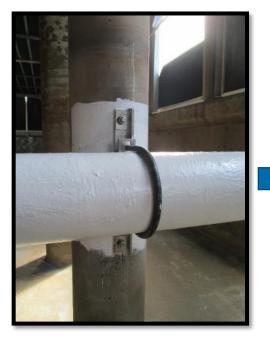
Submerged Pipe-support

- In Sept 2019 submerged pipe supports (Qty 6) were replaced with corrosion resistant and maintainable design.
- Dulux Protective Coatings:
 - Provided ANSTO with a high-performance specification (Flexituff Polyurea) to provide long term protection to an immersed substrate
 - Specification recommended: based upon that used for Australia's Water & Wastewater Industry Asset Protection'

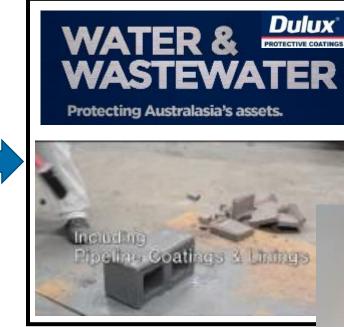
Polyurea Coating System
