# Maintenance Projects at the Oregon State TRIGA Reactor

Robert Schickler  
Steven Reese

2023 TRTR/IGORR Conference  
College Park, MD  
June 18-23, 2023

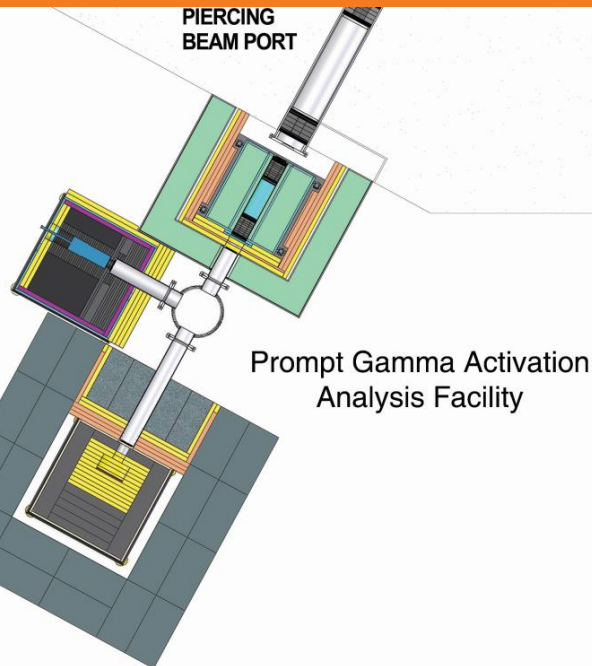
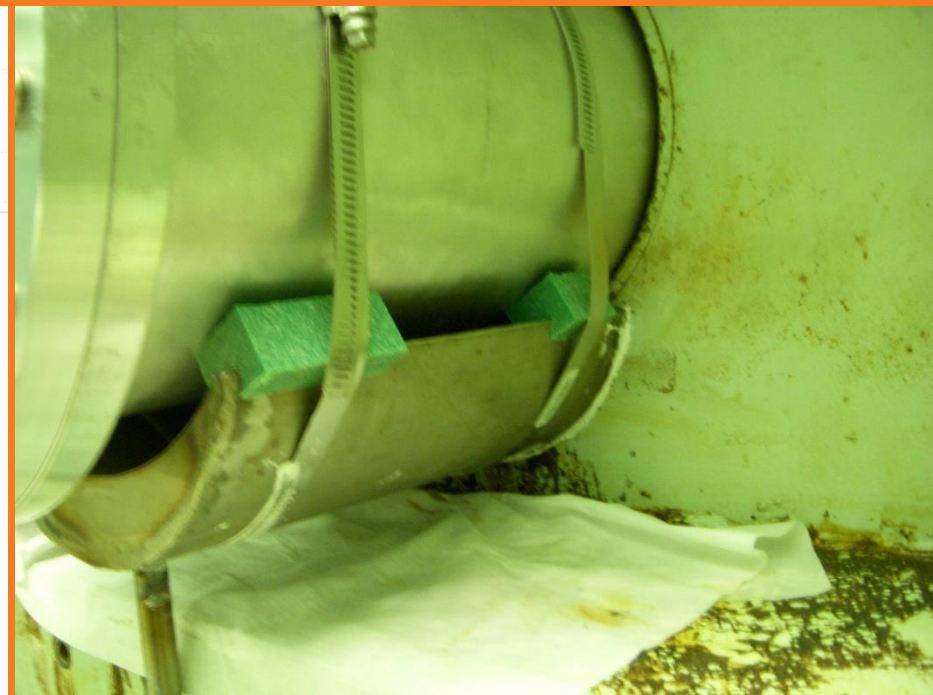
- 7/15/19 – Discovery of leak on east side of PGNAF
  - Drain had stopped leaking after reflector replacement outage of 2013
  - After 6 years, leakage returned, experimenter discovered puddle on the floor
  - Analysis of leakage indicated it was fresh reactor water, making bellows the suspect (rate  $\sim 30$  mL/hr).

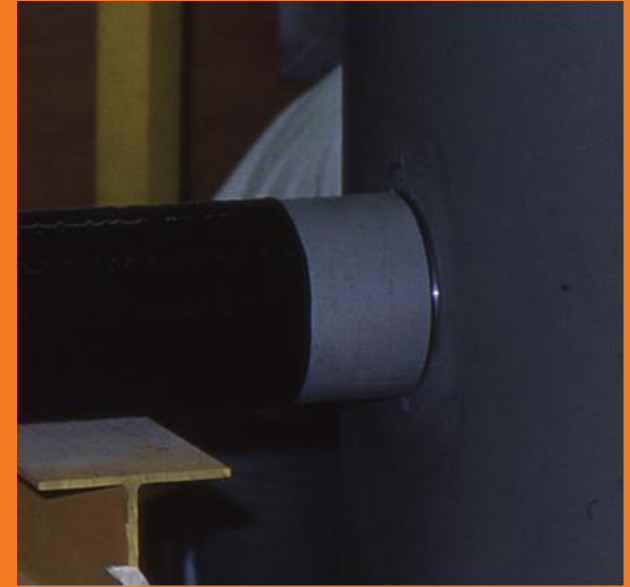
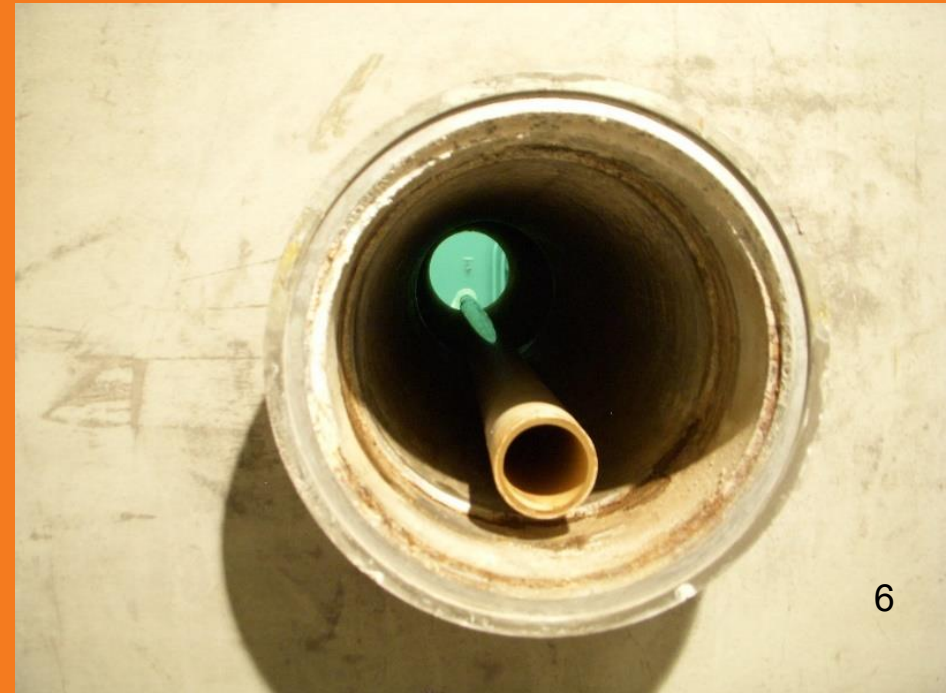
Beam port has a gap between tank and pipe embedded in the bioshield.

Bellows couples to tank via 3" pipe stub welded to inside of tank.

Leak must be sealed within this pipe stub or the leak will continue to propagate in gap.

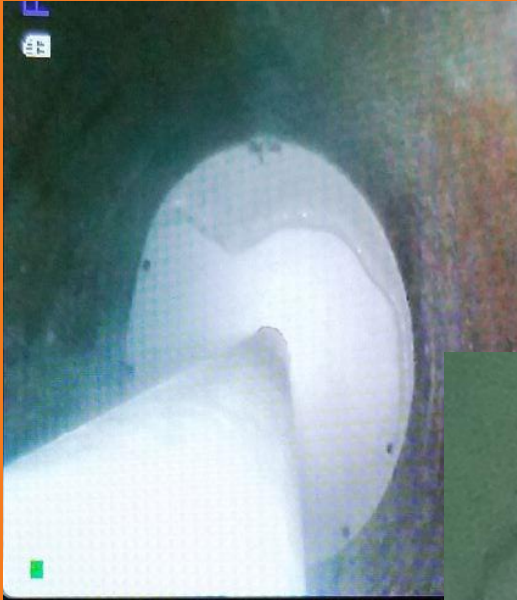
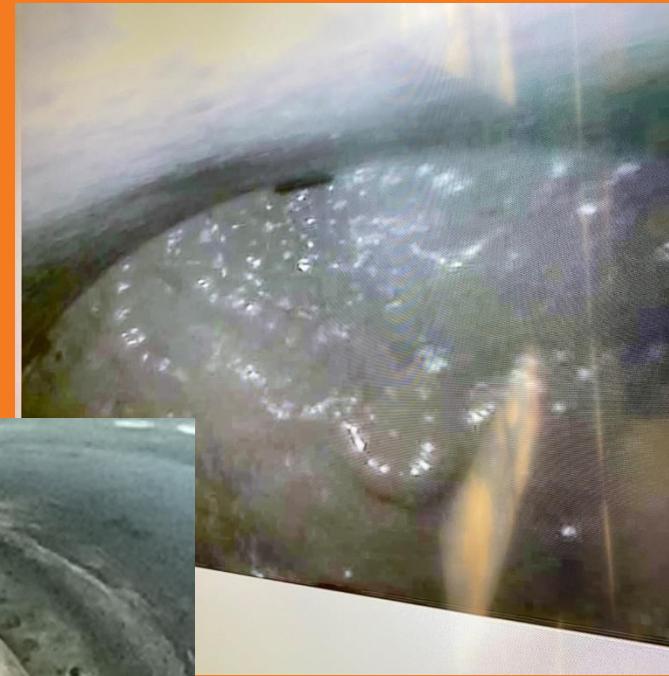
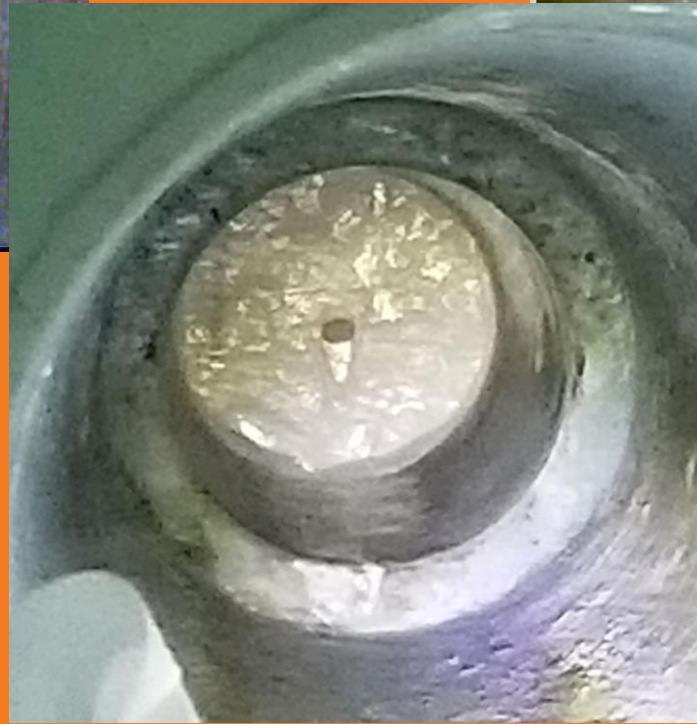
- So close! Leak continues through small gap. Epoxy not viscous enough.

Make sure you're happy with viscosity of epoxy before injecting/sealing. There is a small window before the epoxy is too thick to inject. If we had waited longer for the epoxy to thicken, we may still have a viable beam.

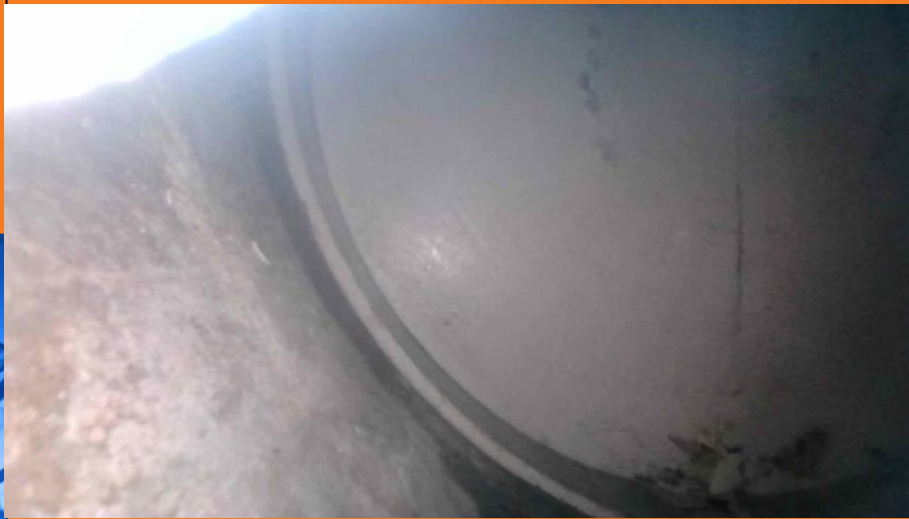
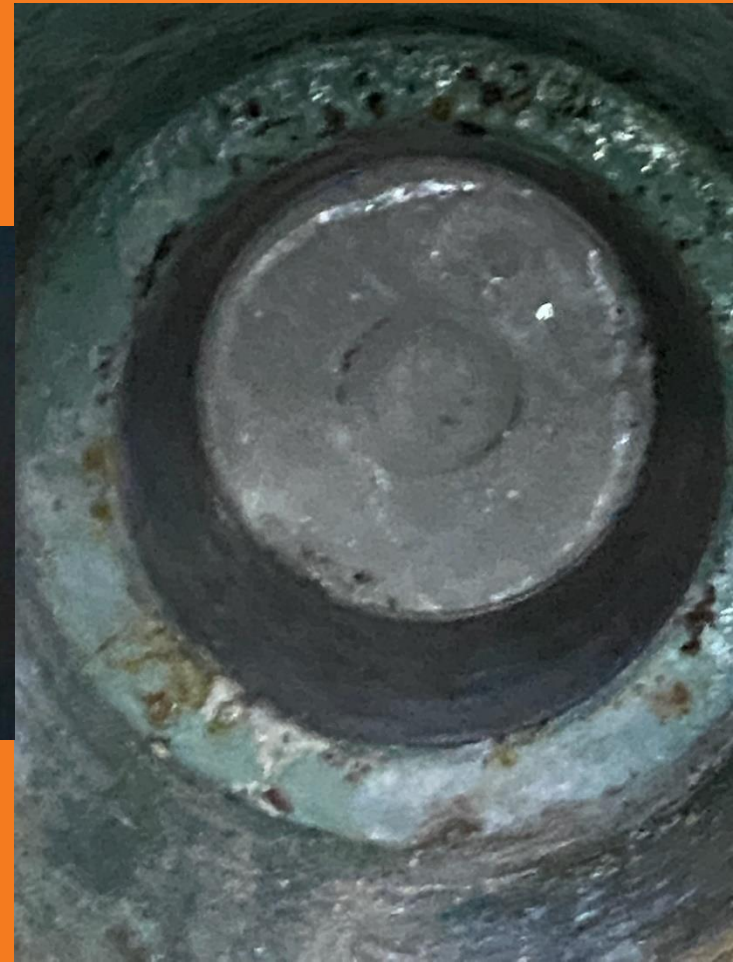
A full 360 degree seal was achieved. During epoxy injection, bubbles were seen emanating from the bellows, then bubble flow stopped.

~2 liters of epoxy were injected.

Unfortunately, the second successful attempt came at a cost: the epoxy disk effectively killed the flux coming out of beam port #4. Subsequent tests showed that the neutron flux was no longer viable. Beam Port #4 was fully decommissioned in March 2023. PGNAA parts were moved to the previously vacant Beam Port #1.

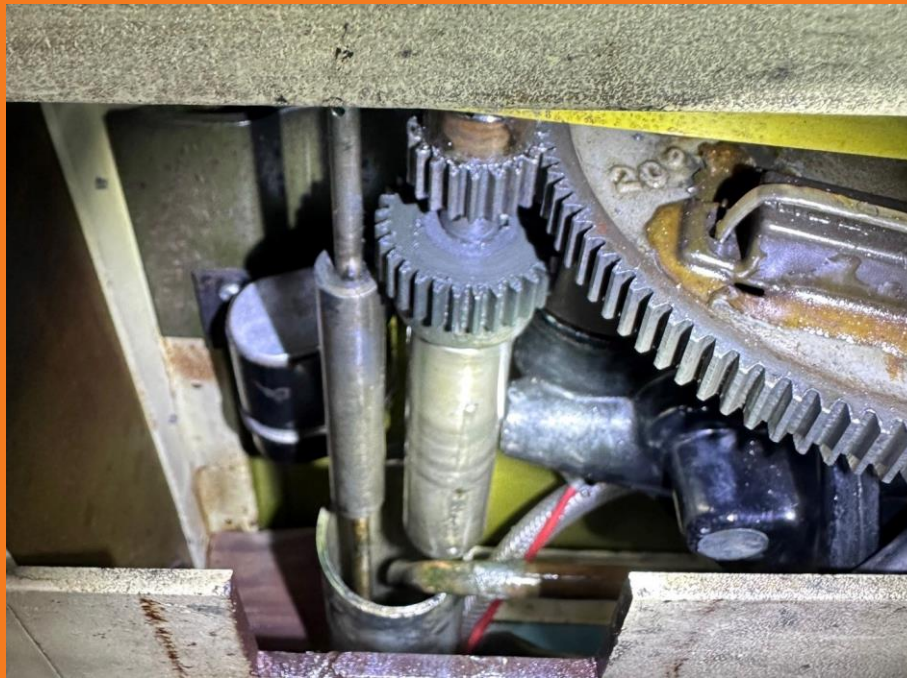
In the summer of 2022, the lazy susan rotating rack began experiencing various issues: sample tubes sticking to the bottom of the rack, and motor stoppages during operation. Both issues were attributed to the oiling regimen. For years, the staff used small amounts of WD-40 to oil the rack.

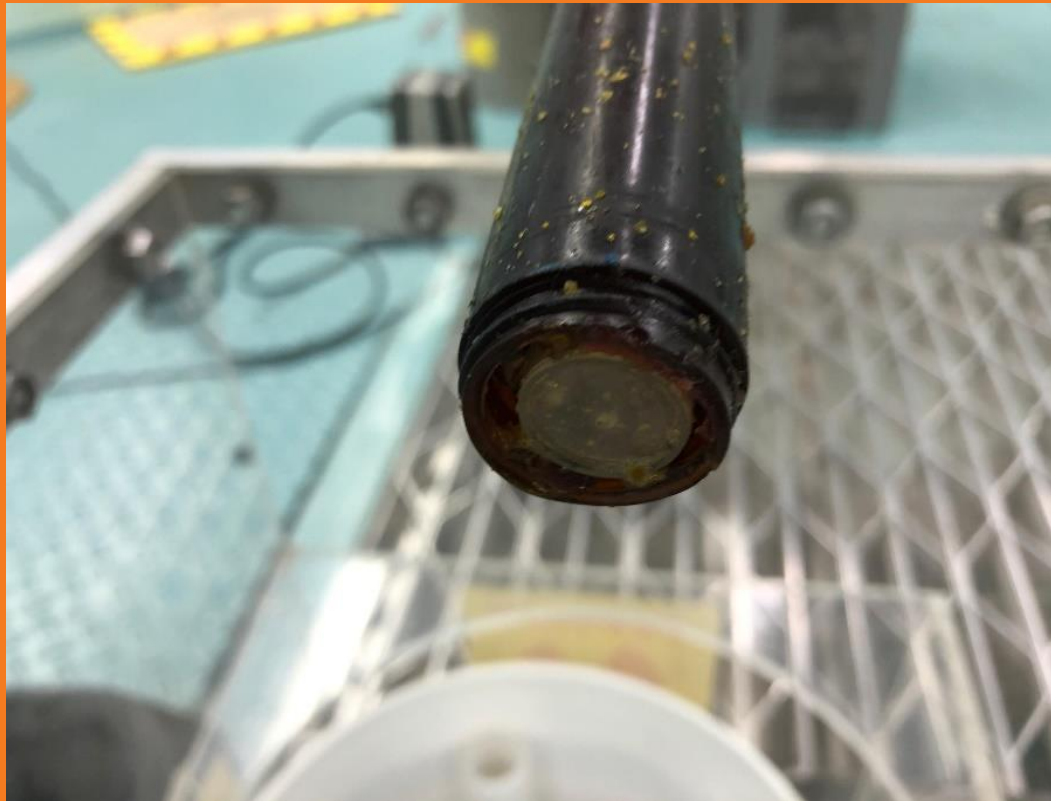
Over the years, the WD-40 began to ooze into the rack's tubes which caused TRIGA tubes to stick to the bottom. This caused multiple problems, such as a broken grapple tool, as well as broken TRIGA tubes upon withdrawal.

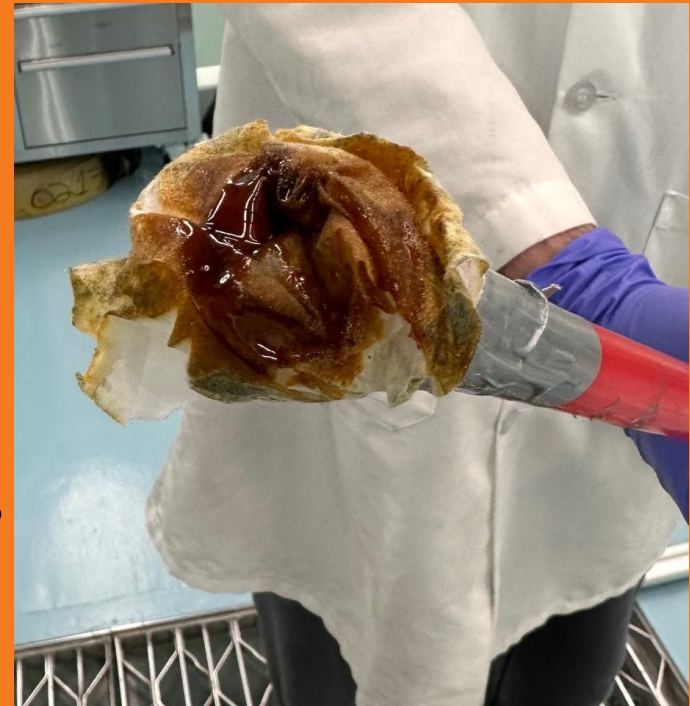
The Lazy Susan is still operable but requires constant “exercise”. If the motor is run at least once a week, it seems to keep the oil smooth enough to avoid motor stoppages.

½ cup of oil was too much. For months, oil continued to seep into the rack tubes. We performed subsequent rack cleanings but this time we used cloths dabbed with acetone. We found acetone did a great job at dissolving and removing the oil residue.
