# MIT Research Reactor

Big Impact of a Small Leak  
at the MIT Reactor

19 June 2023

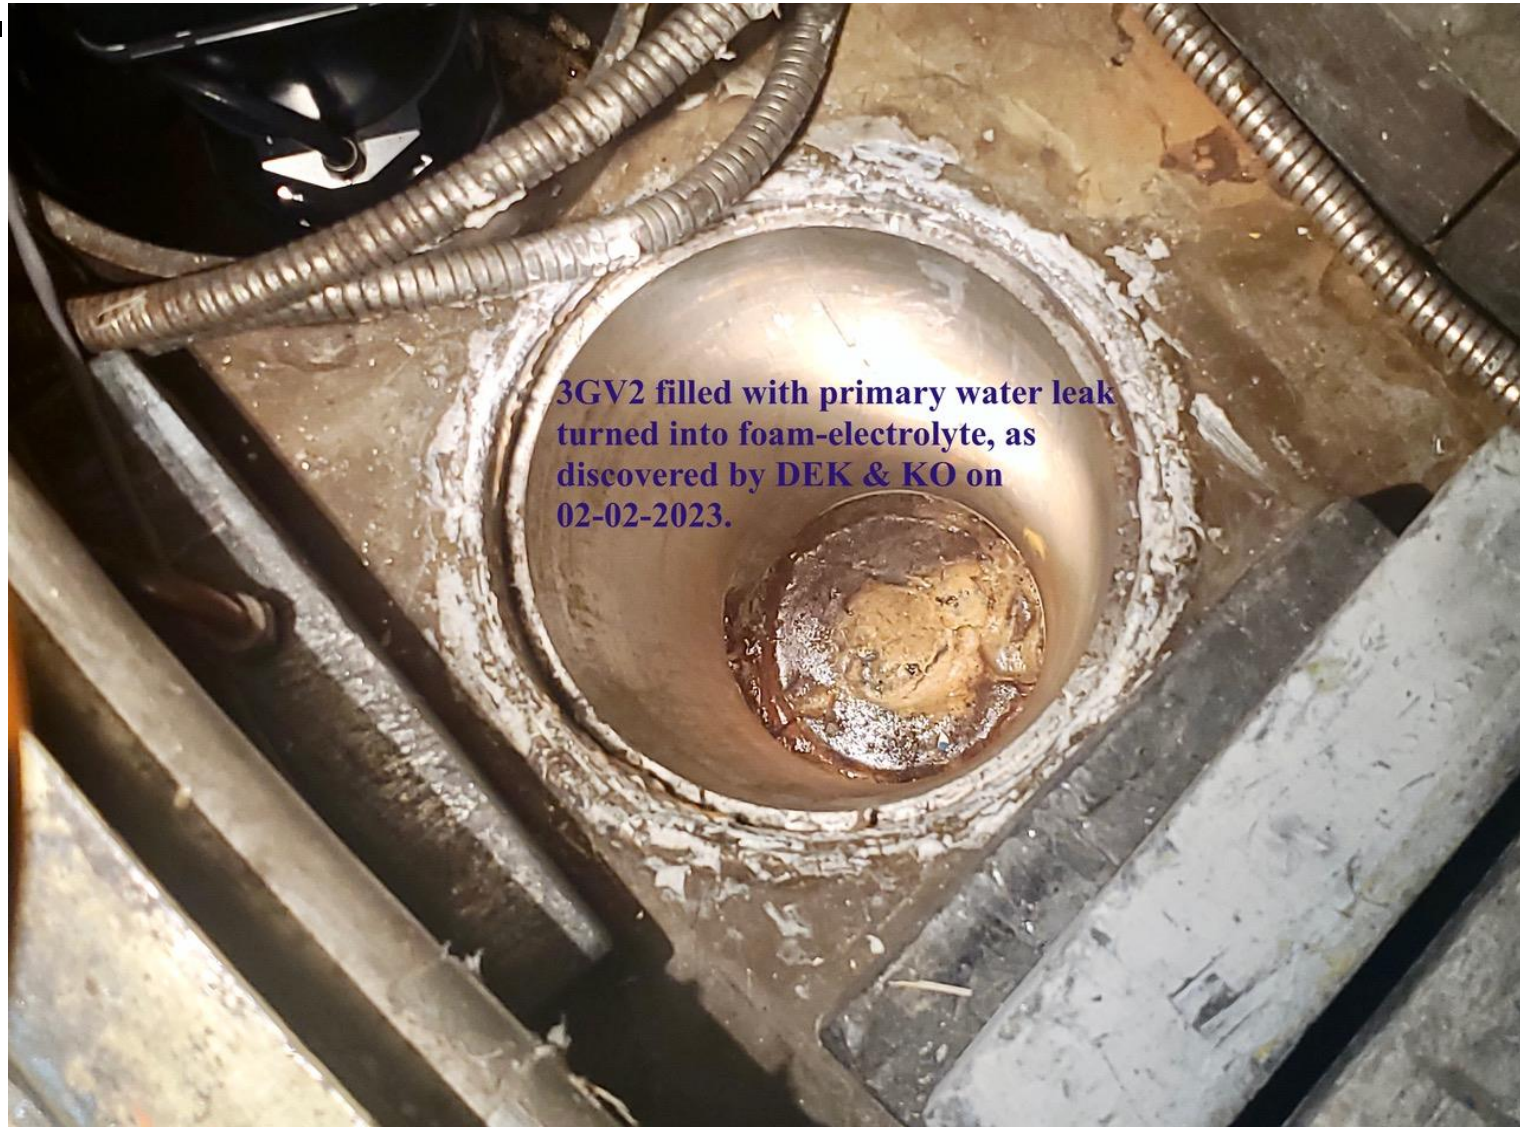
- December 12, 2022: 10% decrease in reading on one of the four nuclear safety channels
- All other neutron flux channels + thermal power channel indicate steady-state full power operation.
- Later that day: 4% decrease in a second nuclear safety channel
- The reactor was then shut down

# Water in Vertical Port Attenuated Signal (Fission Chamber removed in photo)

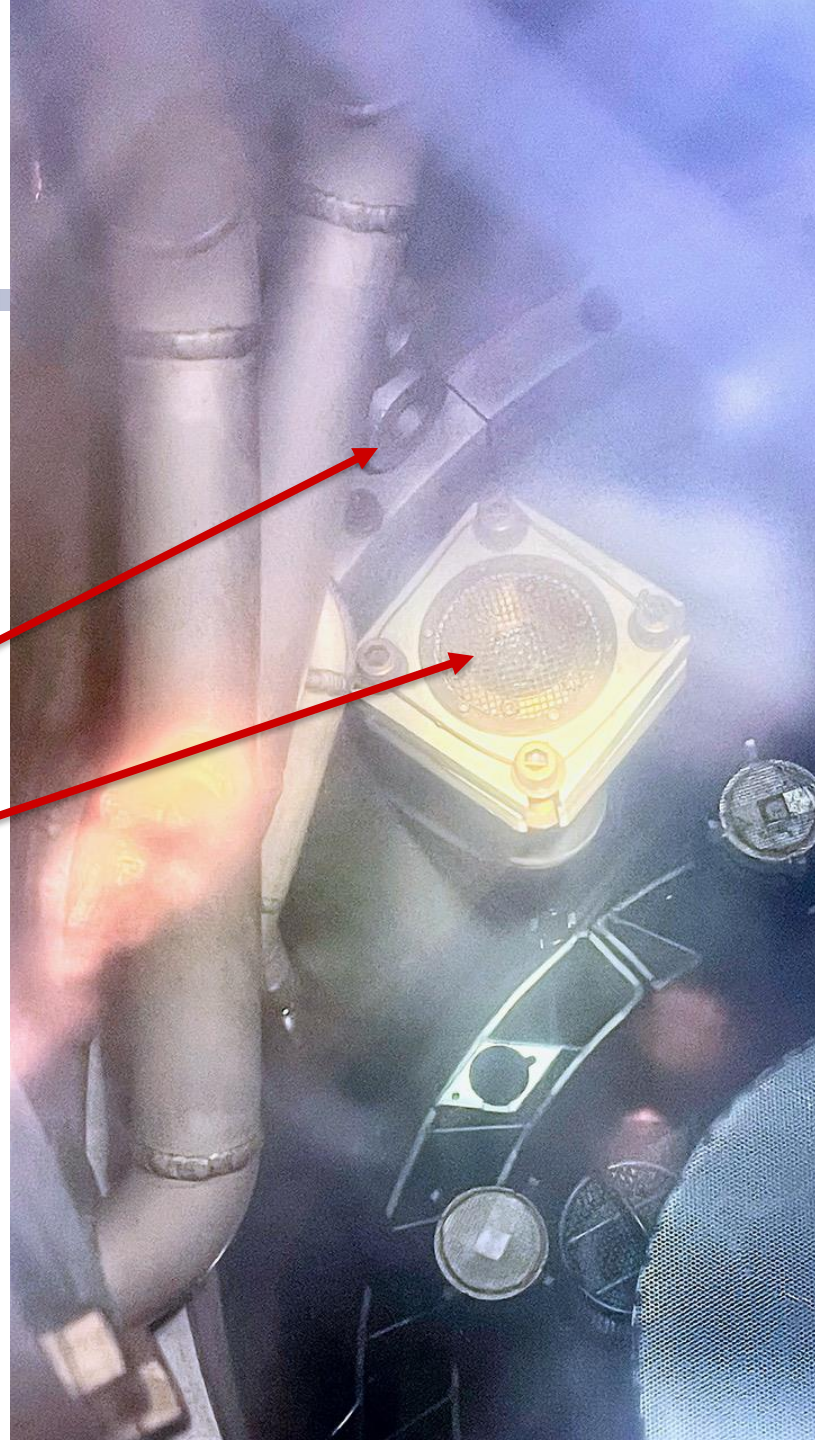
- One pressure gage penetration visible
- One anti-siphon valve visible

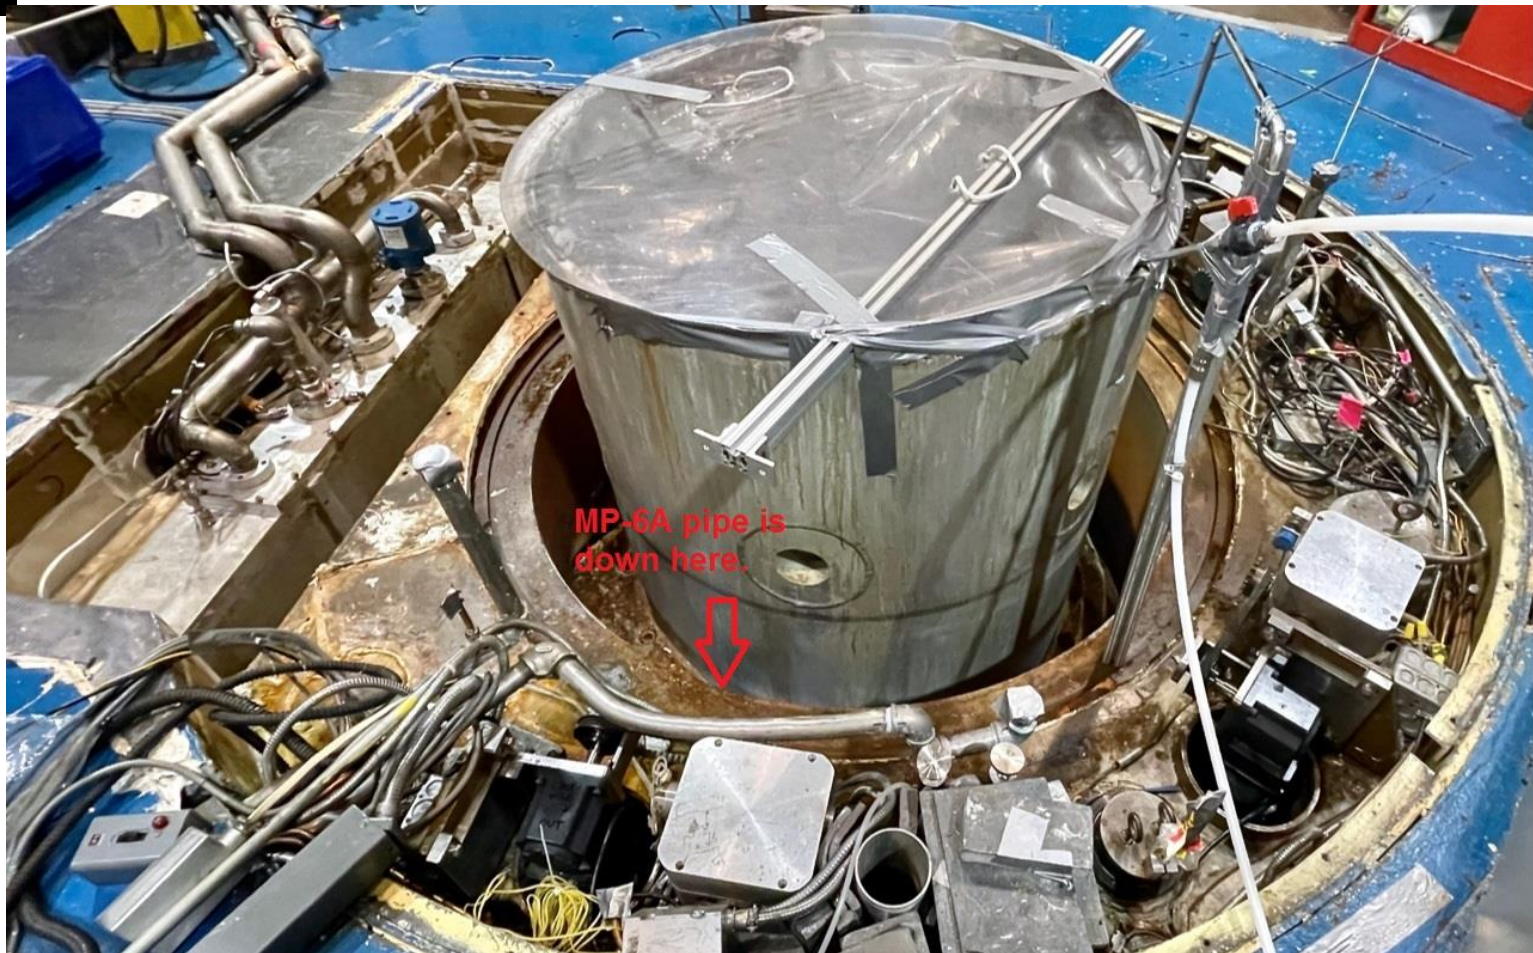
# Leak is at Base of Upper Annular Ring

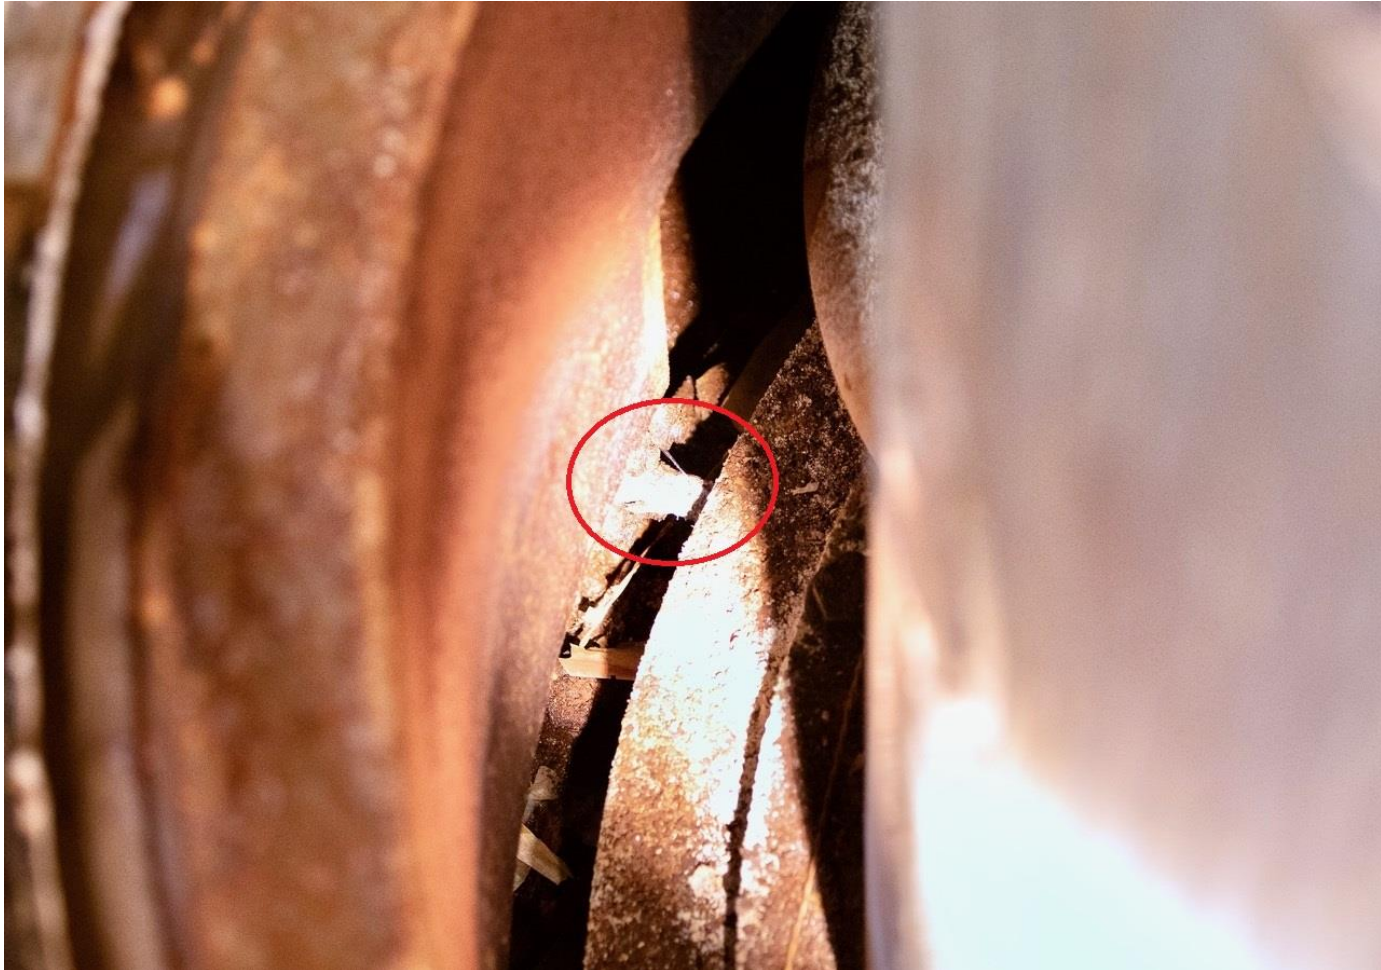
# [ Angled View from Above (with Leak) ]

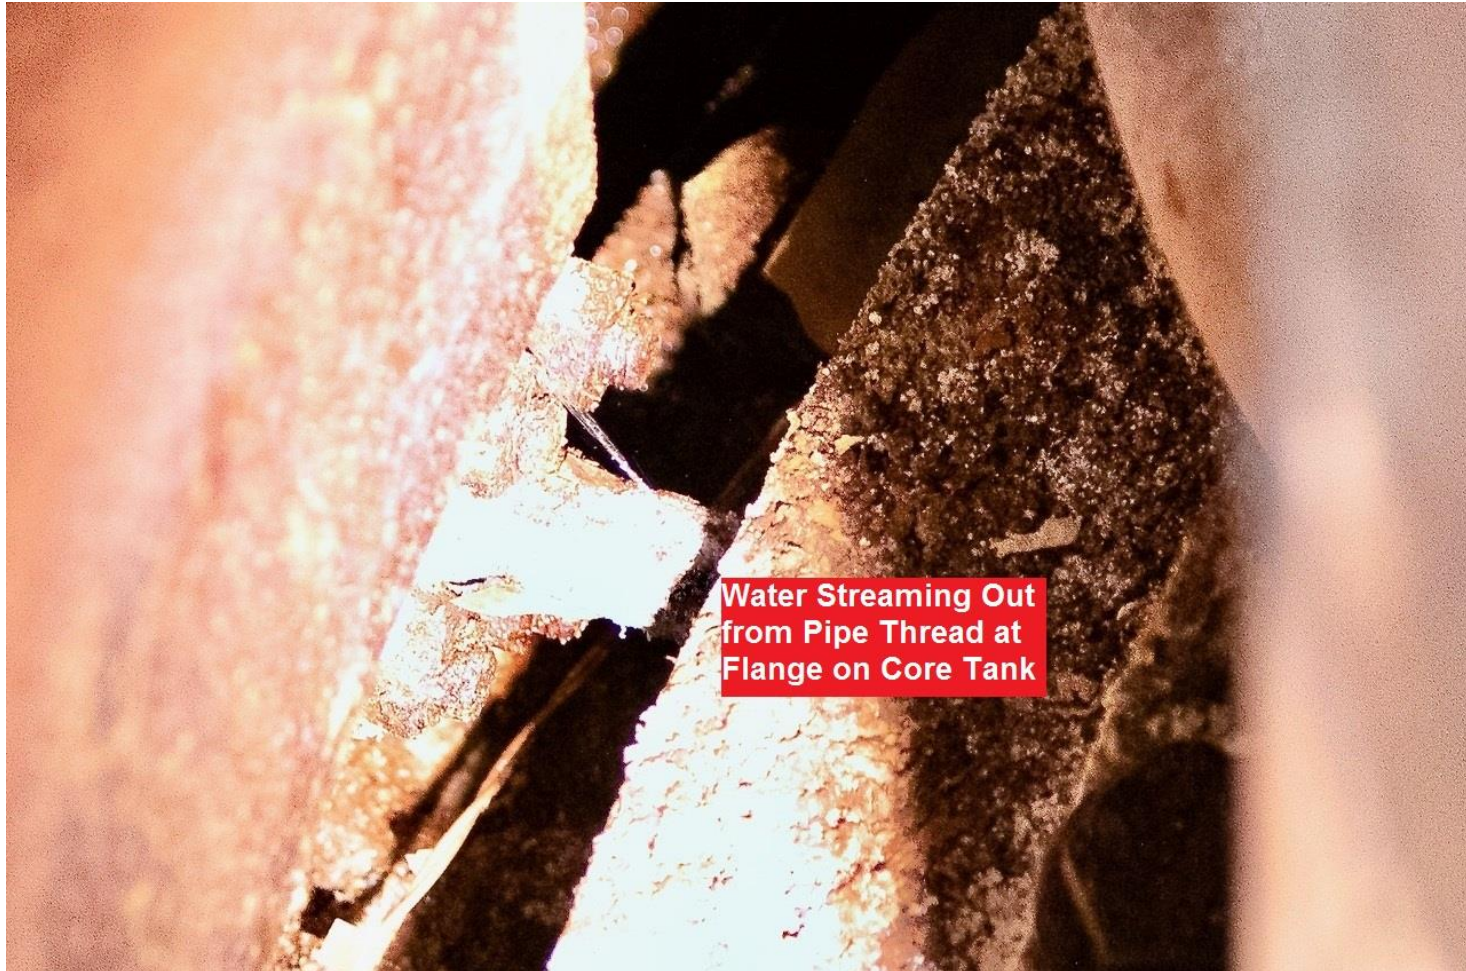
# [ Close-Up View from Above (with Leak – 7.5 gallons per day)

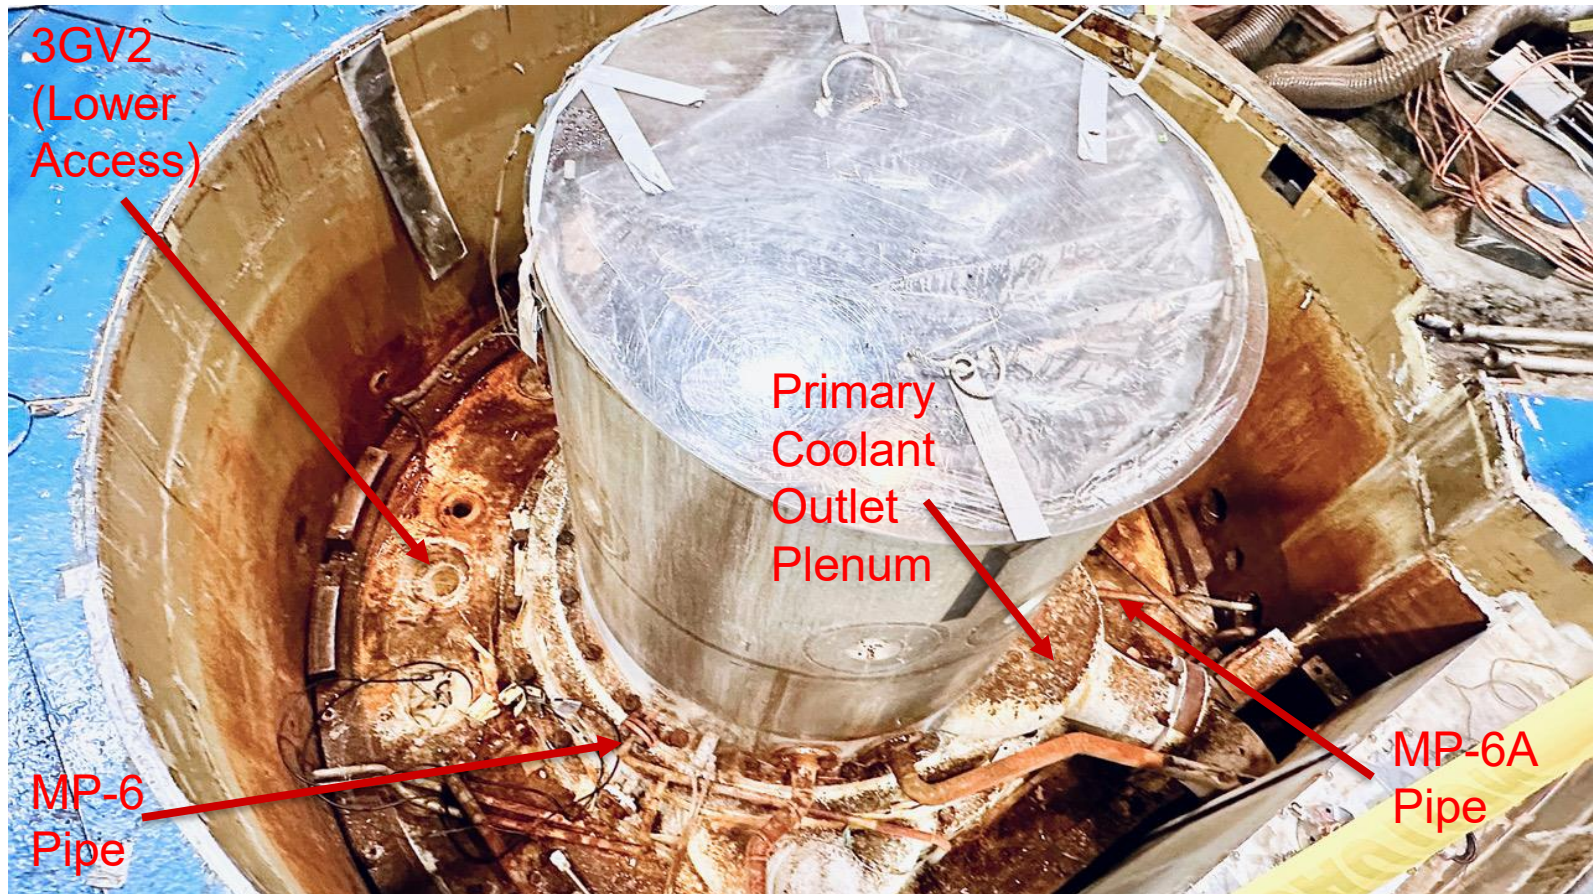
[ ...there was Access to Replace  
the MP-6A (and MP-6) Pipes ]

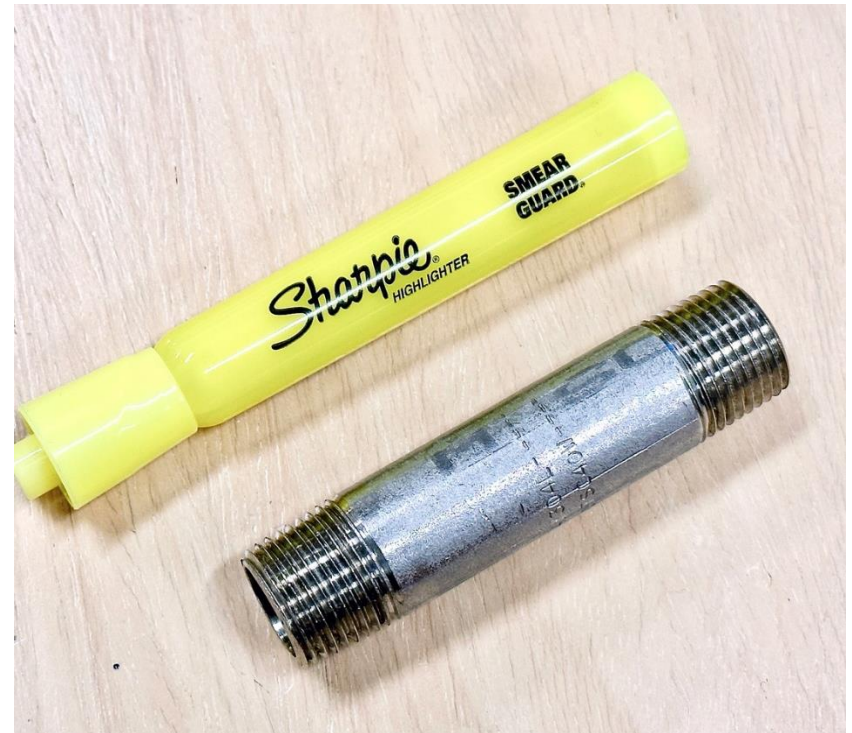
- Corrosion to a 1/2" threaded aluminum pipe section for the MP-6A flow sensor
- Humid conditions prolonged in the area
- Iron rust covered the aluminum pipe!
- The rust acted as an oxygen reduction site, polarizing the aluminum above its corrosion potential, resulting in general localized corrosion.

*Standard catalog part  
costing about \$5 !*

- The leaking aluminum threaded pipe was replaced with a 316 stainless-steel threaded pipe.
- Other threaded piping in the area was similarly replaced as a preventive measure
- The piping area was cleared of iron rust.
- The inner and outer surfaces of the shield rings that sit above the piping area were carefully cleaned by grinding and sanding, and then coated with rust inhibitor.
- All gaskets in the area were inspected; some were replaced.
- Leak detectors added in many locations for early detection. Use of humidity sensors is being considered as well.
- Inspection tubes added for future use.
