## REFURBISHMENT, MODERNIZATION AND AGEING MANAGEMENT PROGRAM OF THE 3MW TRIGA MARK-II RESEARCH REACTOR OF BANGLADESH

<sup>1</sup>Reactor Operation and Maintenance Unit (ROMU), Atomic Energy Research Establishment (AERE), Savar, Dhaka, Bangladesh

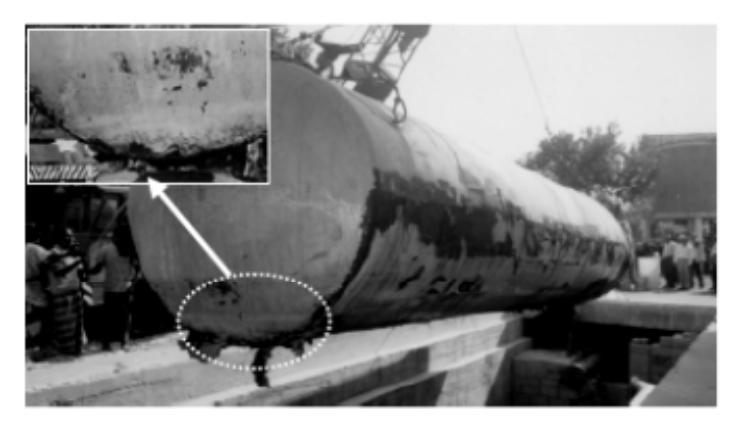
Mark-II research reactor on 14 July 1997. The tank was isolated (Fig.1) and tested both nondestructively and destructively. Extensive corrosion and pitting were found in a particular area where rain water seeped in during the monsoon and remained logged for a long period. Upon inspection, corrosion and pitting were also observed on the inner walls/baffles of the decay tank.

Fig.1 Removal of damaged N-16 decay tank

As a consequence corrosion damaged decay tank was replaced by a new decay tank with four aluminium saddles welded to its body. Each saddle was anchored to floor with four steel routed bolts (3.175 cm dia, 22.86 cm long). The saddles were bolted to the floor in a way such that one of the saddles remained fixed and the other three could slide on the floor. Sliding saddles were used in order to allow thermal expansion of the large decay tank having a length of about 10 m and a diameter of about 2.5 m. New decay tank with aluminium saddle is shown in Fig. 2. It is to be mentioned that the new decay tank was installed after modification of the shielding arrangement around the decay tank. A new plate type heat exchanger was also installed replacing the old shell and tube type heat exchanger, which got heavily fouled. The new heat exchanger required several changes in the piping layouts of both the primary and the secondary cooling loops. The new heat exchanger with modified piping arrangements is shown in Fig 3.

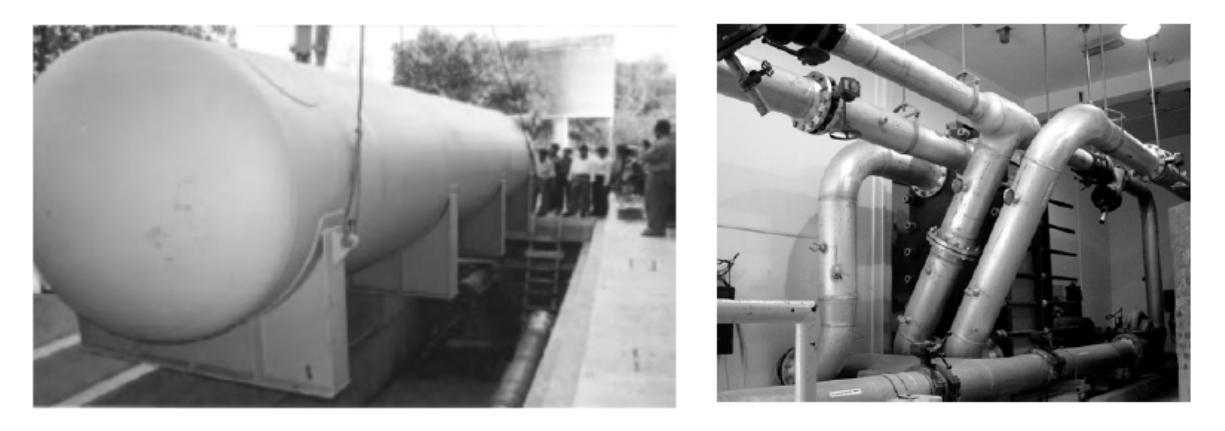
Fig. 2 New N-16 decay tank with aluminum saddle Fig. 3 Piping arrangement around H/E

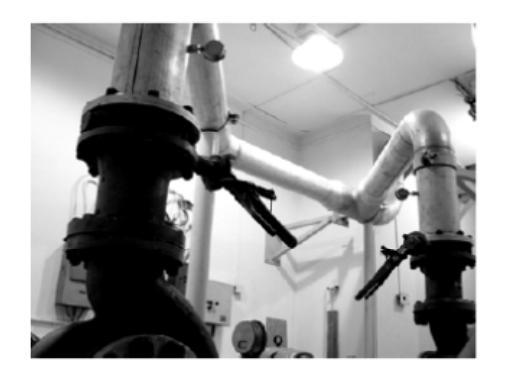
A modified Y-connection (Fig 4) was introduced in place of the T-connection at the discharge side of the two 50-hp pumps, which are operated simultaneously to get the desired primary flow rate of 13,230 liters/minute (3,500 US gallons/minute). It is to be mentioned that a "T" connection in the discharge line of any pumps gives rise to "cavitations" like noise depending upon the degree of turbulence. The pumps in question had a history of vibration problems

and one of the possible causes could have been this turbulence. The "Y" connection in the discharge resolved the matter to a great extent.

Fig. 4 Modified Y-connection

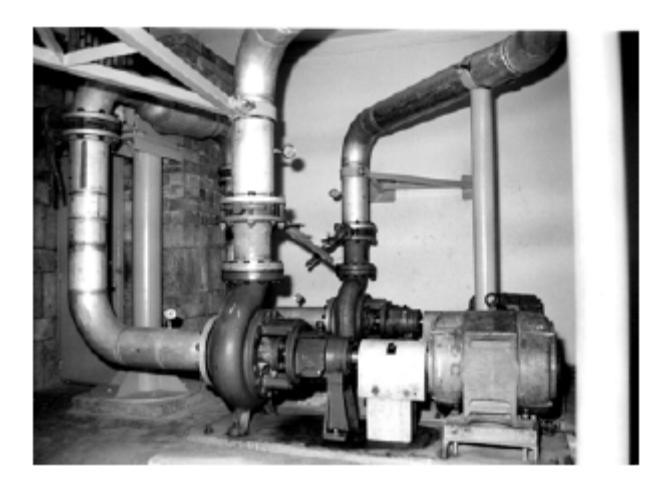
Necessary pipe supports were provided at different locations of the primary and secondary cooling loops in order to reduce the vibration of the piping to a minimum level. Three types of mild steel (M.S.) pipe supports were used for this purpose. The types used include adjustable floor mounted type, adjustable roof mounted type and wall mounted type. In addition to these, a few supports, which were connected simultaneously to the floor and the wall, were also installed (Fig 5). The above were essentially conventional steps taken to mitigate piping vibration. In most cases the inherent vibrations of the pump act as the forcing function. The pipe supports were placed at places of maximum amplitude.

Fig. 5 Modified pipe support

Conventional theoretical approach which is mainly used in the design stage is to see the spacing of supports and calculate the natural frequency "f", for the piping section. If this is a multiple or sub multiple of the pump vibration, it can cause resonance. The remedial steps are to increase/decrease the support distance thereby changing the stiffness.

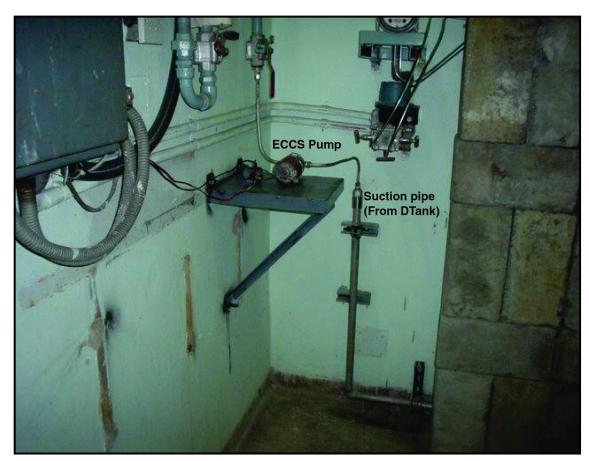
Fig 6a: ECCS Pump-Motor unit

It is essential that the ECCS should remain operational under all abnormal situations. One of such abnormal situation in the flooding of the decay tank and primary pump room by water leaked out from the primary cooling loop. The ECCS must not get under water in the event of such flooding. In order to remain unaffected in the event of the above mentioned flooding safe height of the base plate containing the pump form the primary pump room floor was calculated to be 3'- 6". Accordingly the wall mounted base plate was shifted at this height from its previous height of 3'- 0". The initial installation of the ECCS had several deficiencies, such as improper routing of the piping, defective installation of battery, battery-charger and pump motor unit, etc. Therefore, in order to improve the operational safety of the ECCS, several modifications were needed to be carried out on the system. These modifications were implemented after the installation of the new decay tank and associated components of the reactor cooling system. The modifications of the ECCS mentioned above include the followings:

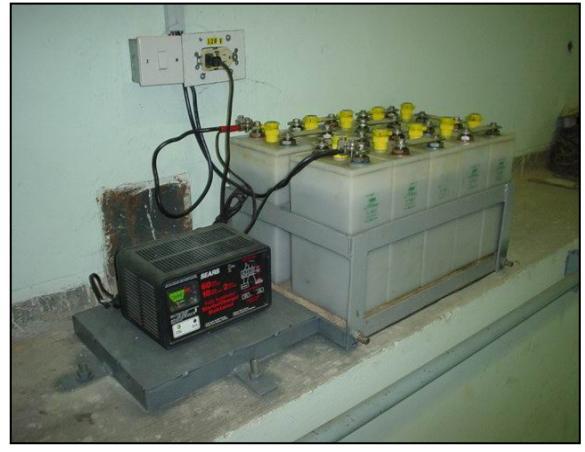
Fig 6b: ECCS Battery & Charger unit

4. Replacement of the old ECCS lead-acid battery by new Ni-Cd battery.

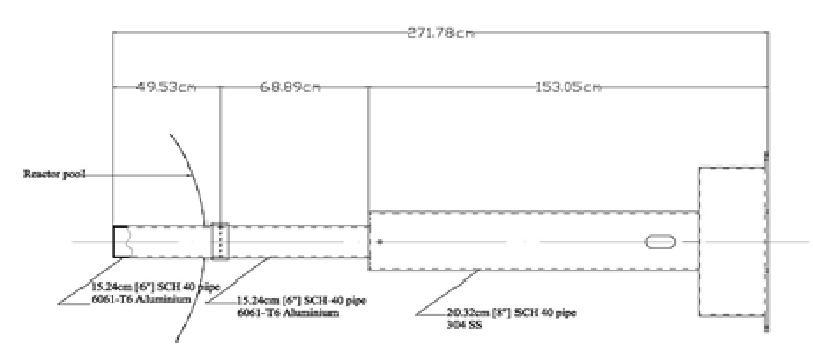
Reactor pool water was found to be leaking through the Radial Beam Port-1 (RBP-1) of the 3MW TRIGA Mark-II research reactor (RR) of Bangladesh Atomic Energy Commission (BAEC) when the graphite shield plug of the beam port (BP) was removed after about 23 years for installation of the collimator of the newly procured high resolution powder diffractometer (HRPD). The leak was found in the aluminium part of the RBP-1, which is located inside the reactor pool at a depth of about 8 m (Fig. 10).

Fig. 10 Details of the radial beam port

Investigation showed that an installation defect caused moisture from the heavy concrete shielding to seep into beam port and initiate the corrosion. As a result of such corrosion, the 1.016m long graphite shield plug got jammed inside the BP very tightly. While trying to remove the plug, it got broken leaving a segment having a length of about 33cm inside the aluminium part of the BP. This segment of the BP plug was removed by using special hand tools designed and fabricated locally (Fig. 11).

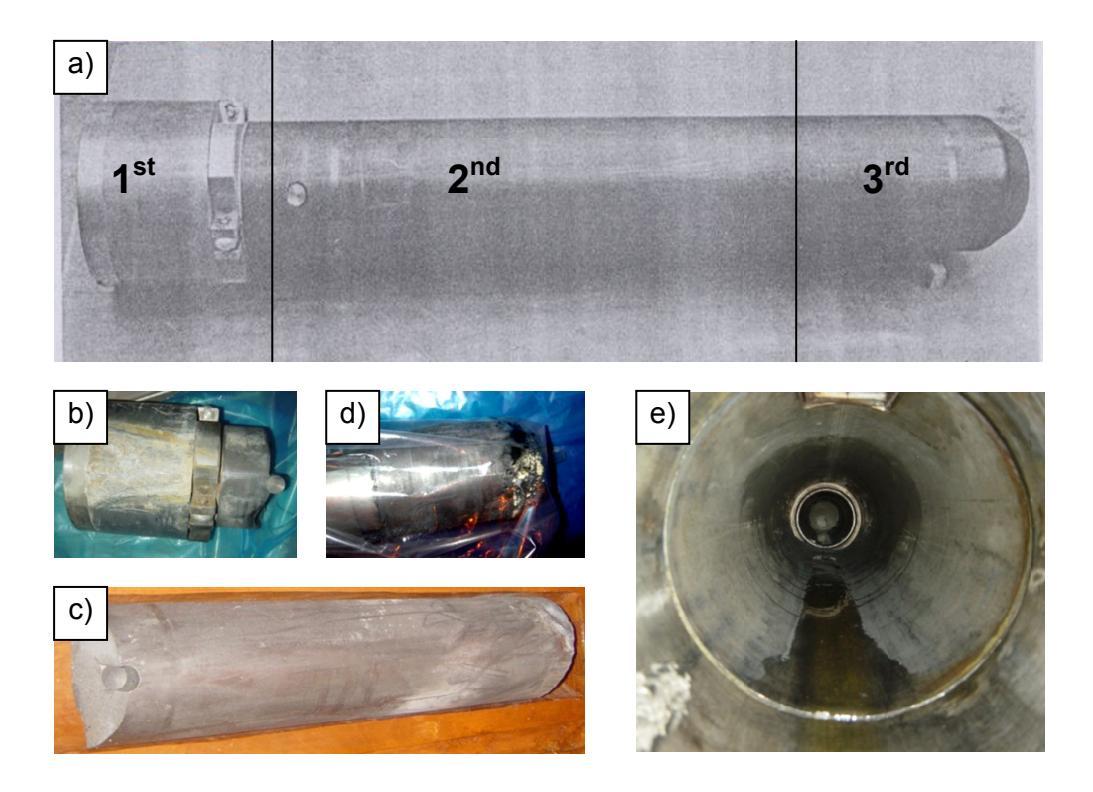
Fig. 11 Graphite plug of RBP-1; a) Graphite plug assembly, b)~d) 1<sup>st</sup>, 2<sup>nd</sup> and 3<sup>rd</sup> broken part of the plug, and e) Water leaking from RBP-1.

Leakage of water at a rate of about 500ml/day came to the notice of the reactor operators a couple of days after the graphite BP plug had been totally removed from the RBP-1. Immediately a rubber strap was installed around the leaking part of the BP by using a temporary arrangement so as to stop drainage of reactor pool water. Detailed investigations were carried out using remote handling cameras including an underwater camera supplied by the International Atomic Energy Agency (IAEA). Corrosion products were collected from the surface of the BP plug and analyzed using scanning electron microscopy and energy dispersive X-ray (EDX) analysis techniques. Results showed the presence of oxygen, carbon, lead, silicon and aluminum. The friable and porous nature of some of the samples indicated the presence of hydroxides in it. The investigation and analysis results were found to be useful in identifying the root cause of the leakage problem. Water leakage was eventually prevented by installing a split type encirclement aluminium clam (Fig. 12) around the damaged part of the RBP-1 by using innovative remote handling fastening devices, designed and fabricated locally.

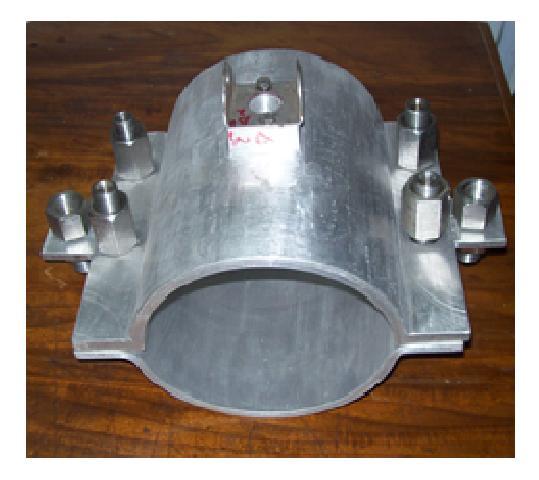
Fig. 12 Split type encirclement clamp
