Modifications on TR-2 Reactor Against an Expected Earthquake

TUNCAY TUNA¹, HAKAN ANAÇ¹

18th IGORR & IAEA WORKSHOP

Improvements Made on SSCs Related to Safety After F-D

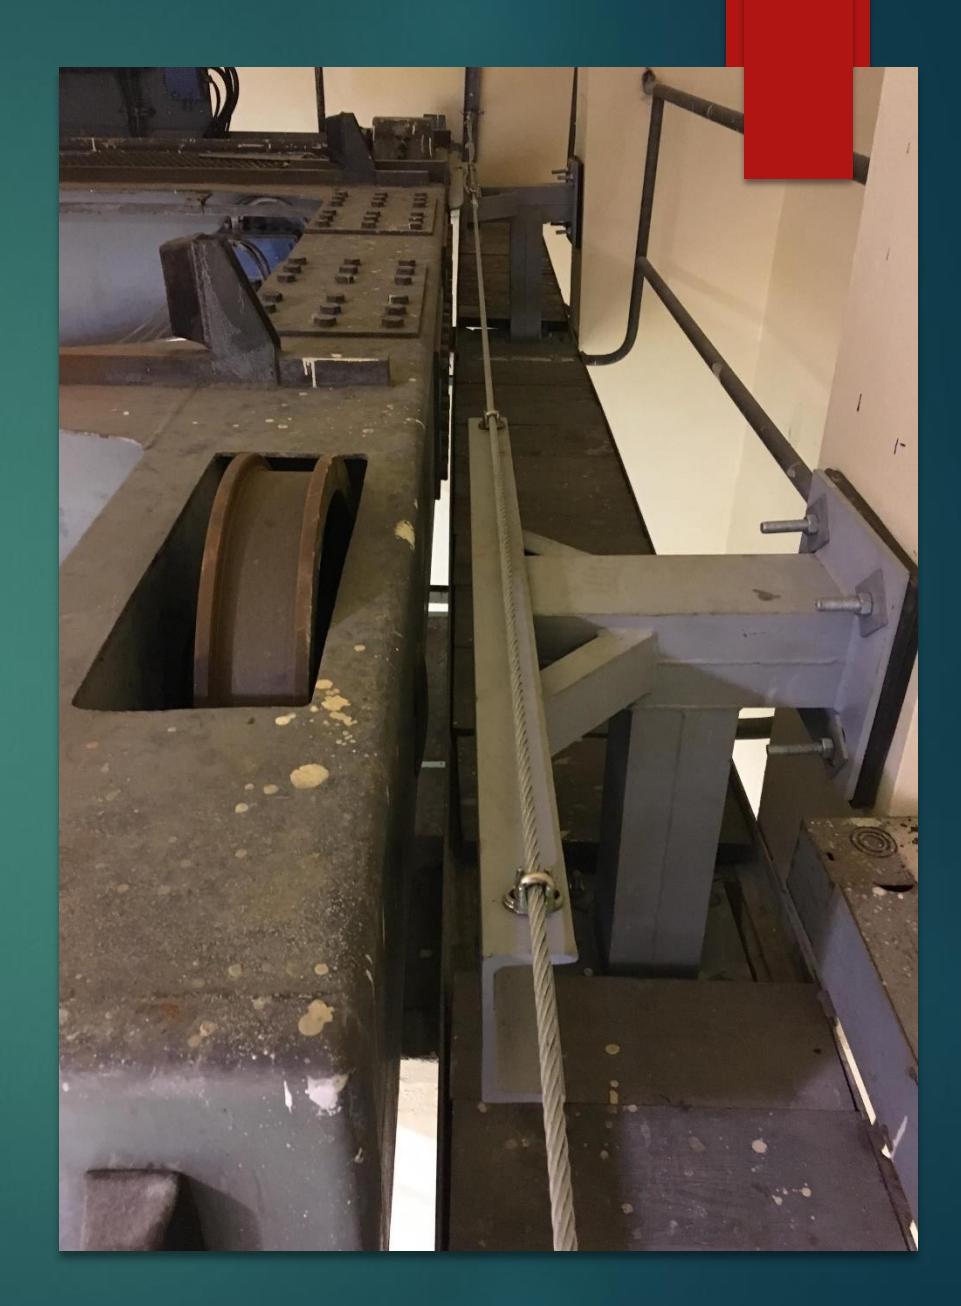
Fixing The Overhead Crane

In comply with the IAEA mission recommendations 10-ton capacity movable crane above the pool were fixed. There were appr. 50 cm huge gaps, between the crane and the columns, reduced to 3 cm by the way using steel construction buffers. Thus, in the expected earthquake, seismic derailing of the crane was eliminated.

2.4 meters of the 5-meter crane width is covered with buffers and the remaining part is covered with steel rope stretched between the buffers
