#### OPAL Reflector Vessel & leak mitigation

**TRTR/IGORR, September 2010**

**Ansto**

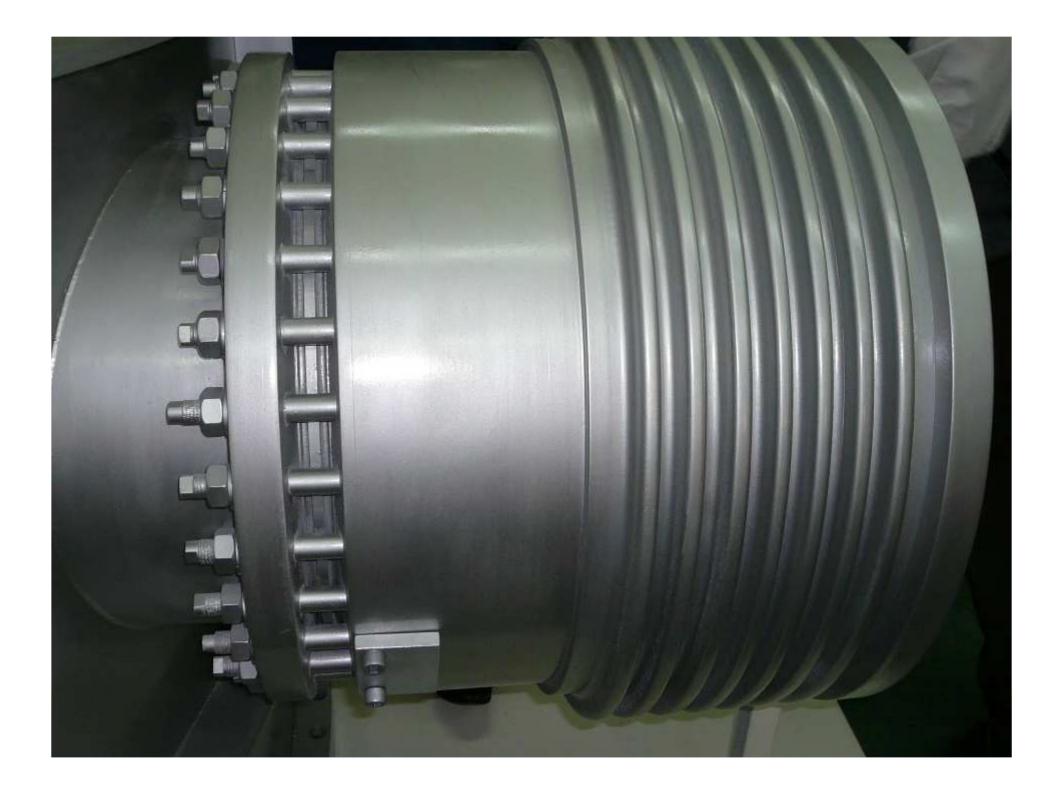
#### **RVE He Leak Test - Results**

- First helium bubbles were observed 3 hours into the test from the TNG1-3 flange
- Smaller helium bubbles were observed on day 4 from CNG1-3 and TNG4
- No other leakages observed
- Collection of bubbles from the TNG1-3 leaks showed a leak rate consistent with the isotopic purity degradation

- No new leak sites identified
- Estimated leak site diameter ~20 micron.
- Estimated leak site length of 20-200 micron.
- Temperature effect may be due to variation in water viscosity
- Alumina injection now largely ineffective

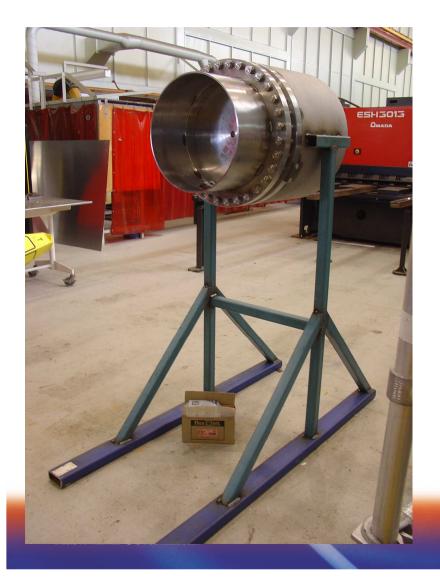
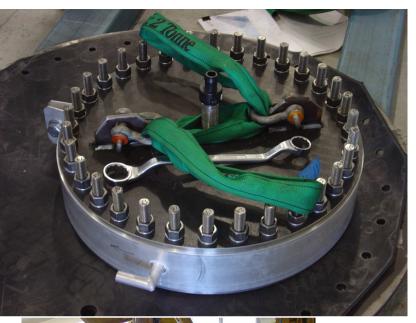
### **Mock-ups**

- Heavy water replacement
  - > Allows operation to continue and major projects to progress
- Global pressure control
  - Increase cover gas pressure
  - Safety submission likely increased risk of tritium in RPO
- Local pressure control
  - Flow loop around beam flanges
  - Mock up tested may require ARPANSA approval
  - Ready in ~1 month
- Leak-site clamp (leak-site "epoxy")
  - Local and no moving parts
  - Ready in 1-2 months
- Temperature adjustment
  - Requires safety analysis and submission
- Particle re-injection
  - Not favoured

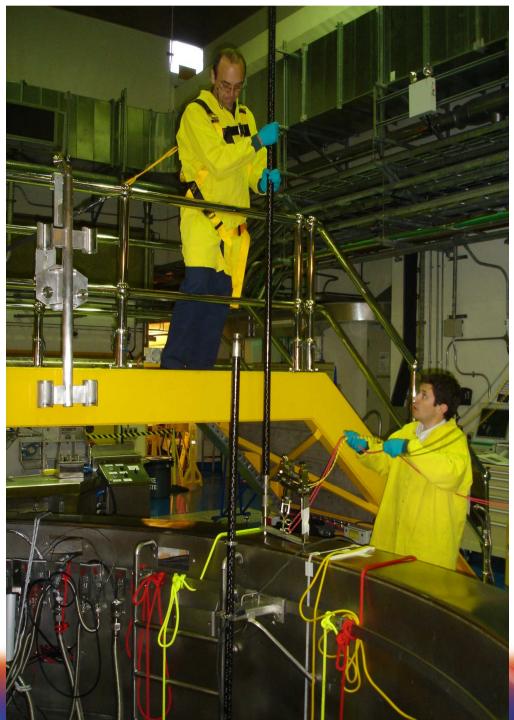
## **Reflector Vessel Trial Repair**

#### Application of Clamps Nov – Dec 2009

- Remove fuel
- Lower Reactor Pool water
- Drain RVE
- > Over-pressurise He bubbles
- Apply clamps graphite pads
- Bubbles halted on major leak sites
- Return to service
- Measured D2O purity
