Completion of Seismic Rehabilitation Project at HANARO after the Fukushima Daiichi Accident

Byung-Hun Hwang¹, Jin-Won Shin¹, Choong-sung Lee¹, Sang-Ik Wu¹, Hoan-Sung Jeong¹
1) Korea Atomic Energy Research Institute, 989-111 Daedeok-daero, Yuseong-gu, Daejeon, Korea

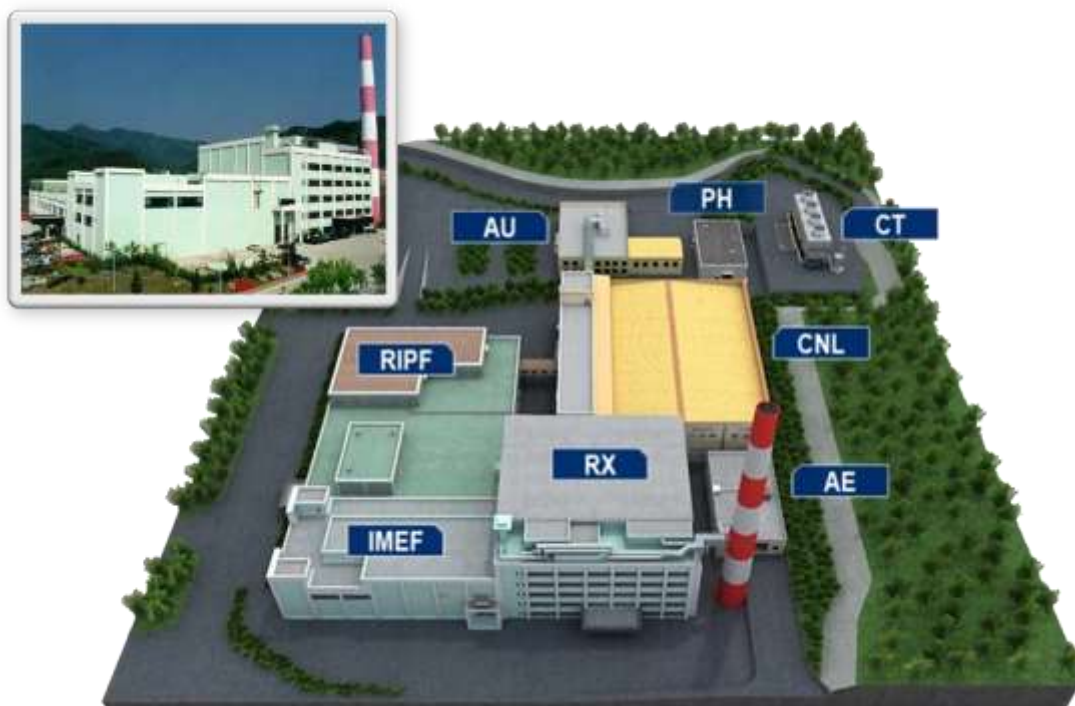
FIG. 2. Bird-eye view of Reactor facility complex (right: North direction)

Reactor building is located at reactor facility complex in KAERI site. (see FIG.2.) In the south side of reactor building, there is RIPF (Radio Isotope Product Facility) building and IMEF (Irradiated Material Examine Facility) building. And the CNL (Cold Neutron Laboratory) building is located at the west side of reactor building. Spaces between the reactor building and adjacent buildings are particularly narrow. The maximum space with adjacent buildings is 4.2 m at north side and there is a utility-pipe conduit at the underground.

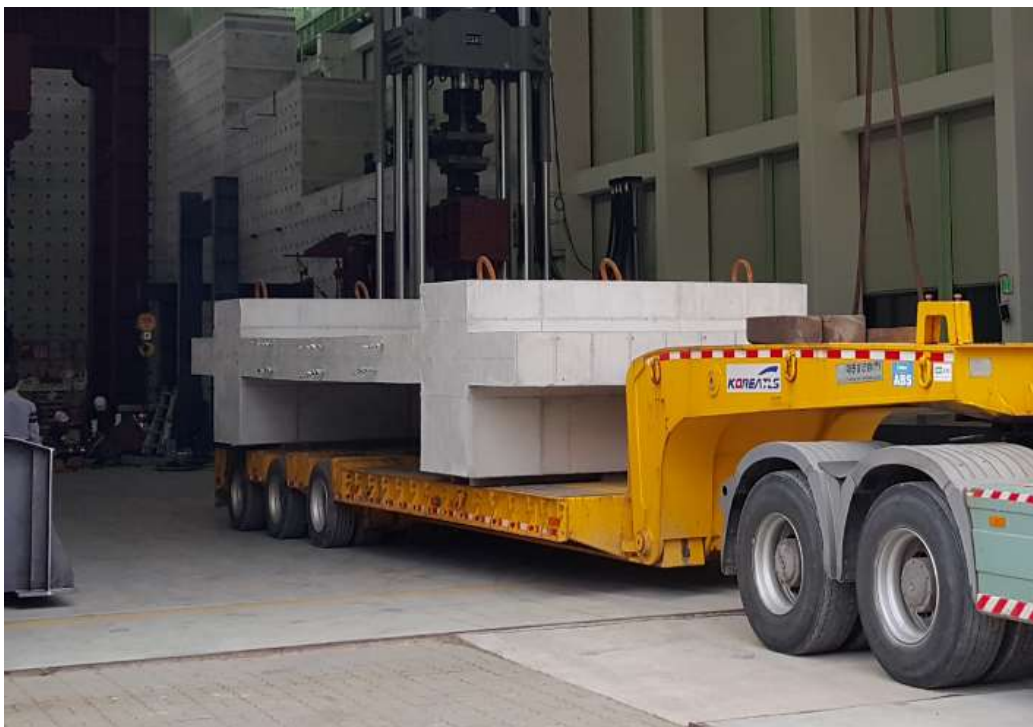
In approval process, KINS requested a structural performance verification test to confirm the reinforcing effect of built-up section in concrete outer wall. (*see FIG.4.*)

To check the reinforcing effect of built-up section, KAERI made 2 samples for the test. One was in original condition and the other was reinforced with built-up section. A part of the real wall was made as the sample at 1:1 scale, of which size was 6.2 x 2.45 x 3.0 m.

FIG. 4. Relocate the test specimen (original condition)

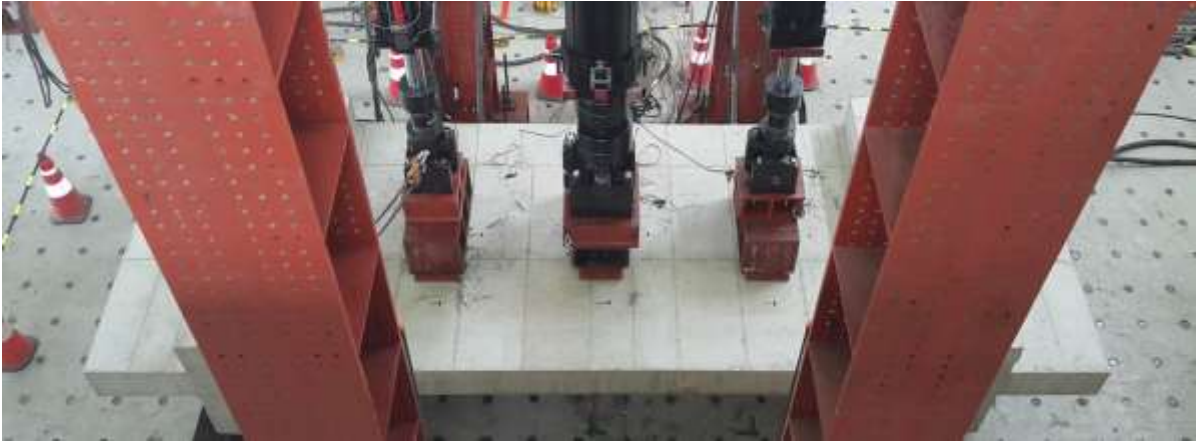
Static loading was given to check the reinforcing effect. (*see FIG.5~6.*) Test criteria was determined from the result of maximum value through an analysis of the whole reinforcing 3D-FE model.

FIG. 5. Static loading test (original condition)

The test result showed that the static loading capacity of the reinforced specimen was stronger than the one in original condition. The built-up section showed that the increase of structural strength capacity.

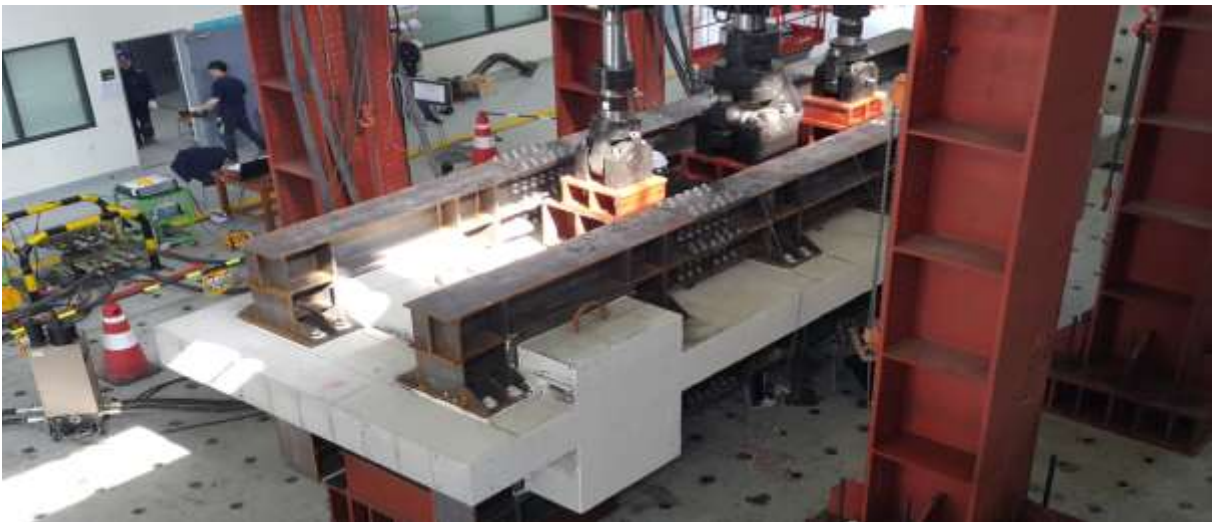
FIG. 6. Static loading test (reinforcing with built-up section)

We tried to check the ultimate strength of reinforced specimen. But it was impossible to check. Its strength was too high to test with a prepared loading machine. It exceeded its expected yielding strength and it was hard to exactly expect the failure.

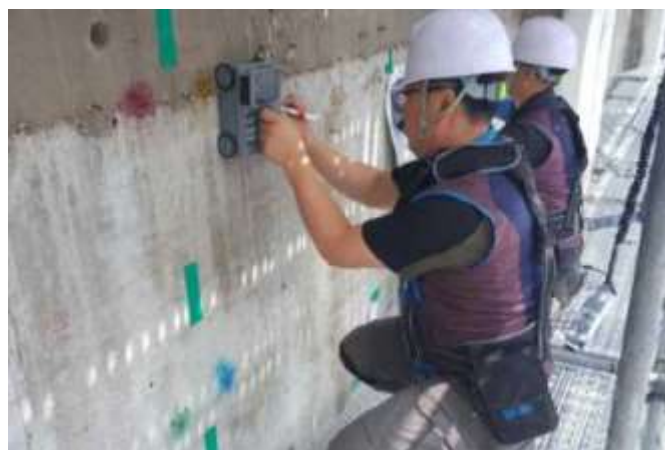
Measuring and recording the points of installation: To determine the positions of built-up sections, KAERI made a precision survey. After that, rebar scanning was conducted to avoid cutting the existing rebar in the wall. (see FIG.7.) If rebar existed in the installation position, the installation position was changed for maintaining the existing rebar.

FIG. 7. Rebar scanning to avoid cutting existing rebar

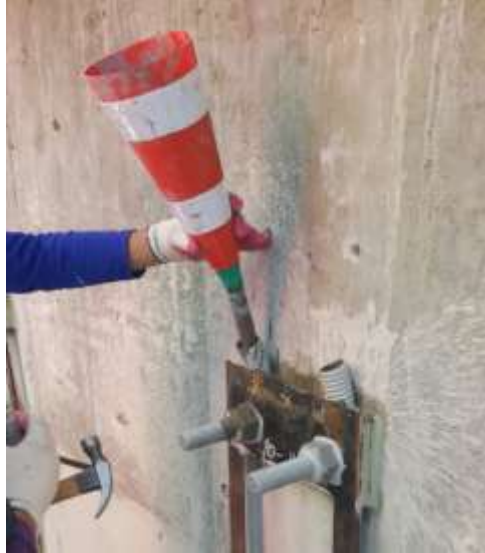
To make the through bolt centered in the hole, we made a special template to locate the through bolt. After that, we injected non-shrink grout between the through bolt and the wall of reactor building. (*see FIG.9.*)

FIG. 9. Inject non-shrink grout into hole to fix the through bolt in the hole.

In the construction field, it was generally recommended that non-shrink grout should have its own thickness to keep the structural strength. And the recommended thickness is about 1 in. (2.54 cm). To keep this advice, we set up the size of hole ($\varnothing=89$ mm) and through bolt diameter ($\varnothing=36$ mm).

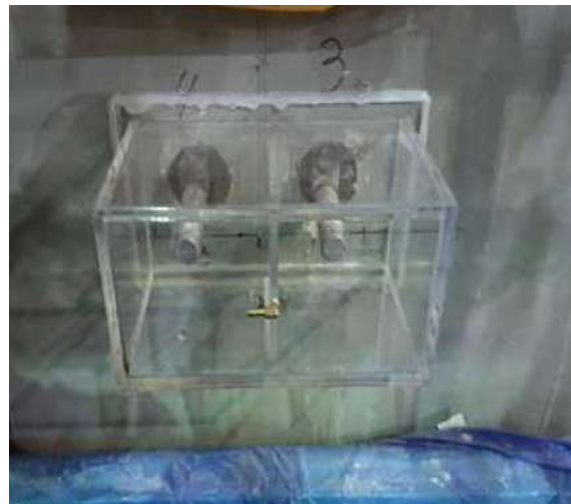
After the injection, we checked all of the holes to keep the confinement function of the reactor building. To check the individual leak, we made the leak test box and attached the box at the inspection point. (*see FIG.10.*) After that, we made a -0.5 bar vacuum condition inside the box and checked if it is maintained over the 20 seconds at the inspection position. The result showed that all holes are filled with non-shrink grout well and have airtightness.

FIG. 10. Leak test box

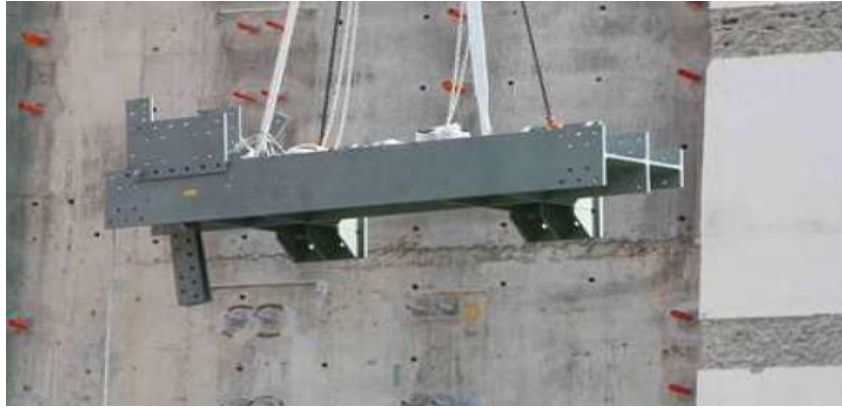
Install the built-up section on the wall by using through bolt: The built-up sections were lifted by using a crane and integrated on the through-bolt installed at the wall of the reactor building. (see FIG.11.) A snug tightening was applied when connecting the built-up sections with through-bolts according to the design concept. The built-up sections were connected with each other by tightening high strength bolts using an electric impact wrench. A specific torque was applied to the connecting bolts and the full inspection was fulfilled to check it using a torque wrench. (see FIG.12.)

FIG. 11. Crane is lifting the built-up section to install with through bolt at the wall

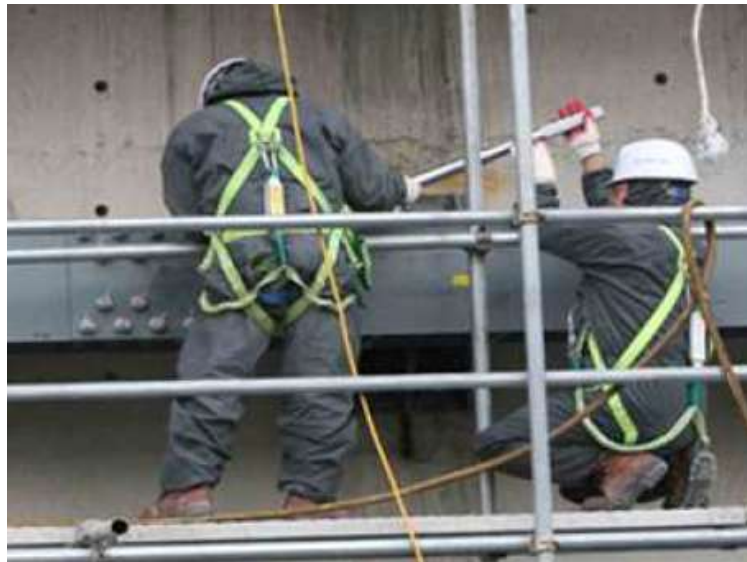
FIG. 12. Workers are tightening the high-tension bolt with regulated torque.
