Completion of Seismic Rehabilitation Project at HANARO after the Fukushima Daiichi Accident

2017.12.5

Byung-Hun Hwang*, Jin-Won Shin, Choong-sung Lee, Sang-Ik Wu, Hoan-Sung Jeong

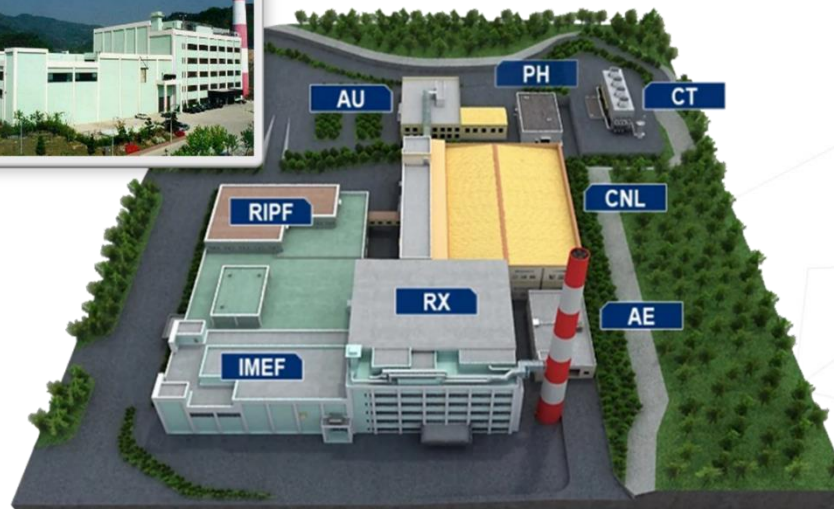
HANARO Reactor Complex

- In the south side of the reactor building, there is a RIPF (Radio Isotope Product Facility) building and an IMEF (Irradiated Material Examine Facility) building.
- the CNL (Cold Neutron Laboratory) building is located at the west side of the reactor building
- The spaces between the reactor building and adjacent buildings are particularly narrow. The maximum space with the adjacent buildings is 4.2 m at north side, and there is a utility-pipe conduit underground.

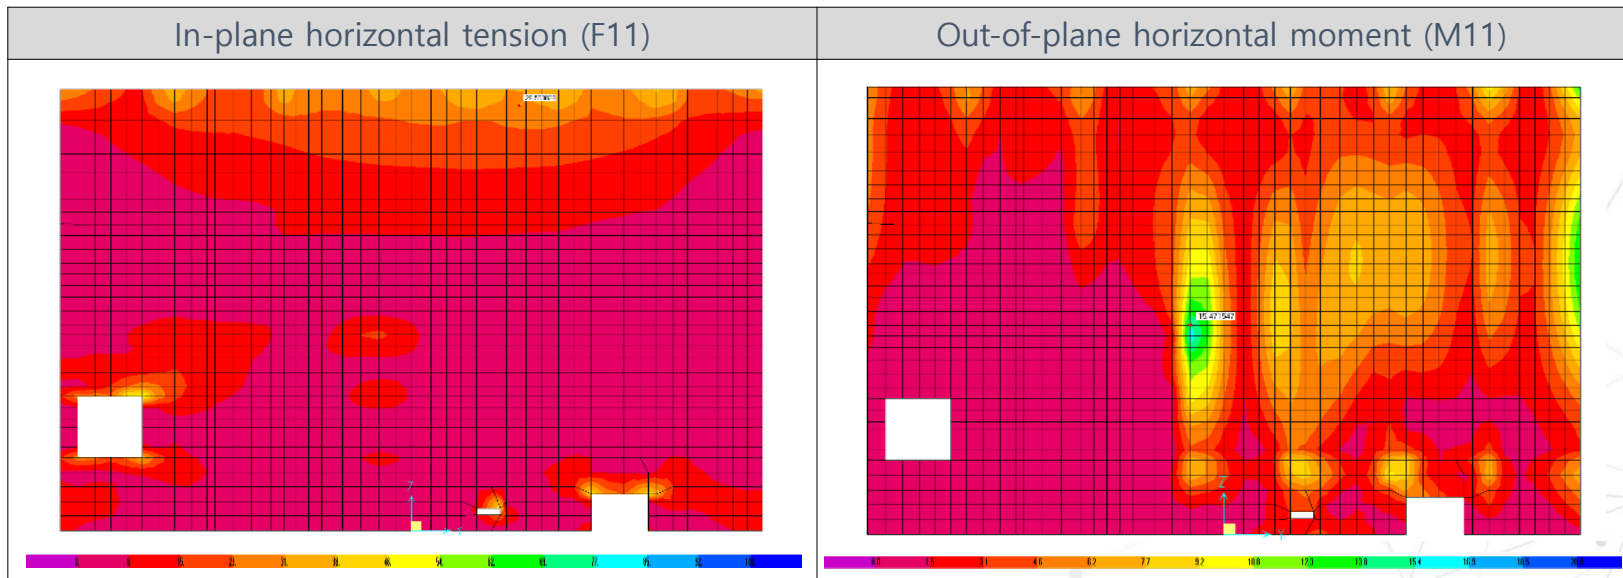
- When the draft SMA report was presented, we suspected some error occurred at SMA procedure.
- We checked modeling, assessment procedure and actual field condition.
- As a result of evaluation, some part of the outer wall (about 4.8%) is not satisfied the design criteria(SSE 0.2g).

This picture shows member force of the reactor building (west side of outer wall).

Maximum in-plane horizontal tension (F11) is 30 ton and maximum out-of-plane horizontal moment (M11) is 16 ton.m. It means that the performance of minimum allowable seismic load for horizontal moment is only 0.09g.

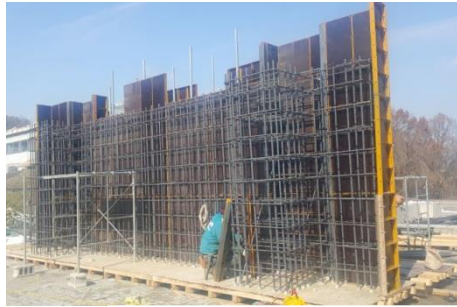
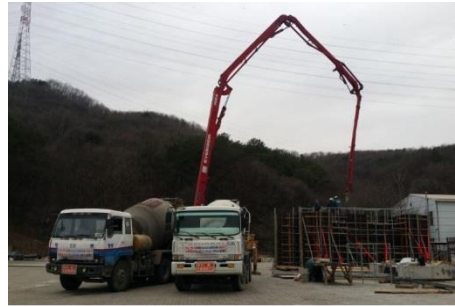
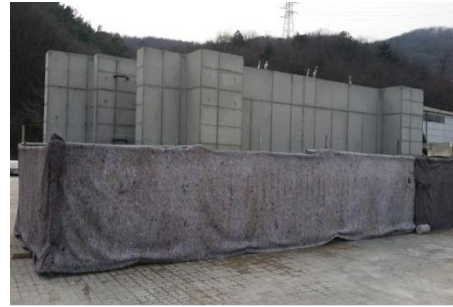
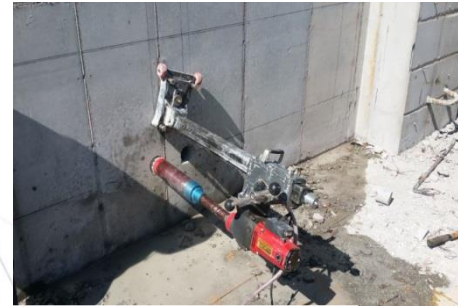
- A course of making specimen, we regard it as a rehearsal of real reinforcement construction.
- We check the whole process following quality management plan.

Formwork and rebar arrange, Concrete casting, Form removal, Core drilling

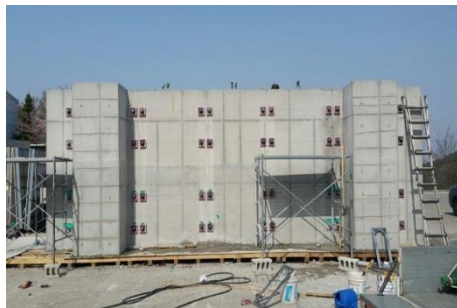
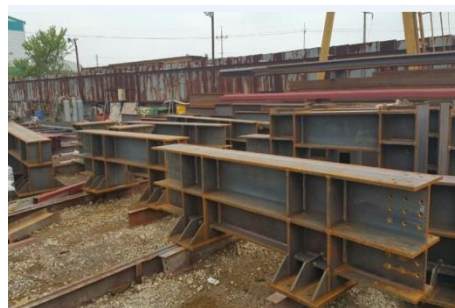
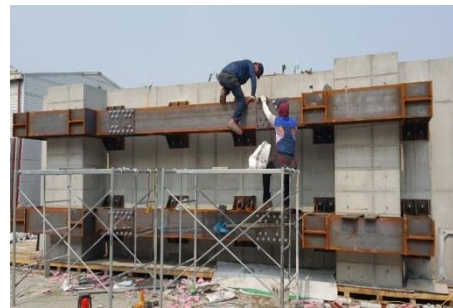
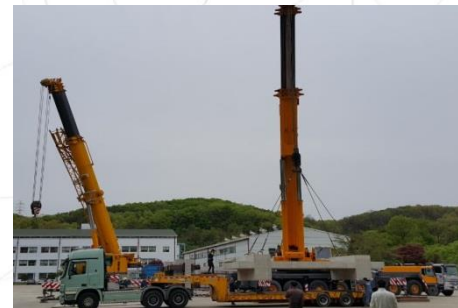
Arrange anchor bolt using template, Size inspection of built-up section, Assembling of built-up section, Relocate the specimen

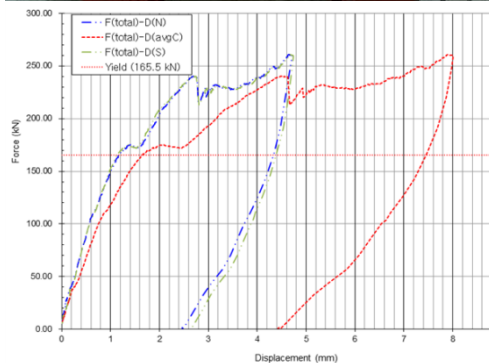
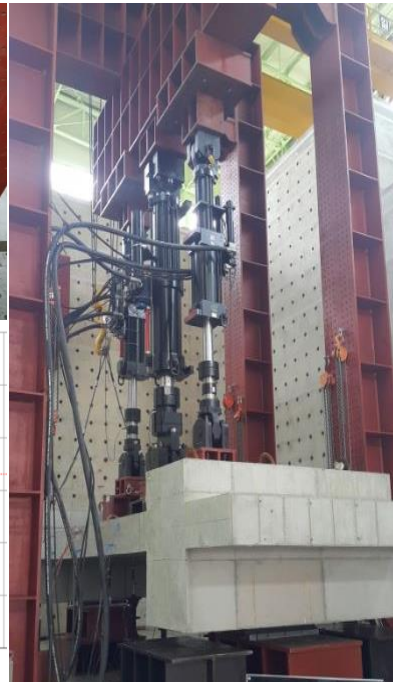
- The test result showed that the static loading capacity of the reinforced specimen was stronger than the one in the original condition.
- The built-up section showed an increase in the structural strength capacity.
- Original wall specimen yields at (about) 170kN and reinforced specimen is not yields until 2000kN. It was not able to check. (Limited capacity of actuator)

Static loading test (Left : Original wall, Right : Reinforcing with built-up section)

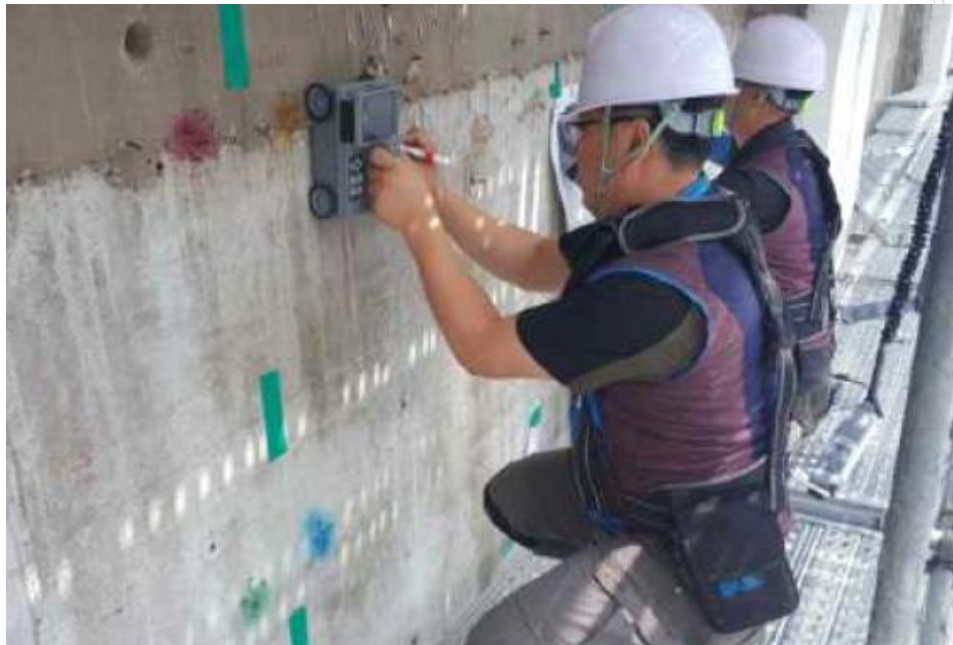
- **Measuring and recording the points of installation**
 - To determine the positions of built-up sections, KAERI made a precision survey.
 - After that, rebar scanning was conducted to avoid cutting the existing rebar in the wall.
 - When rebar existed in the installation position, the installation position was changed to maintain the existing rebar.

Rebar scanning to avoid cutting existing rebar

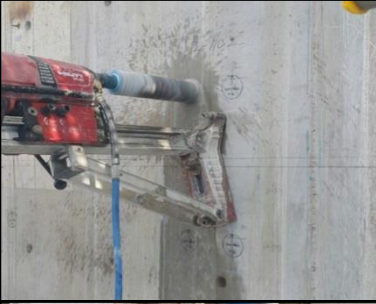
○ Drilling the outer wall by using core drill

- As a result of precision survey, KAERI determined suitable coring point.
- To locate the through-bolt through the wall, we made holes using a core drill machine at the installation points

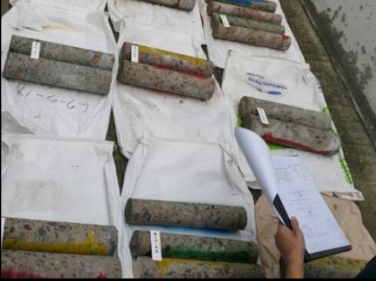
- To check the cutting of the existing rebar, we carried out the total inspection about the core remainder.
- In case an unexpected rebar cutting is detected, we stopped drilling and checked the design calculation.
- If the design margin was sufficient, we made the report with 'use as is'. And if not, we applied additional reinforcement.

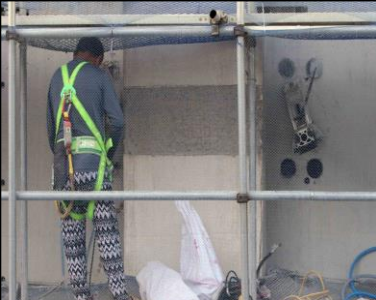
- The HANARO building adopted a confinement concept for the reactor hall, which isolates the air, but allows a small leakage.
- To keep its own function in the construction period, we used a rubber plug.
- Right after the wall was penetrated, we stopped up the holes with rubber plugs. It functions as a physical shield between the reactor hall and outside

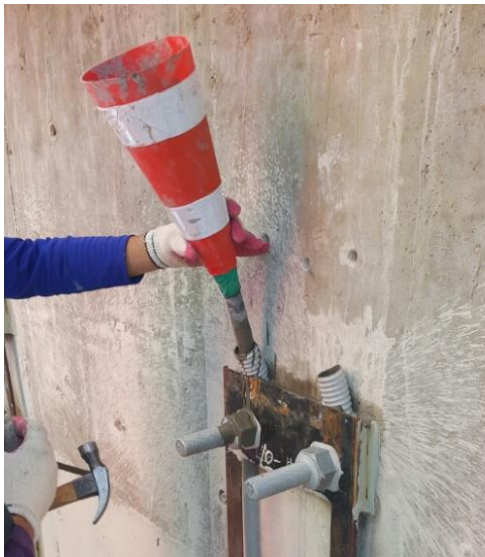
- To make the through bolt centered in the hole, we made a special template to locate the through bolt. After that, we injected non-shrink grout between the through bolt and the wall of reactor building
- After the injection, we checked all of the holes to keep the confinement function of the reactor building. To check the individual leak, we made a leak test box and attached the box at the inspection point. After that, we made a -0.5 bar vacuum condition inside the box and checked if it is maintained over 20 seconds at the inspection position. The results showed that all holes are filled with non-shrink grout well and have airtightness.

Inject non-shrink grout into hole to fix the through bolt in the hole

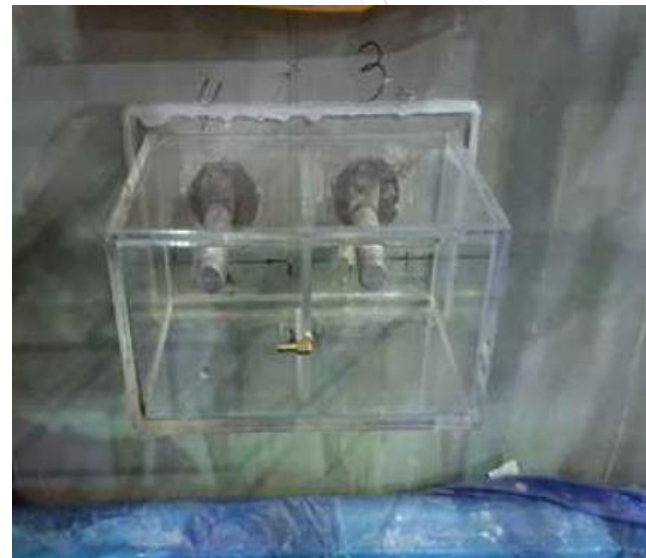
Leak test box

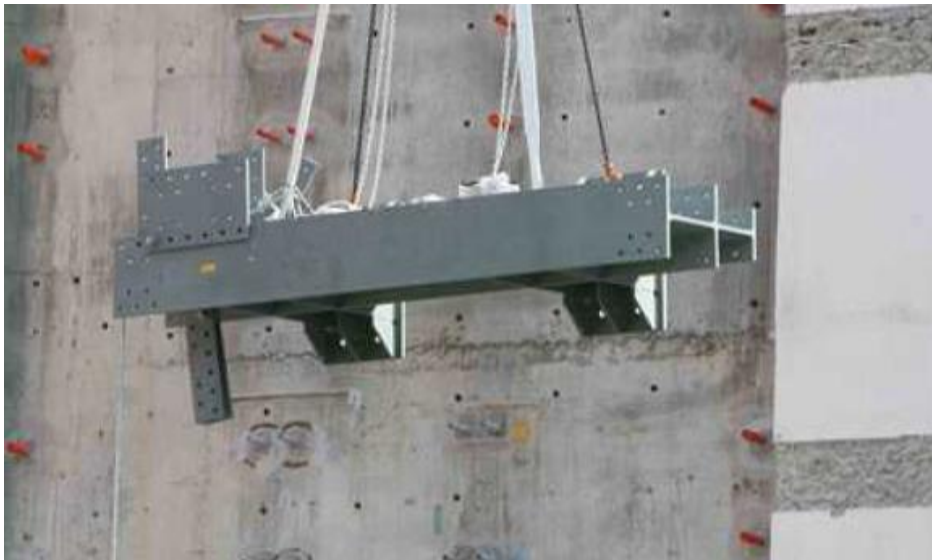
- The built-up sections were lifted using a crane and integrated on the through-bolt installed at the wall of the reactor building. The built-up sections were connected with each other by tightening high strength bolts using an electric impact wrench. A specific torque was applied to the connecting bolts and the full inspection was fulfilled to check it using a torque wrench.
- Finally, an epoxy was injected into the gap between the baseplate of the built-up sections and the wall of reactor building, which works as a filler and also helps with airtightness.

Crane lifting the built-up section to install with through bolt at the wall

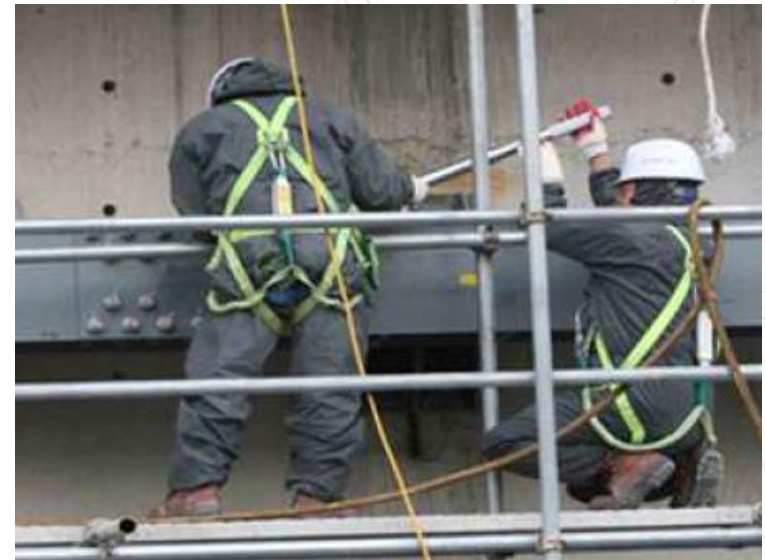
Workers are tightening the high-tension bolt with regulated torque.
