# **A Brief History of the NRU Reactor Vessel Leak and Repair**

TRTR Conference

G.B. Wilkin

2010 September 19-24

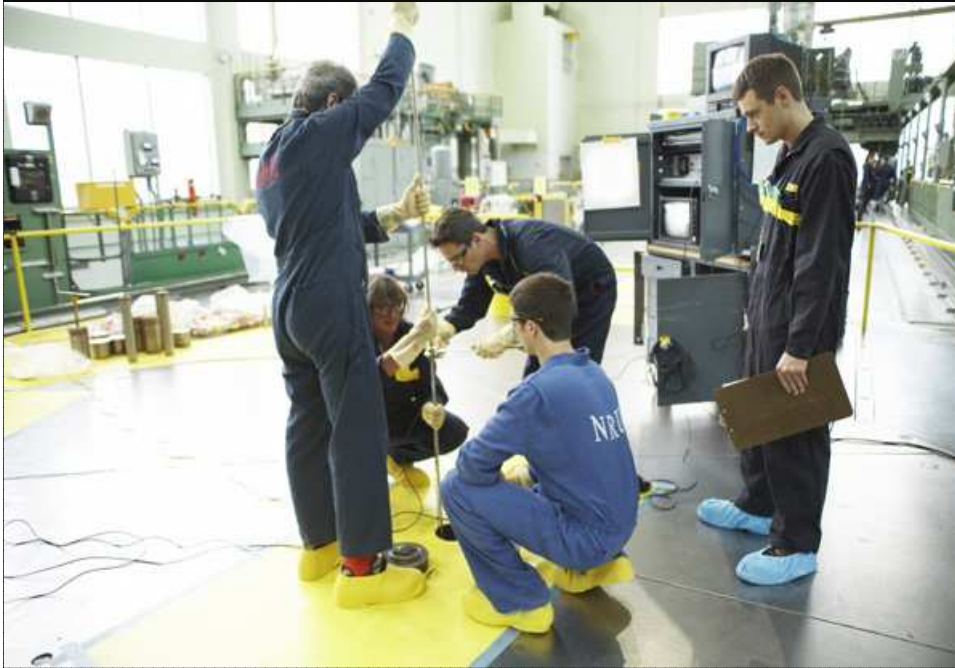
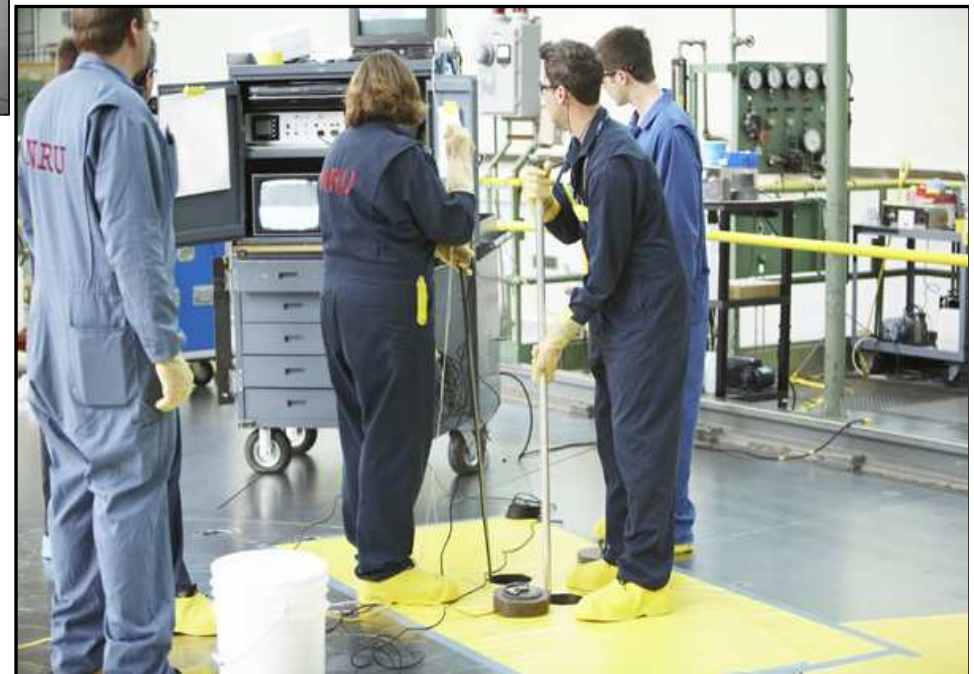
# Condition Assessment of Vessel

- Remote video inspections
- Ultra-sound examination
- Eddy current probes
- Over two million data points
- Four phases

One of largest single NDE inspection campaigns ever carried out in the nuclear industry.

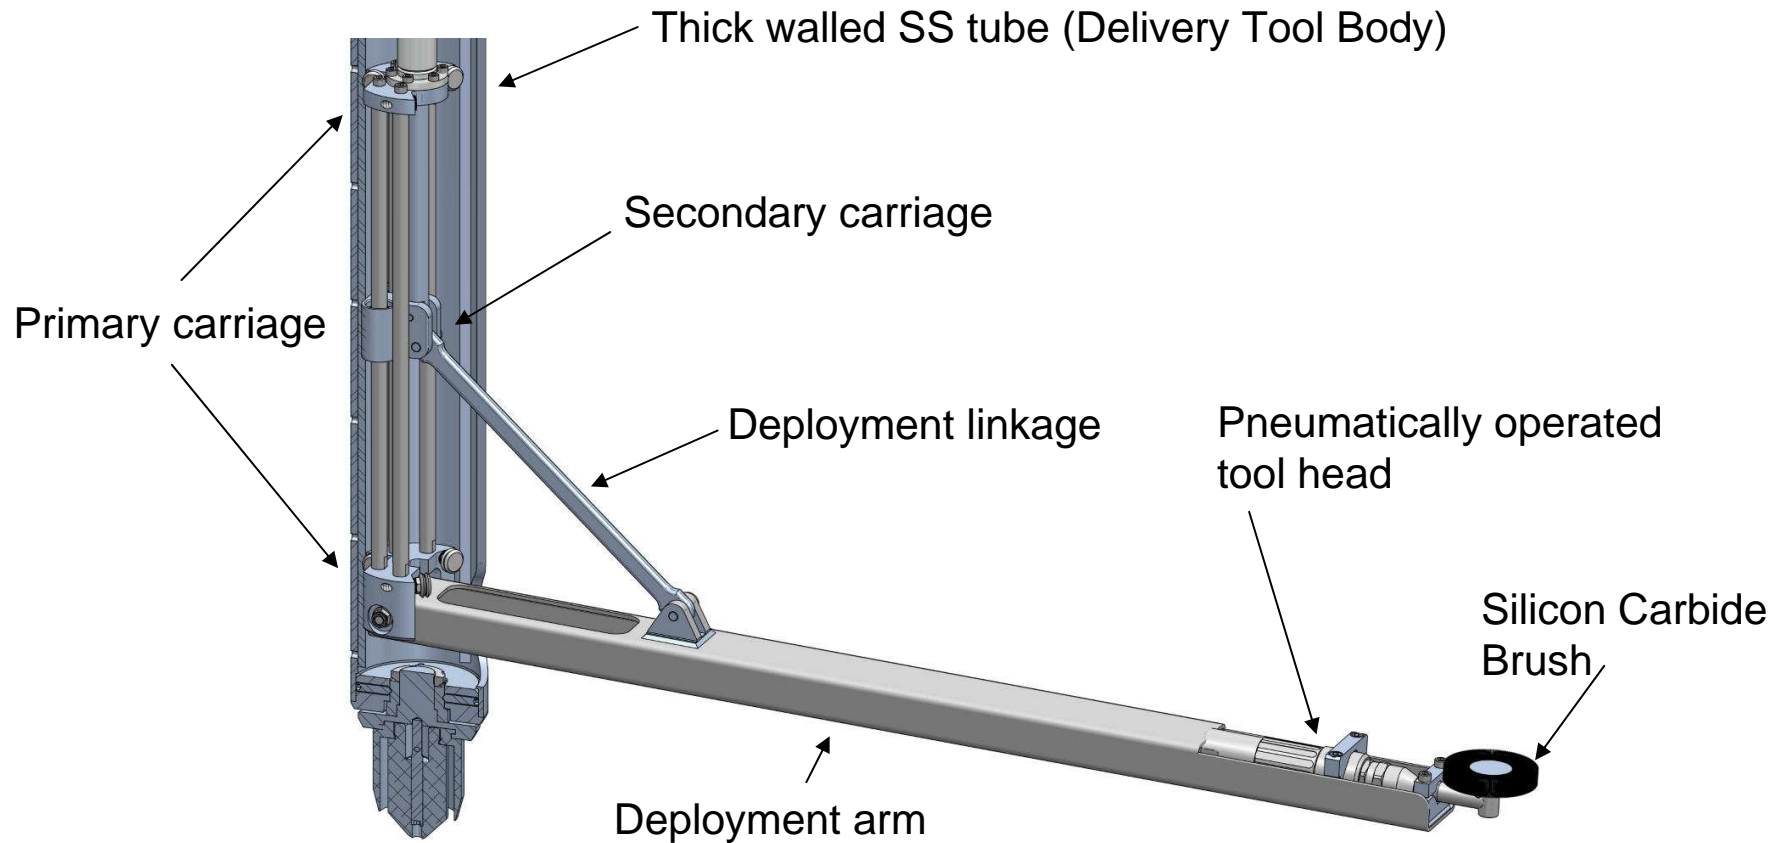
# Cleaning Tool Deployment Arm

- Arm has 965 mm horizontal reach
