FRM II: LESSONS LEARNED FROM THE REPORTABLE INCIDENT “RELEASE OF C-14 ABOVE DISCHARGE AUTHORISATION”

F. JESCHKE, A. PICHLMAIER, R. SCHÄTZLEIN

Technische Universität München, ZWE FRM II

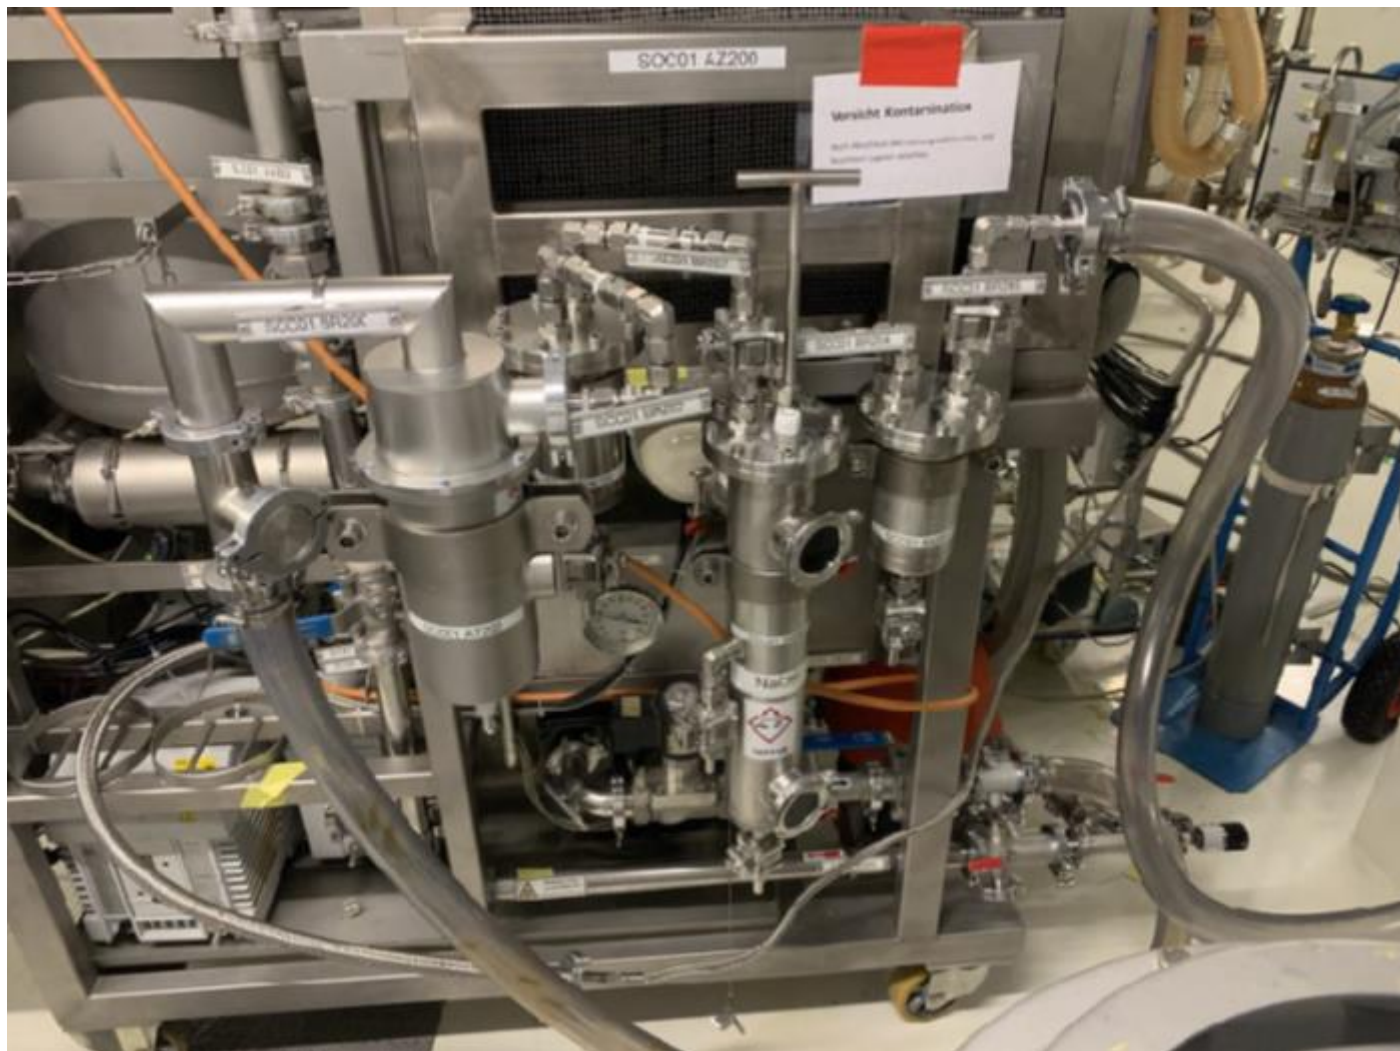
- In the D₂O, the C-14 is present in the form of carbonic acid and is being removed on ion exchange resins.
- Once exhausted, the resins need to be dried for further treatments. During this process, inevitably C-14 will be released.
- Without filtering, the C-14 in the form of (C-14)O₂ would be released into the atmosphere.
- To prevent this from happening, a device using NaOH to remove this radioactive CO₂ had been retrofitted in 2013.

- In 2020, during the first of anticipated four drying cycles the CO₂-removal device had not been installed (in spite of a detailed checklist on how to use it).
- The second cycle was done with the device installed, by precaution and as requested by the regulator, cycles 3 and 4 have not been carried out.
- This continuation was justified by
 - the excellent overall experience
 - earlier, before the removal device had been retrofitted, never more than 50 % of the annual release limit had been reached when completely drying these resins
 - the proven 100 % efficiency during commissioning
 - Investigations by the radio chemistry department that the C-14 release would mainly happen towards the end of the drying process.
- Nevertheless, 115 % of the permissible limit were released, the FRM II had to suspend reactor operation and all work with potential C-14 release for the calendar year.

- Reactor operation suspended for more than one year
- Complete new construction of the C-14 removal device (ongoing)
- Root cause analysis was done, the main conclusions lead to:
 - Training of the personnel on communication and improved professional behavior (HPO, first and second round completed for 100 % of employees)
 - New construction of the C-14 removal device (cf. above, confirmed by the root cause analysis)
 - Several minor changes concerning e. g. review of the management system, handling of procedures, organization of recruitment.
