STATUS OF THE RESEARCH REACTOR FRJ-2 AT THE RESEARCH CENTER JÜLICH, GERMANY

J. Wolters

Central Division of Research Reactors and Nuclear Facilities
Forschungszentrum Jülich GmbH, D-52425 Jülich

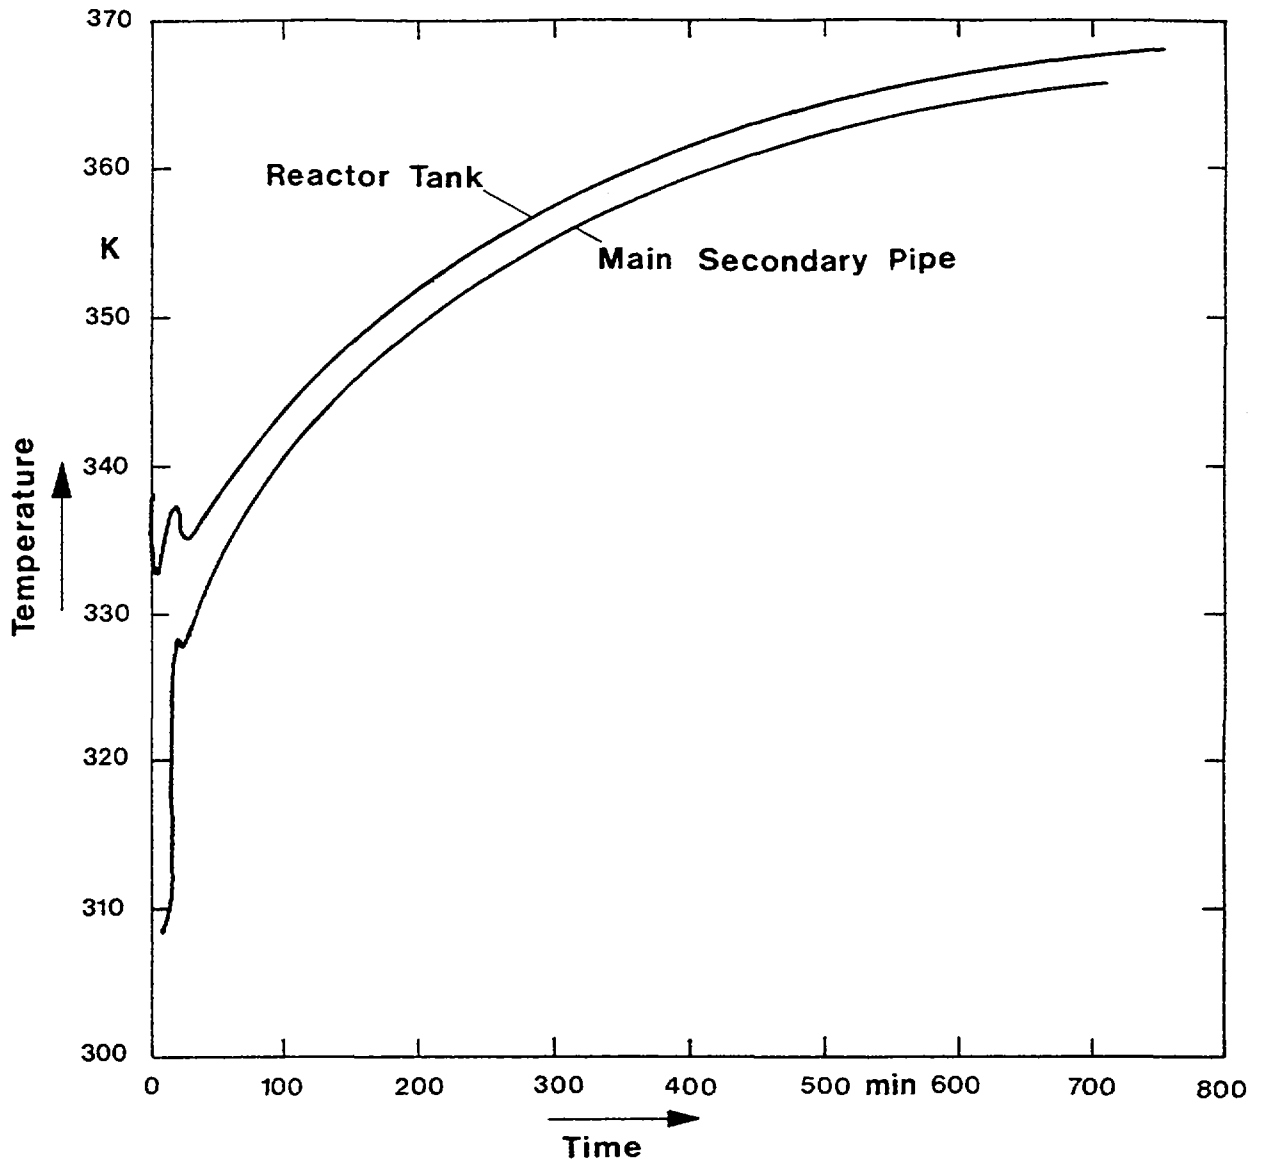
Fig 4: Time Dependent Temperature of the Water in the Reactor Tank and in the Secondary Manifold in Front of the Primary-Secondary Heat Exchanger in the Case of Secondary Cooling by Natural Convection

the boiling point, as can be seen from Fig. 4. This will be demonstrated by a reactor experiment using the primary cooling pumps as the heat source which will be of the order of the decay heat after about one hour.
