## **Wear Inspection for Fuel Channels in HANARO**

*Sang-Ik WU, Yeong-Garp CHO*

HANARO Applications Research, Korea Atomic Energy Research Institute

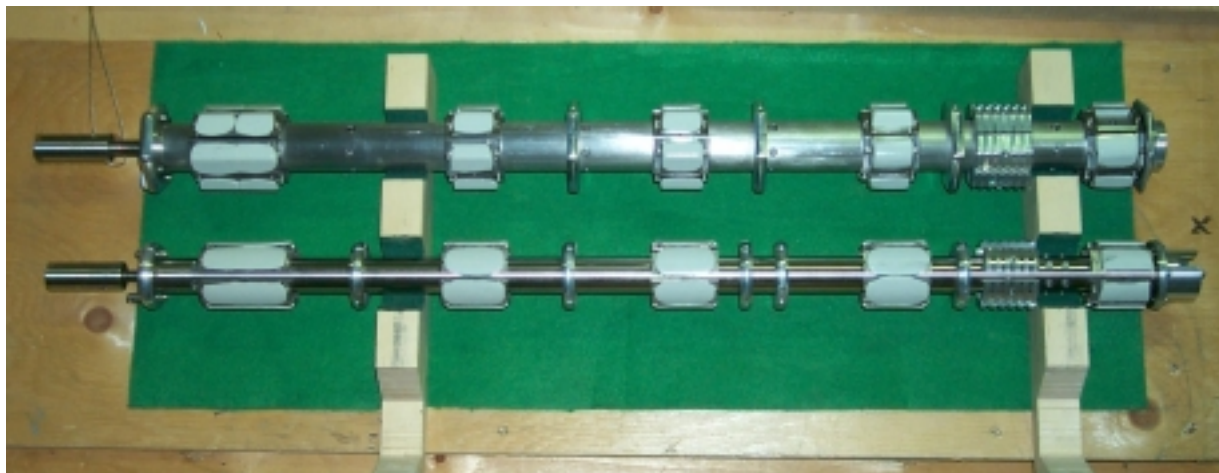
Figure 4. Wear inspection tools with the impression material  
(Upper one for the hexagonal and another for the cylindrical fuel channels)
