# AGEING MANAGEMENT AND PREVENTIVE MEASURES FOR REACTOR POOL LINER AND BEAM TUBES AT THE DALAT RESEARCH REACTOR

NGUYEN NHI DIEN\*, NGUYEN MINH TUAN AND TRANG CAO SU

*Nuclear Research Institute, 01 Nguyen Tu Luc Street, Dalat City, Vietnam*

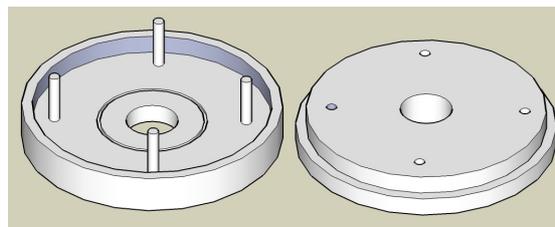
**Fig. 7.** Watertight instrument for neutron beam tubes at the DNRR.

For the above-mentioned purposes, during the last ten years, some proposals and designs were taken, tested and installed at the beam ports, for example, a manual open-close system with humidity sensor generated alarm signal, resin probes manually used in case of serious leak of the beam port, an on-line system for monitoring the reactor pool water level with alarm signal transferred to the facility entry where security guards on duty, etc. The last design is a watertight instrument which was directly installed inside the beam tube together with other components such as neutron filters, gamma and neutron shielding and collimators, etc. in order to prevent the loss of shielding water if the beam tube should develop a serious leak. Fig. 7 shows the watertight instrument and the full components of the beam tube No #2 are shown in Fig. 8.

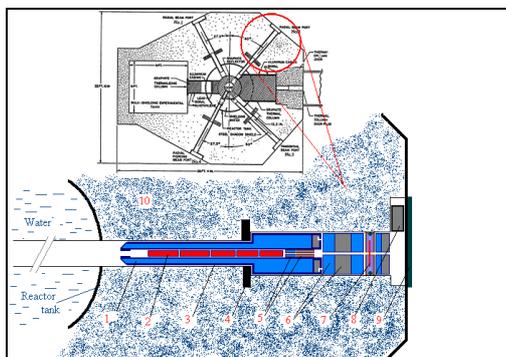
**Fig. 8.** Watertight instrument was installed in the beam tube No #2.
