# Development of a Low Temperature Irradiation Capsule for Research Reactor Materials

## ABSTRACT

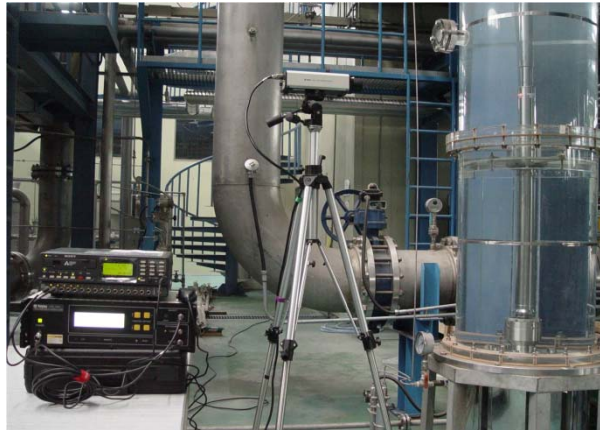
Fig. 4. Measuring the vibration of a capsule installed in the single channel out-pile test loop

Owing to the internal flow of the coolant, the bottom part of the capsule was suspected to be susceptible to a vibration-induced fatigue failure. To strengthen the soundness of the bottom parts, the material of the rod tip was changed from stainless 304 to stainless 316L, and the welding method was also changed from TIG welding to an EB welding method.
