Current Status of JRR-3

Yoichi KASHIMA

Japan Atomic Energy Agency

2.1 Recovery works (1/2)

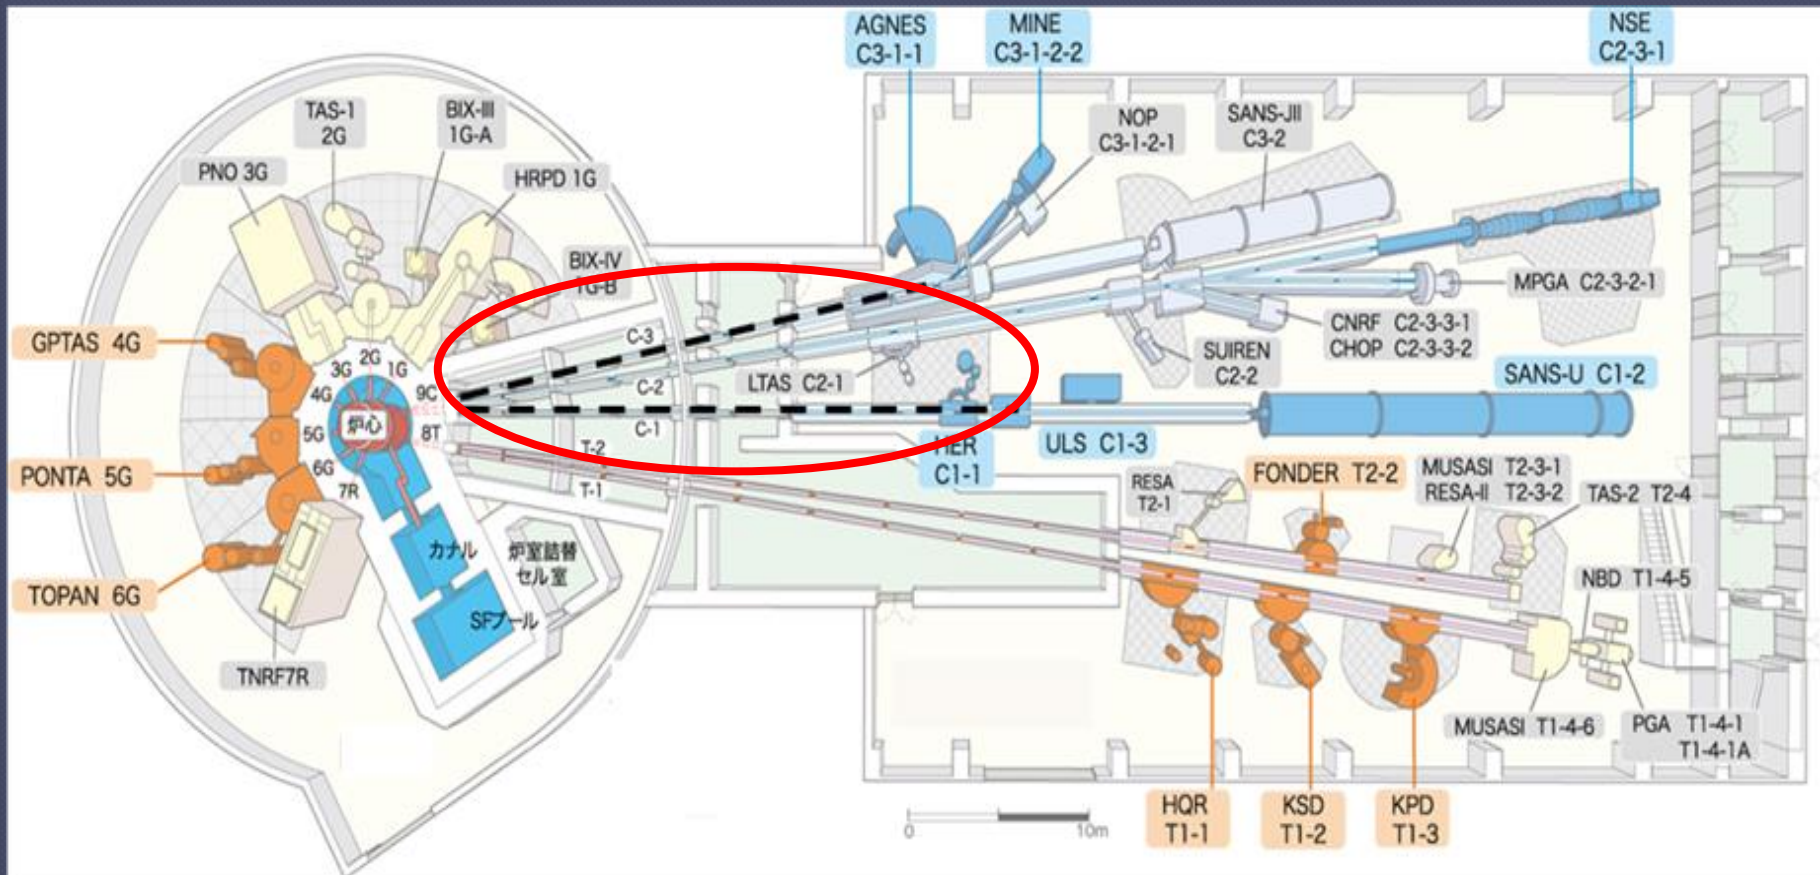
Current Ni mirror in two cold neutron guide tubes C1 and C3 were replaced with Ni/Ti supermirror.

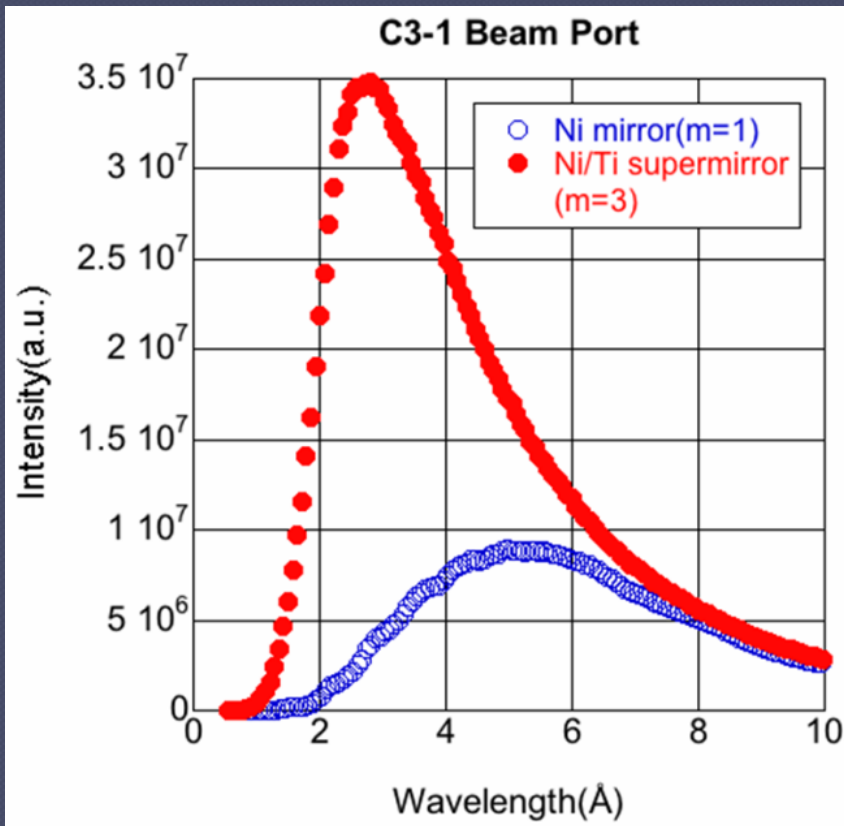
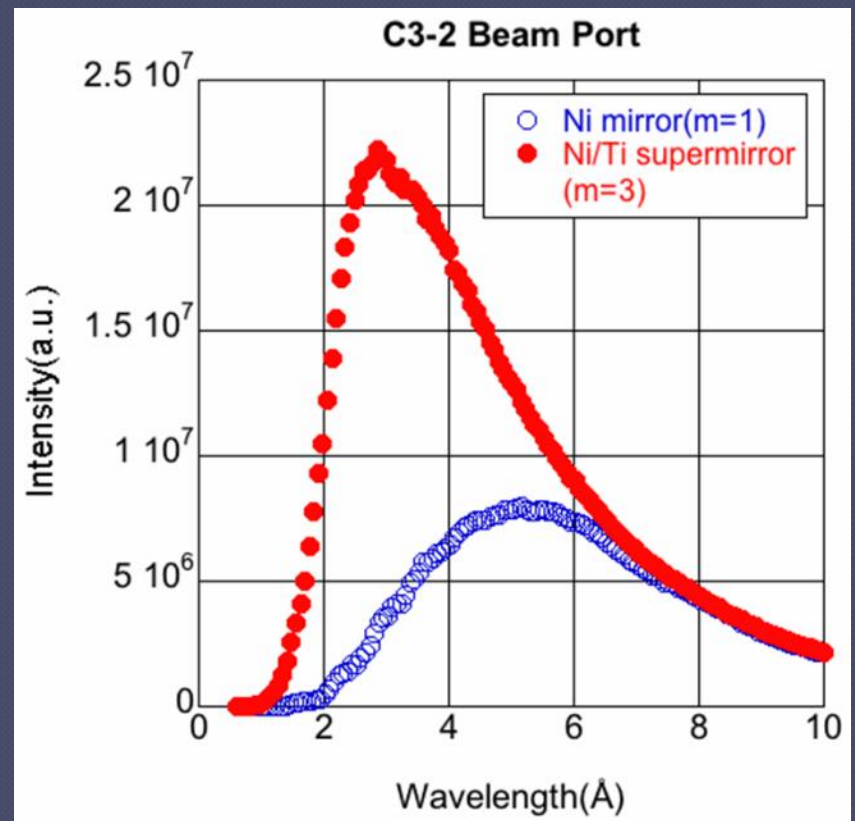
The characteristic wavelength would be shifted from 5 Å to 2.4 Å and the gross neutron intensity would be increased about 2.5 times with Ni/Ti supermirror case.
