Modifications on TR-2 Reactor Against an Expected Earthquake

TUNCAY TUNA¹, HAKAN ANAÇ¹

18th IGORR & IAEA WORKSHOP

Improvements Made on SSCs Related to Safety After F-D

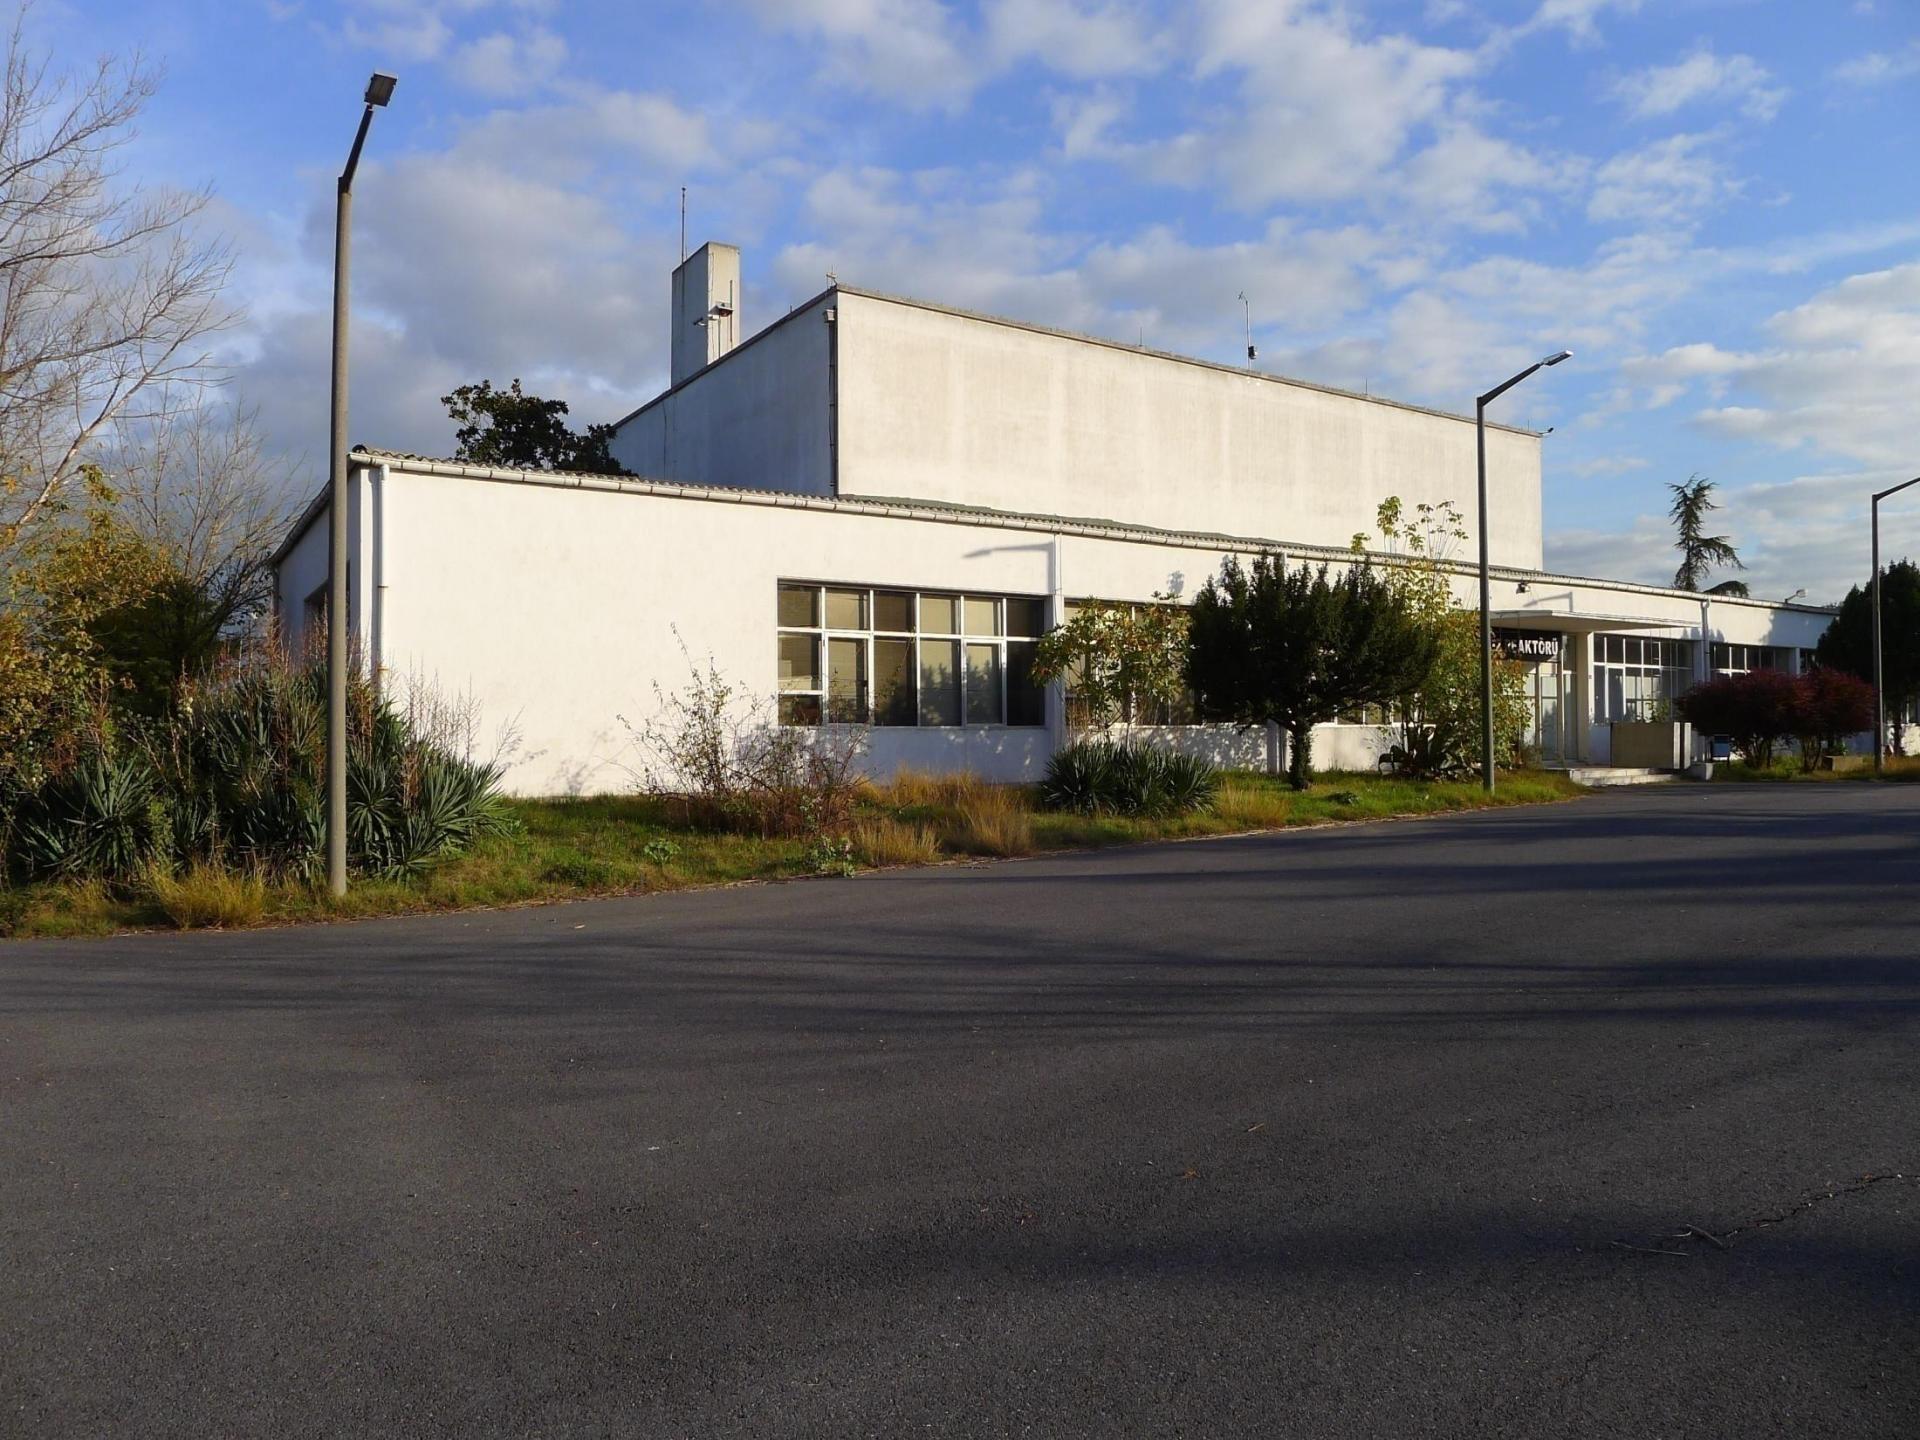
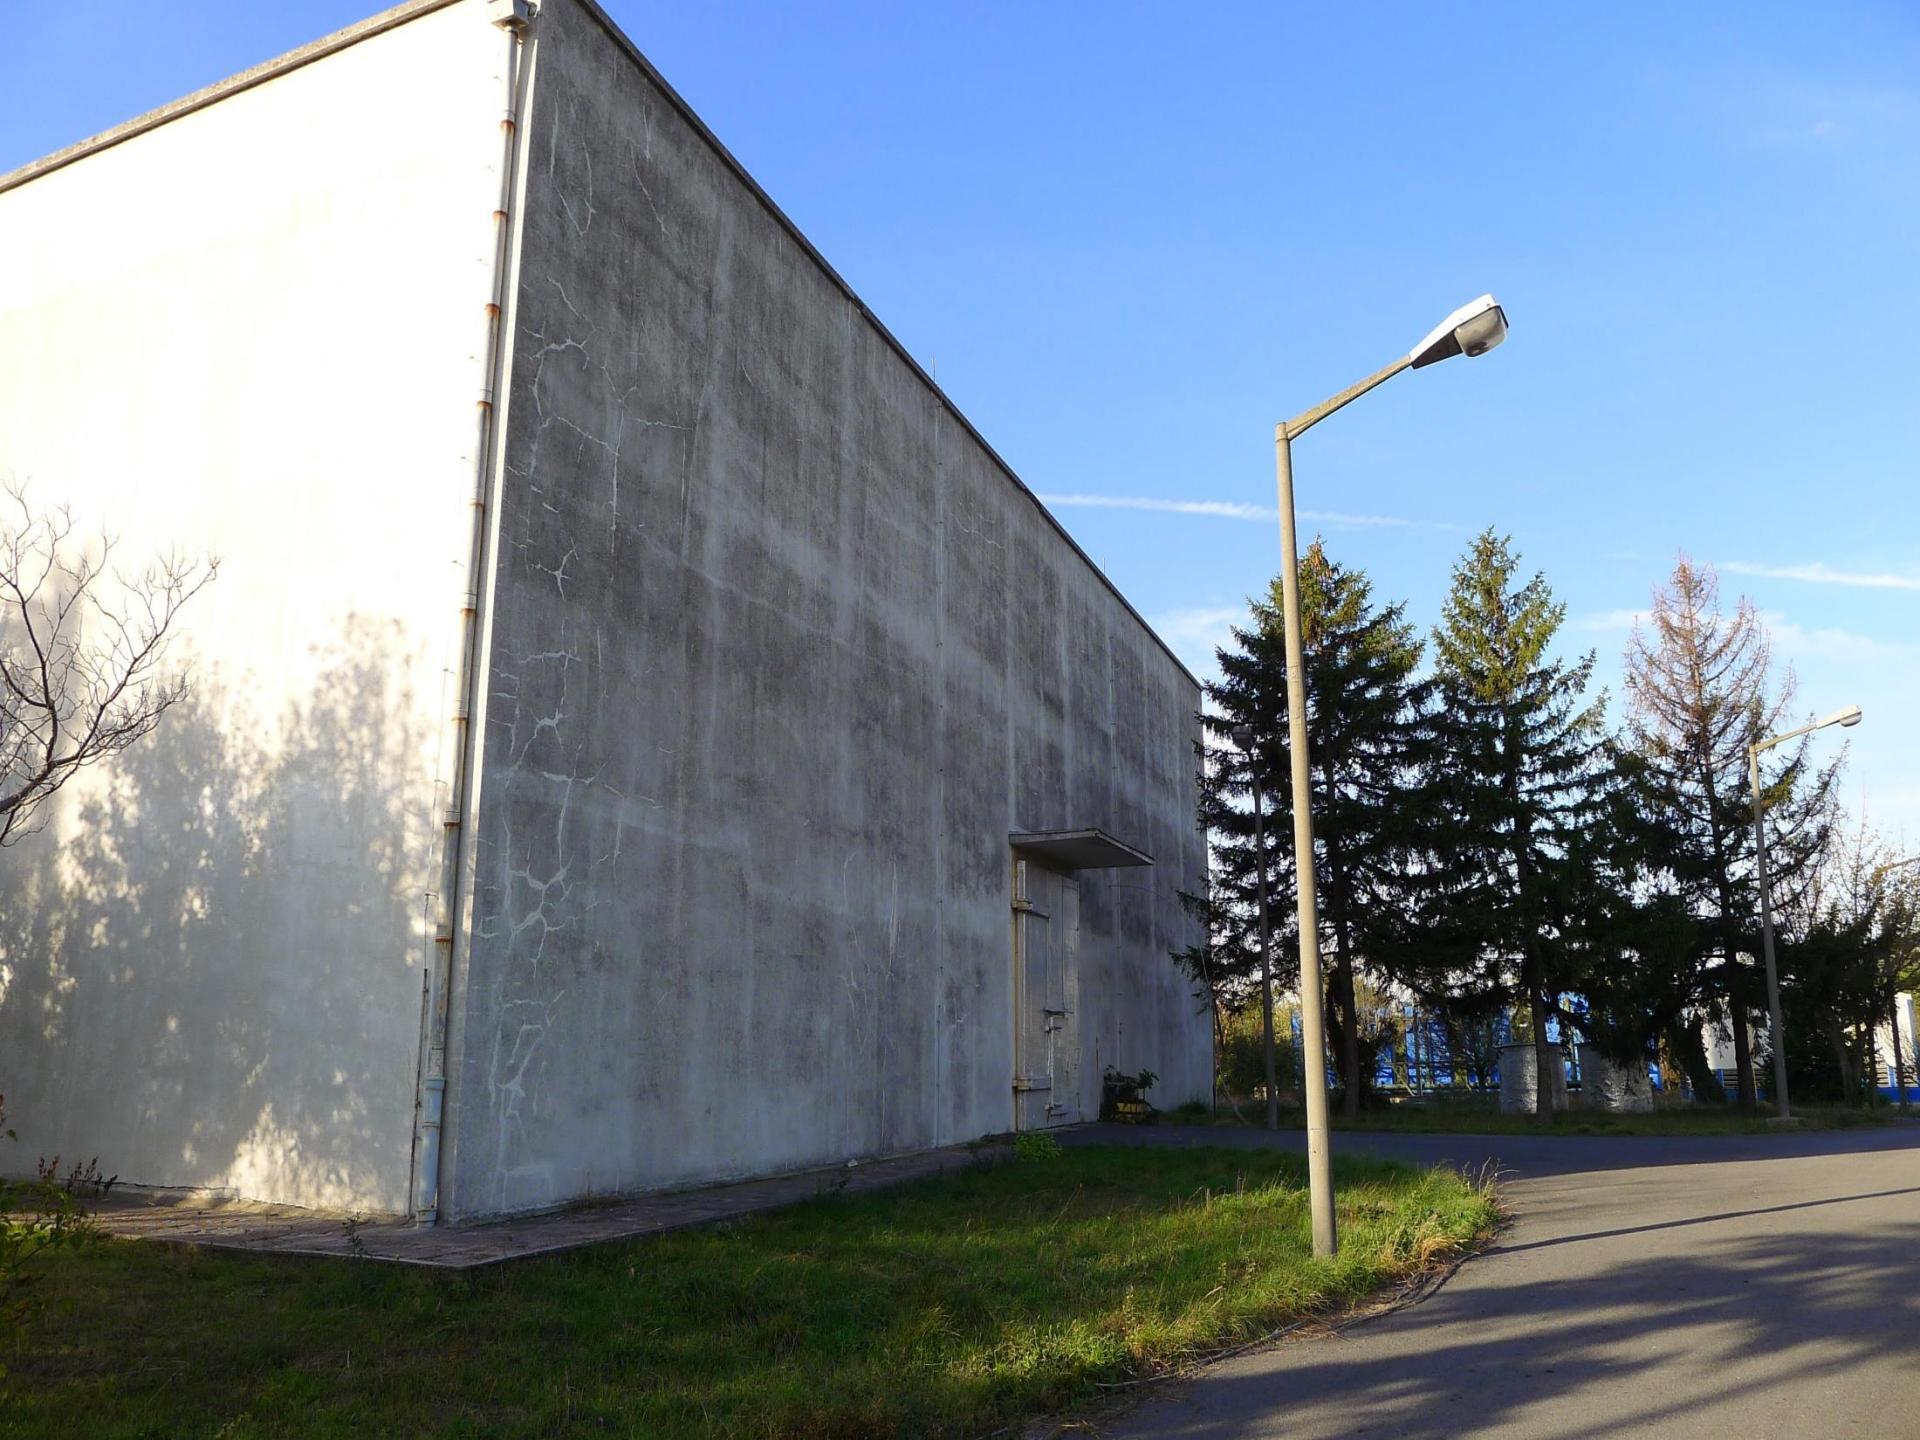
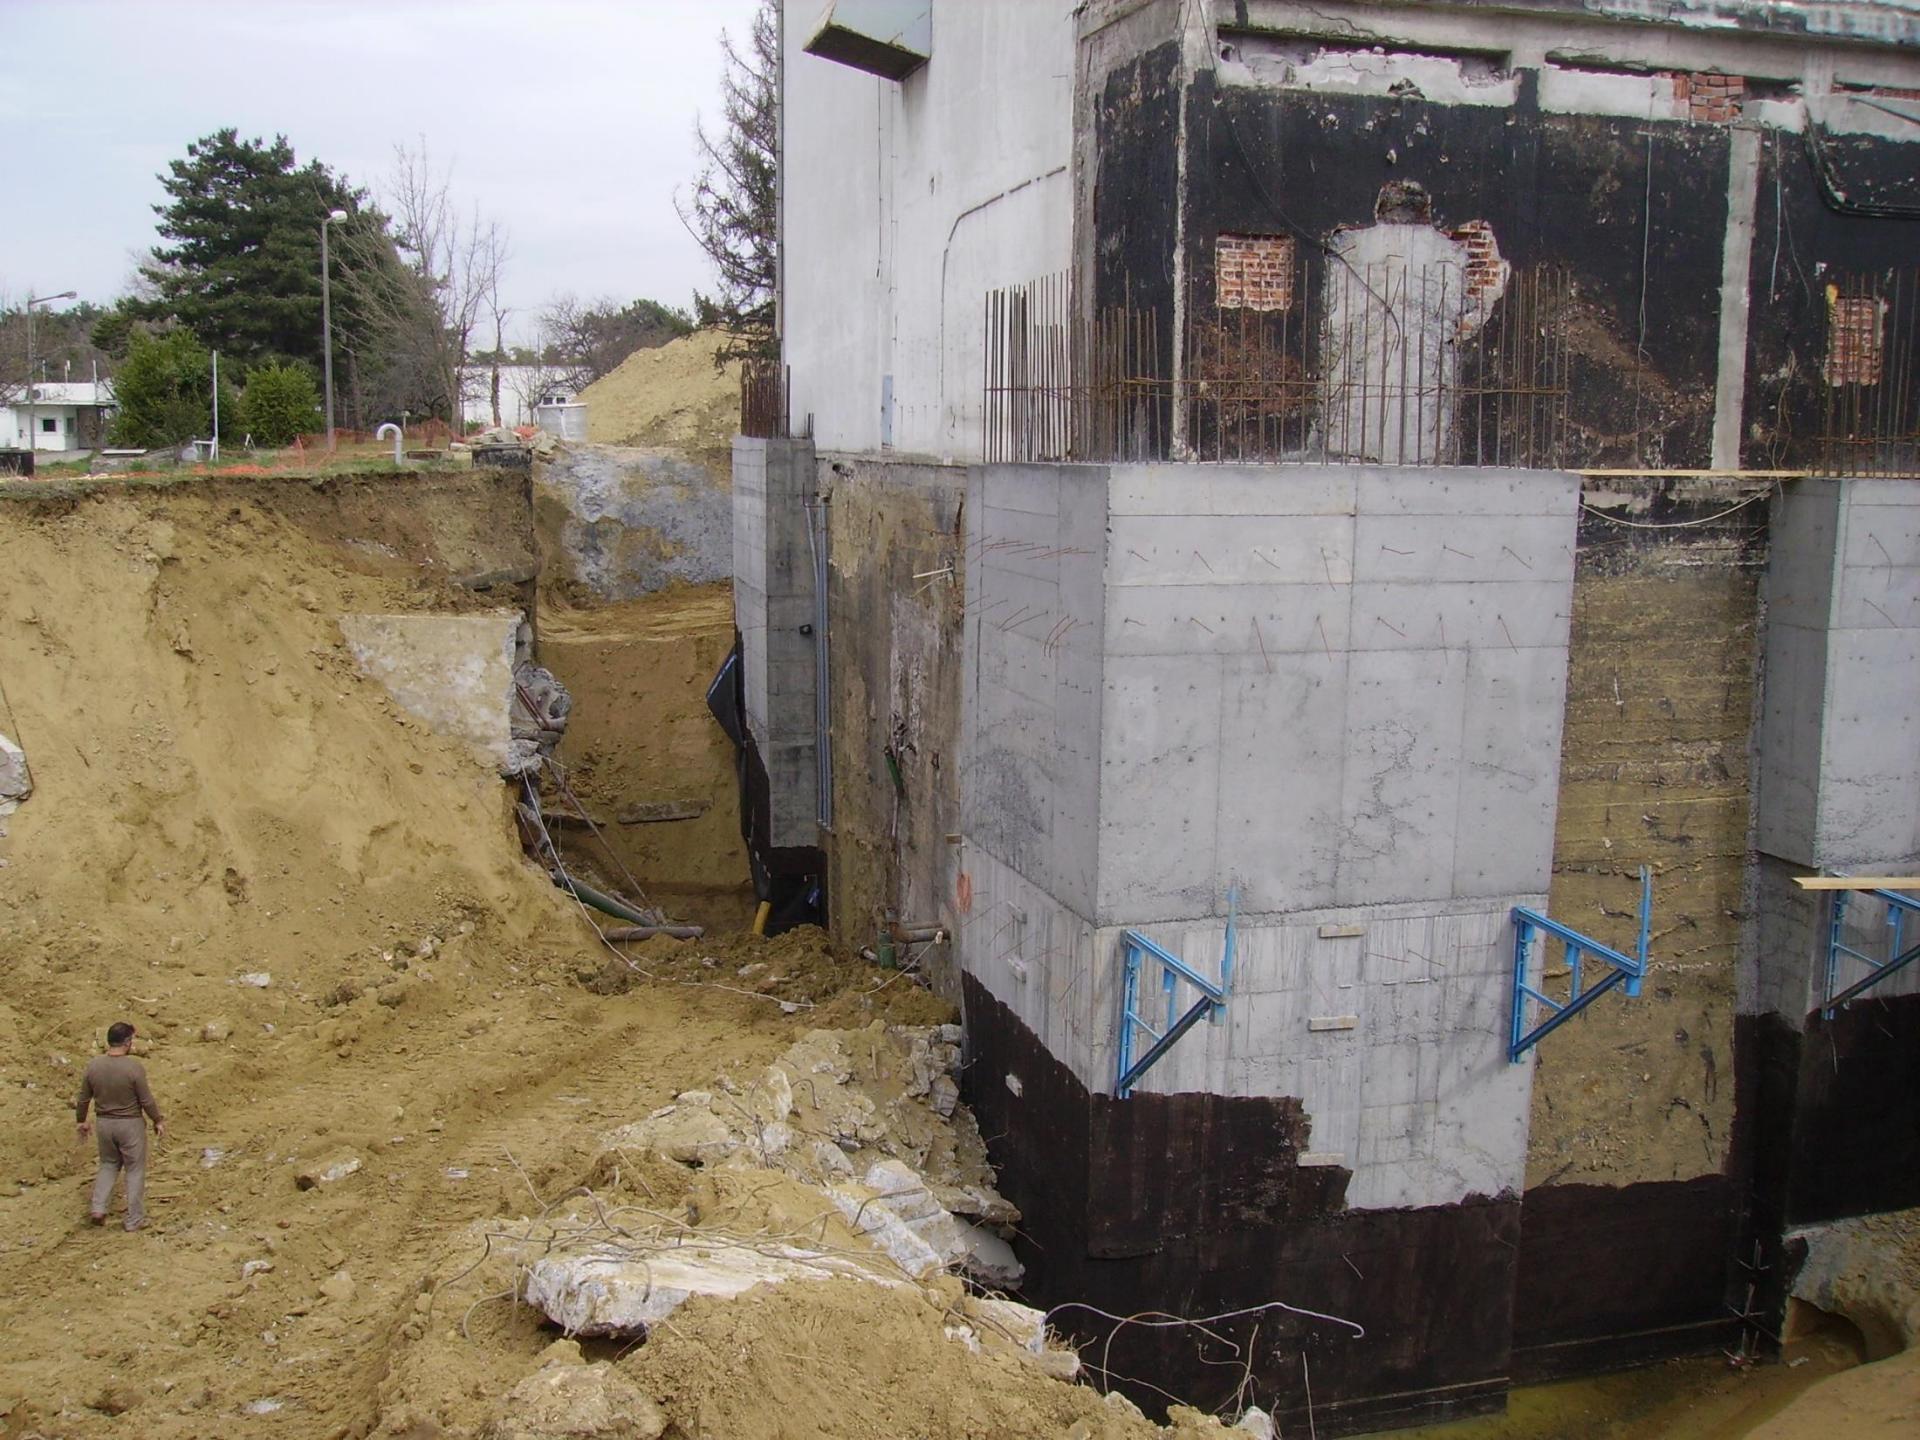
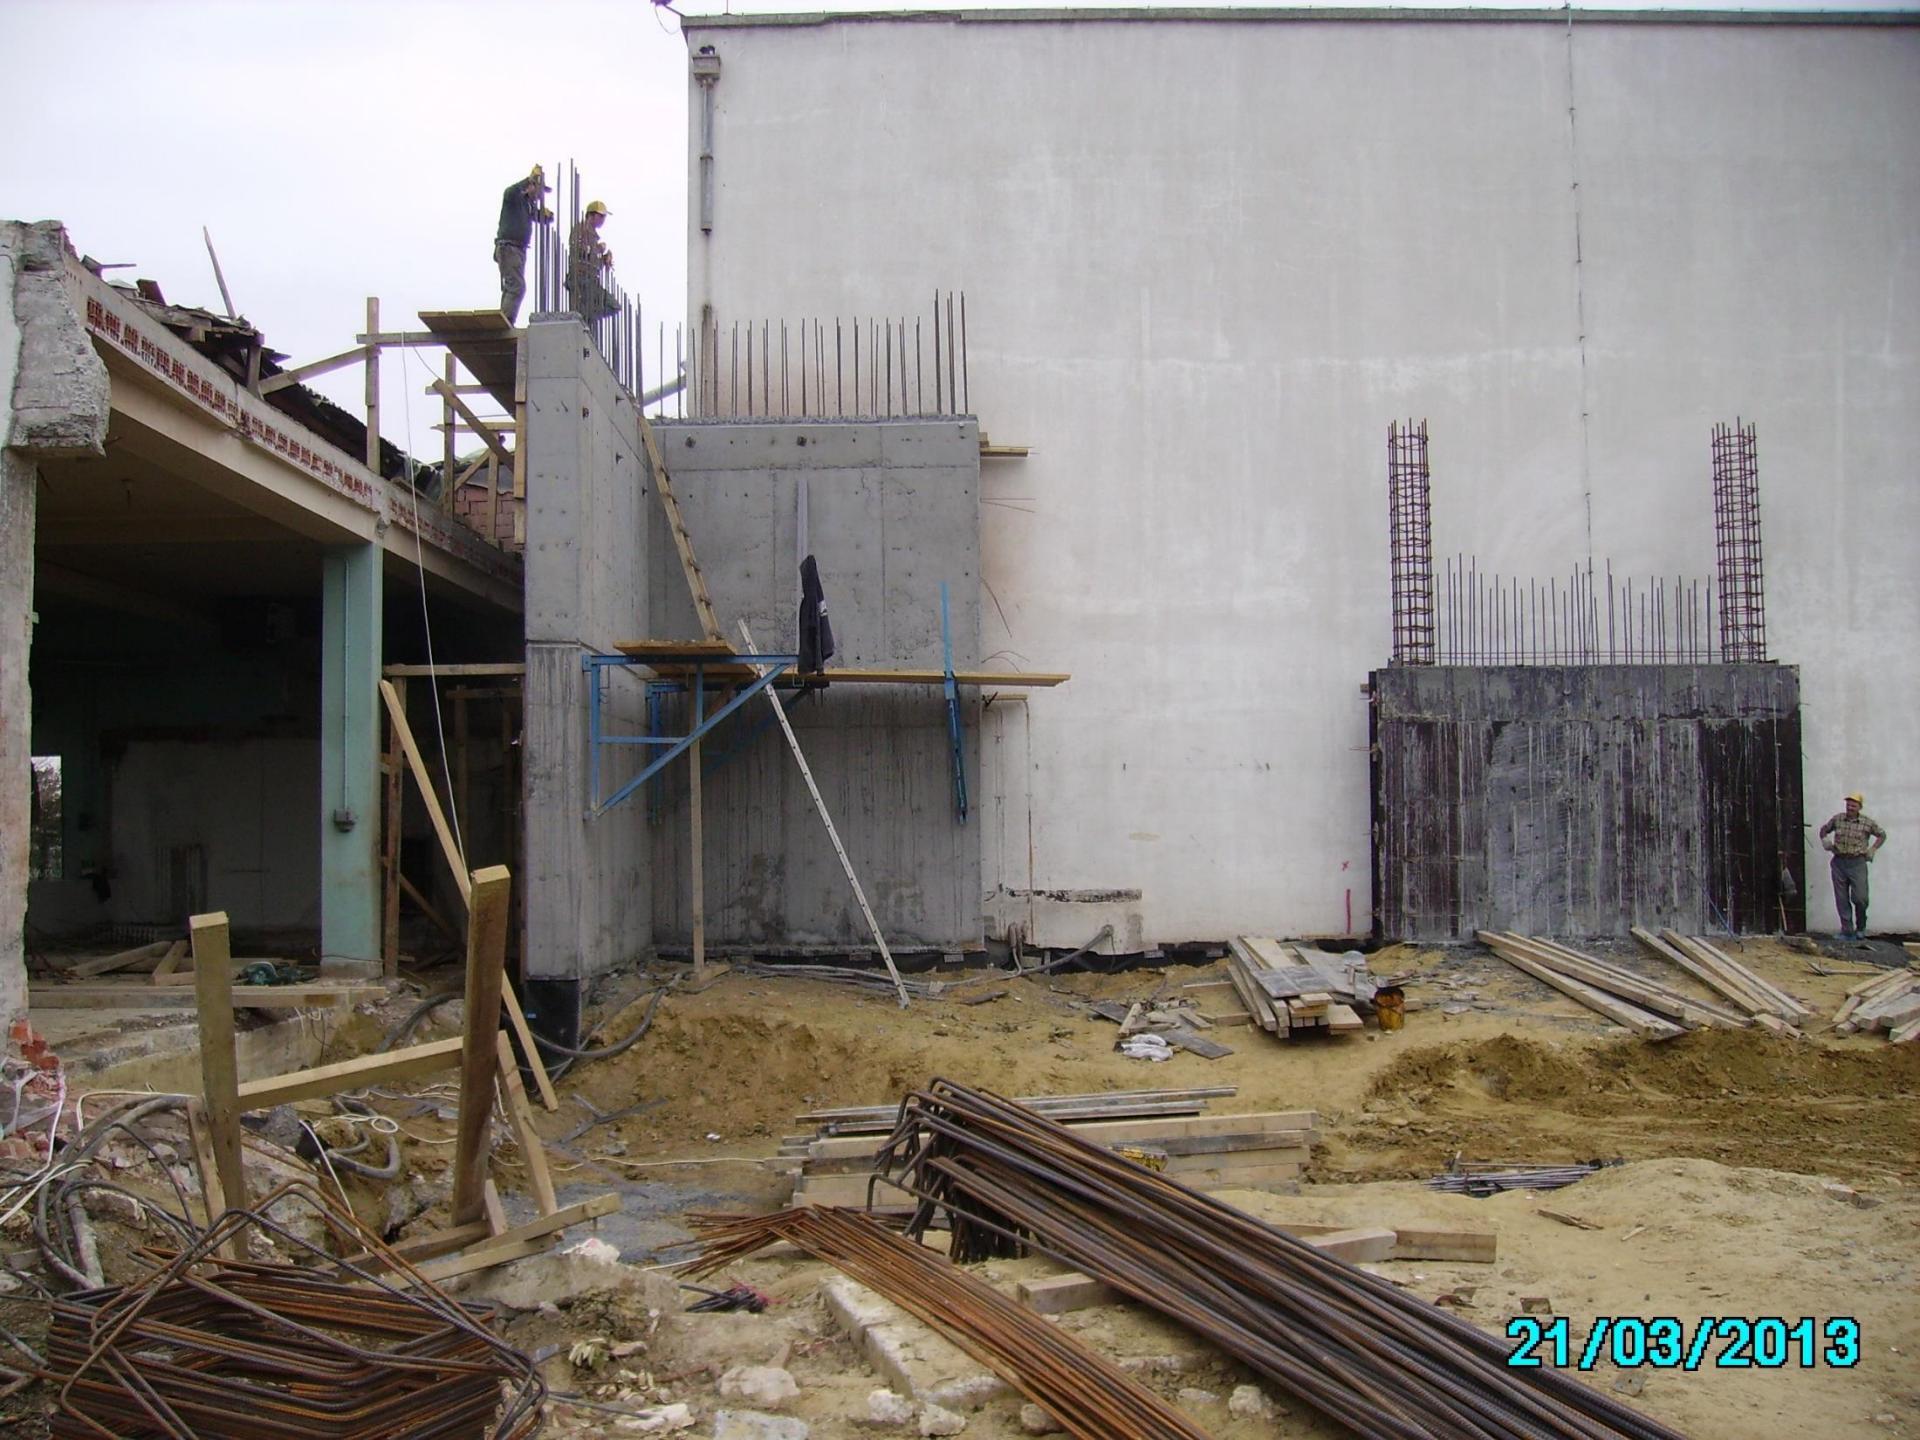
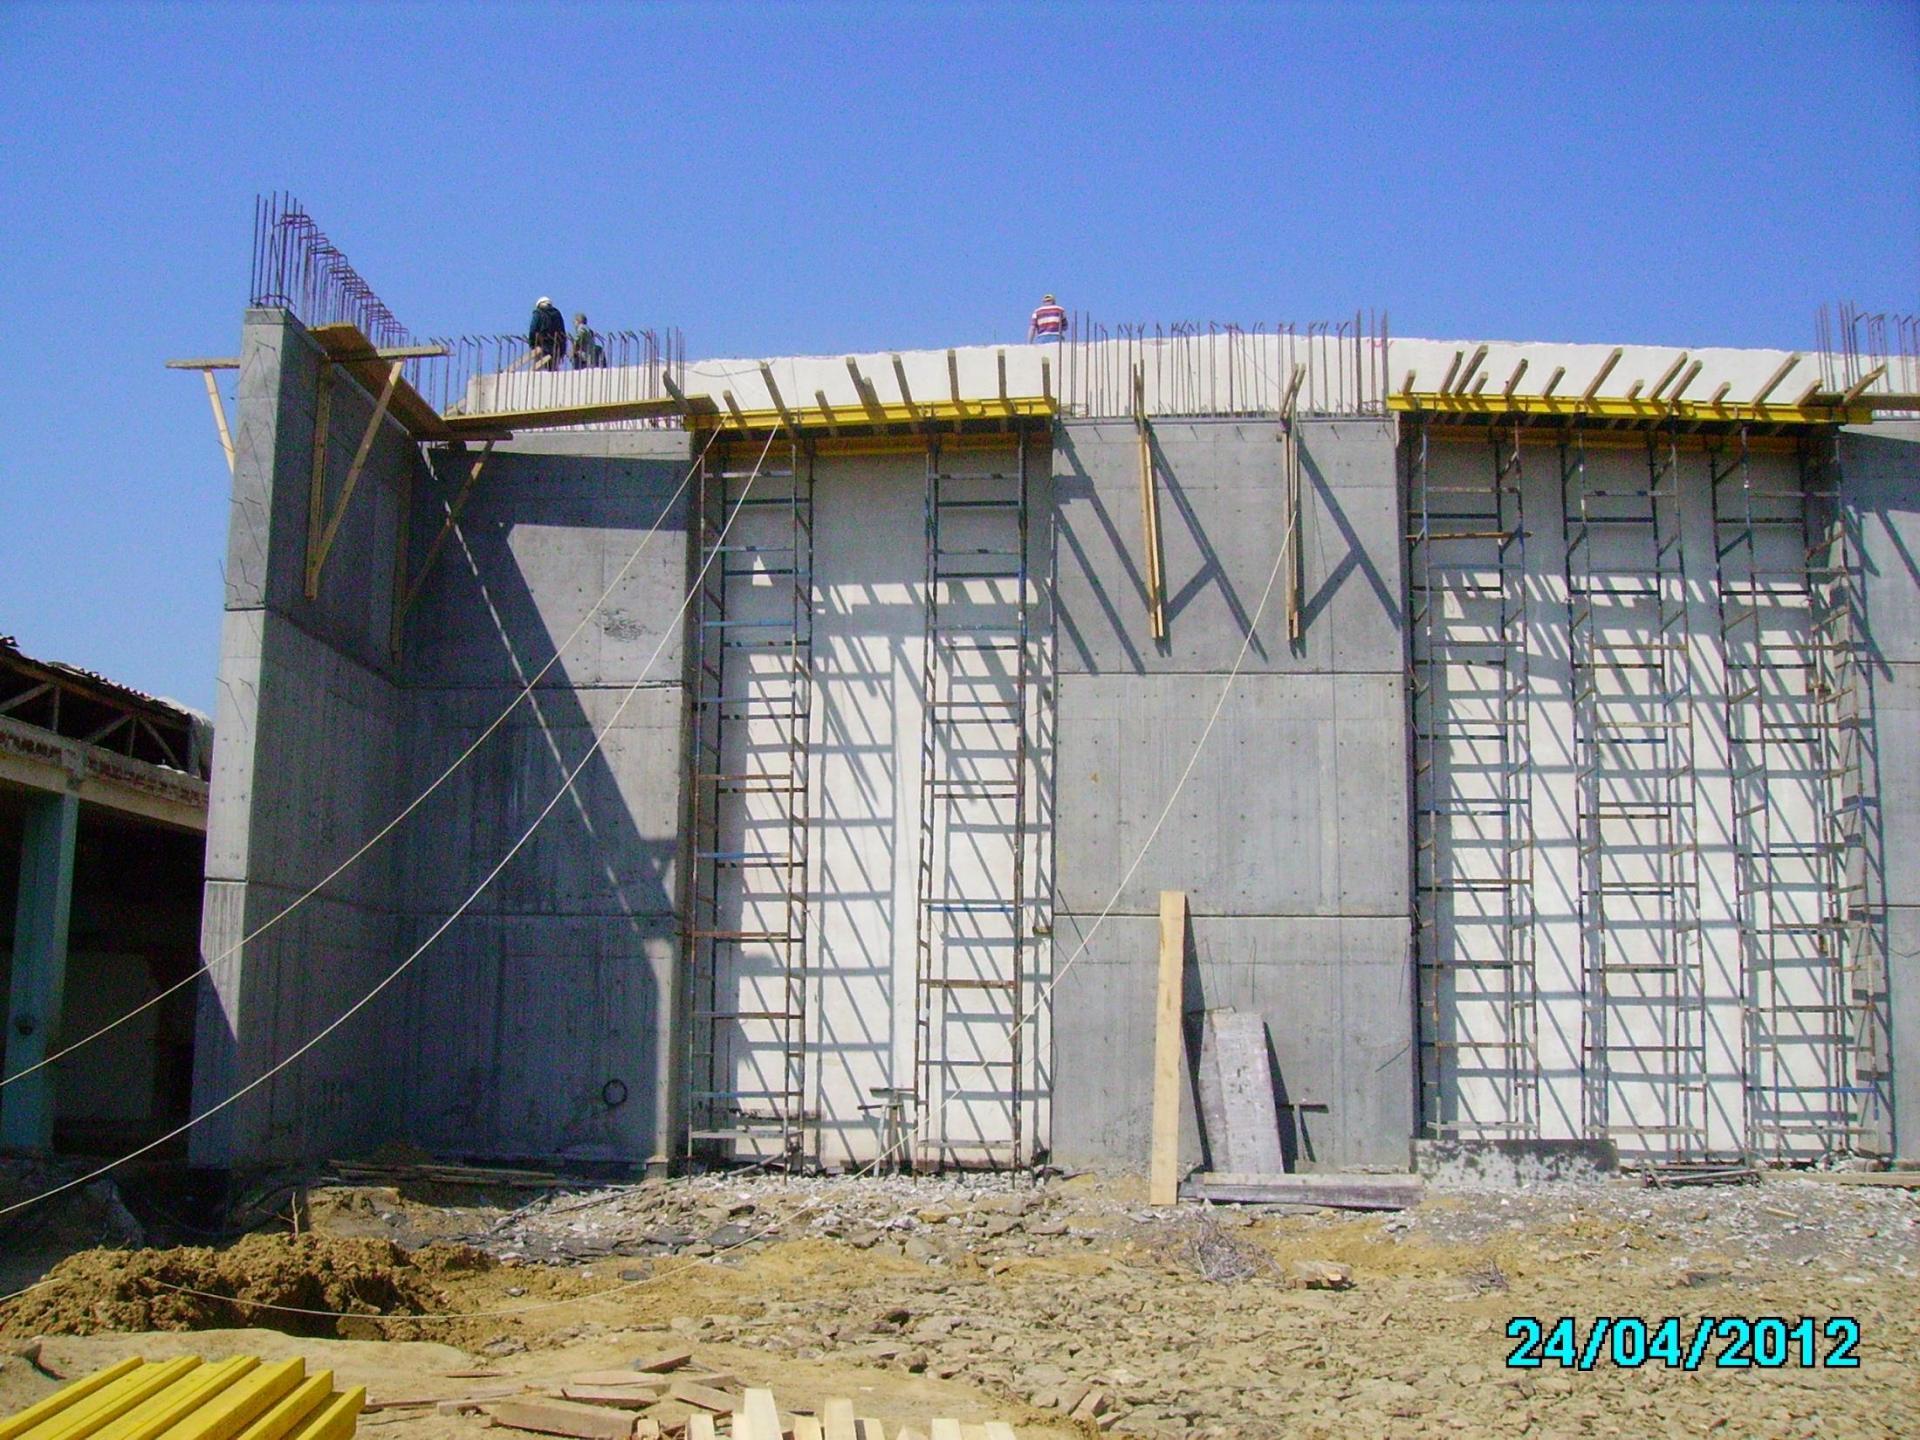
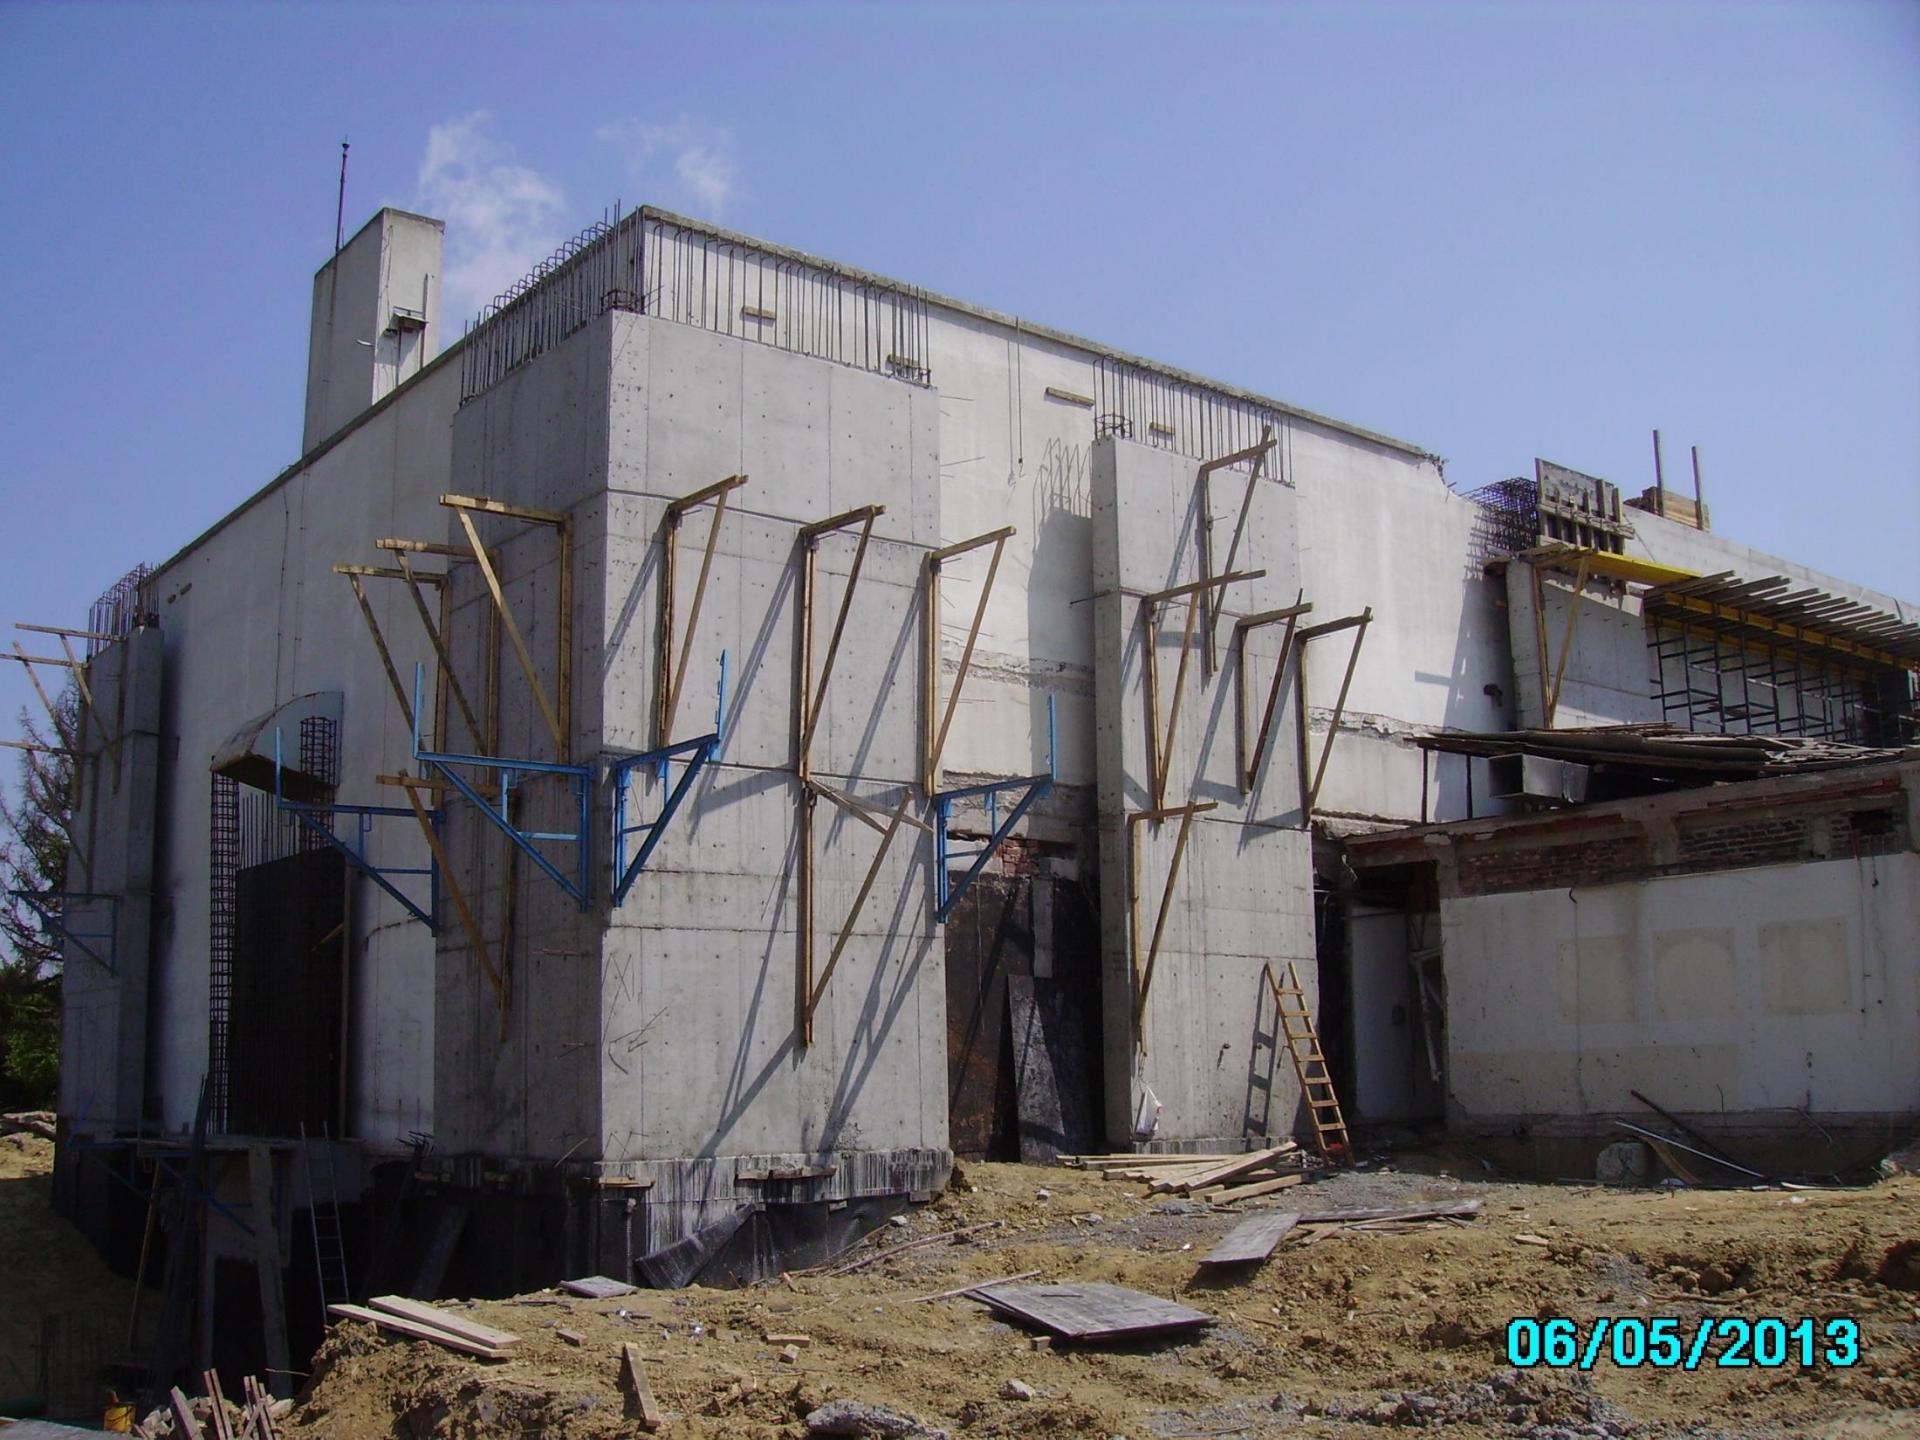
- Components important to safety were seismically analyzed
- Two Earthquake sensor integrated to SCRAM system. (New seismic sensor with high sensitivity and accuracy adapted to the safety systems) (double for reduncancy 1/2 logic scram)
