Secondary Cooling System Ageing Management and Refurbishment Activities at the OPAL Reactor

IAEA: Technical Meeting on Research Reactor Ageing Management, Refurbishment and Modernisation

Chris Humphrey OPAL Engineering

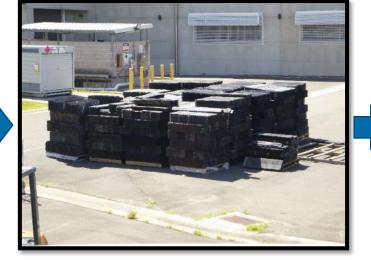
- Original internal fill or packing identified as in degrading condition in 2017 and should be replaced progressively over the next approximately 5 year period:
 - Cracking, fouling and scale build-up, sagging due to loss of elasticity, softening due to long term exposure to warm chemically treated water
- Spending is phased across financial years, so far two modules are completed with Brentwood CF1200MA:
 - Tower A: Aug 2019
 - Tower E: Mar 2021
 - Tower B, C & D: future
- Modification approved (Component Replacement Evaluation):
 - Change to material (PVC from PP) with lower inherent flammability, stronger, improved performance wettability

Fouling
