# Maintenance Projects at the Oregon State TRIGA Reactor

Robert Schickler  
Steven Reese

2023 TRTR/IGORR Conference  
College Park, MD  
June 18-23, 2023

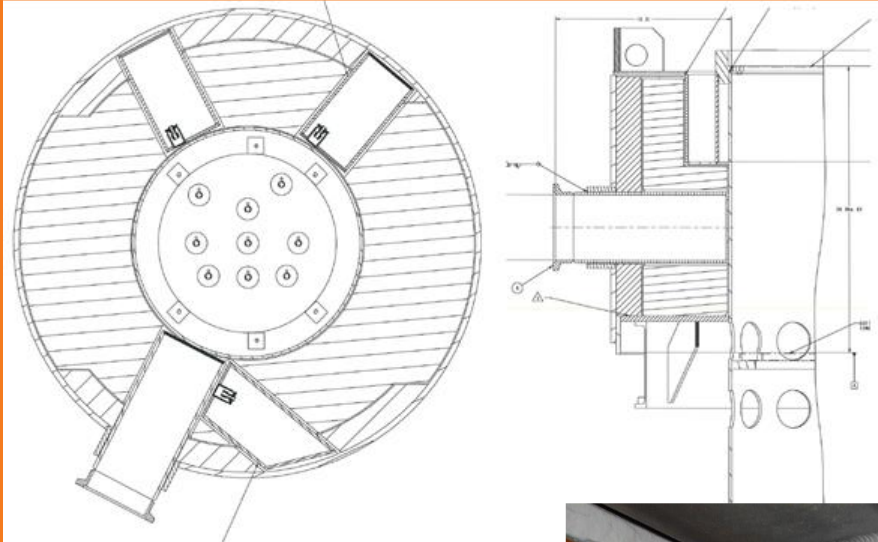
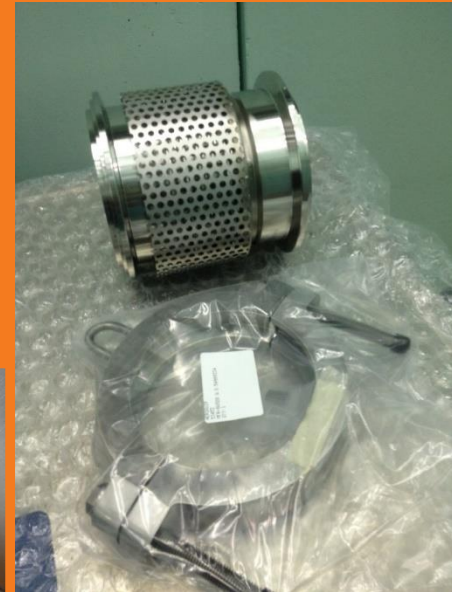
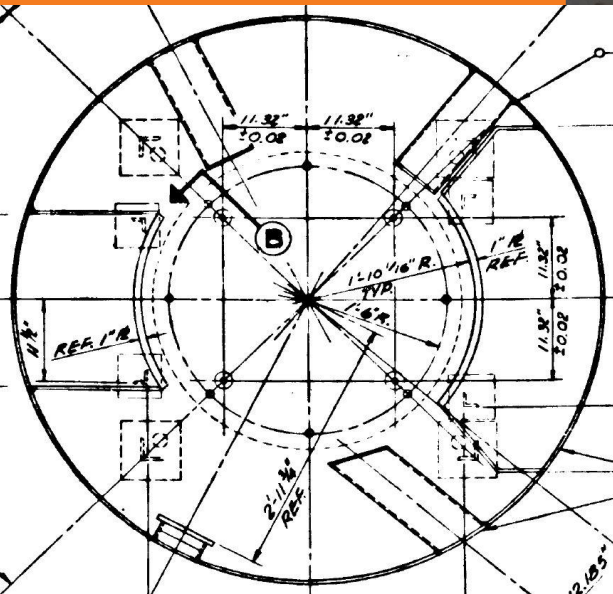
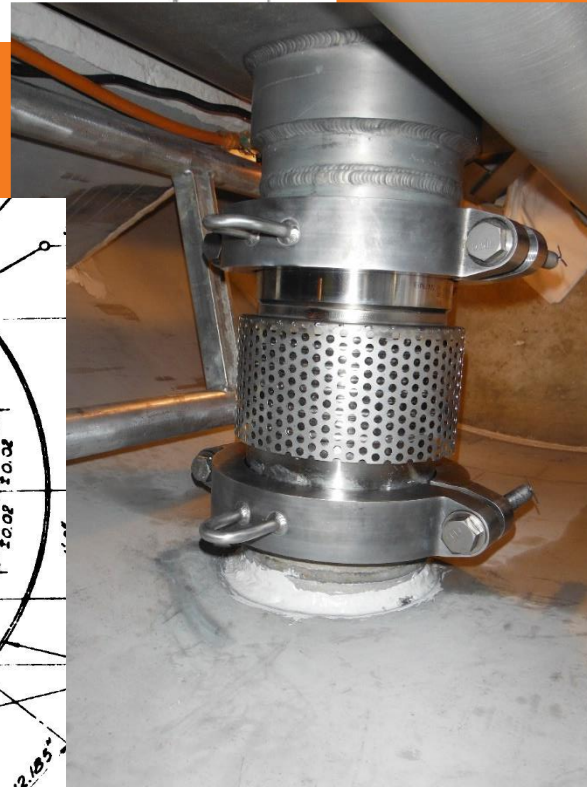
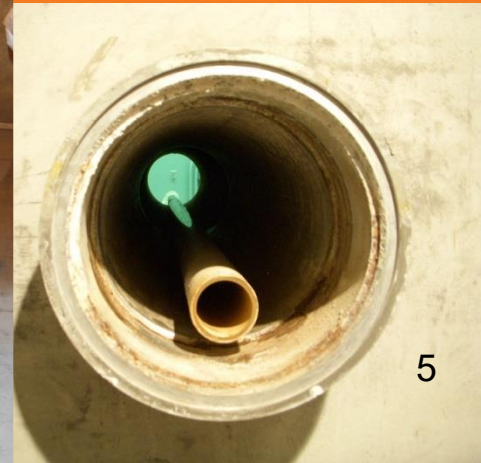
# Beam Port #4 Bellows Connection

Beam port has a gap between tank and pipe embedded in the bioshield.

Bellows couples to tank via 3" pipe stub welded to inside of tank.

Leak must be sealed within this pipe stub or the leak will continue to propagate in gap.

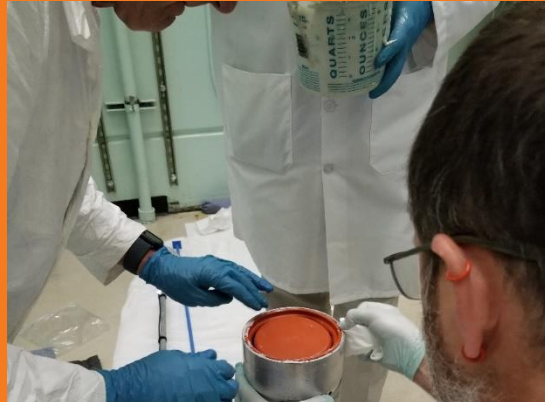
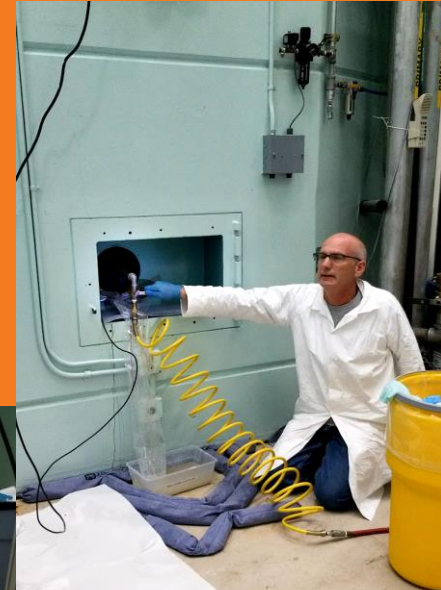
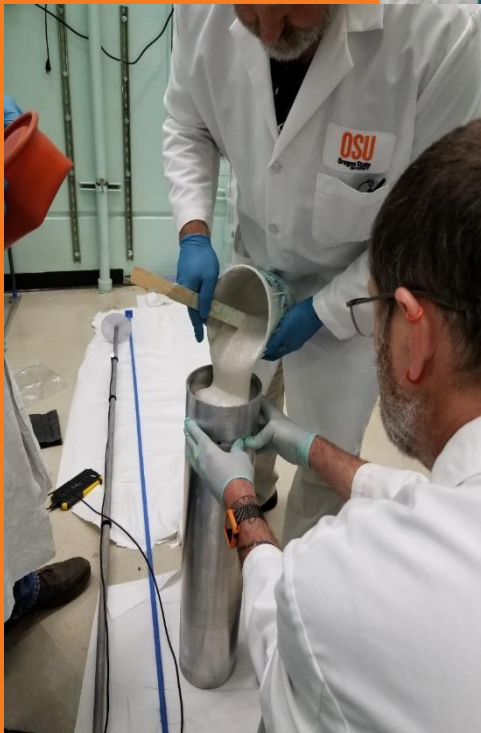
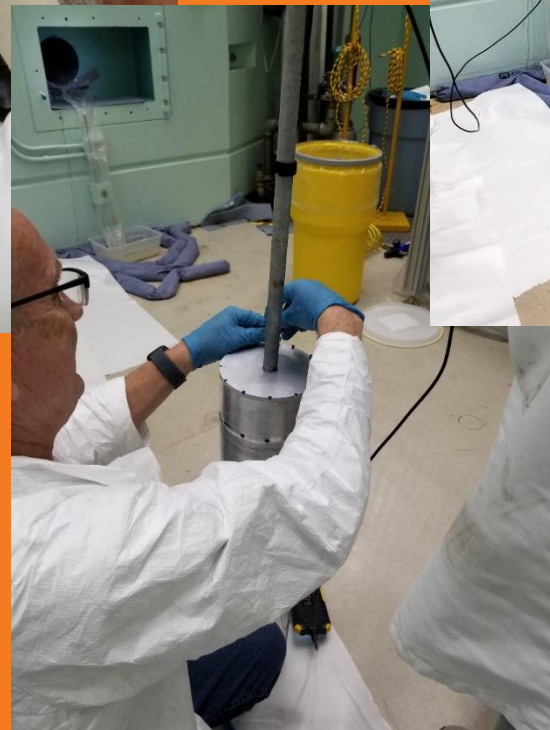
# Beam Port #4

- Plug fill, insertion and injection. How did it do?

- So close! Leak continues through small gap. Epoxy not viscous enough.

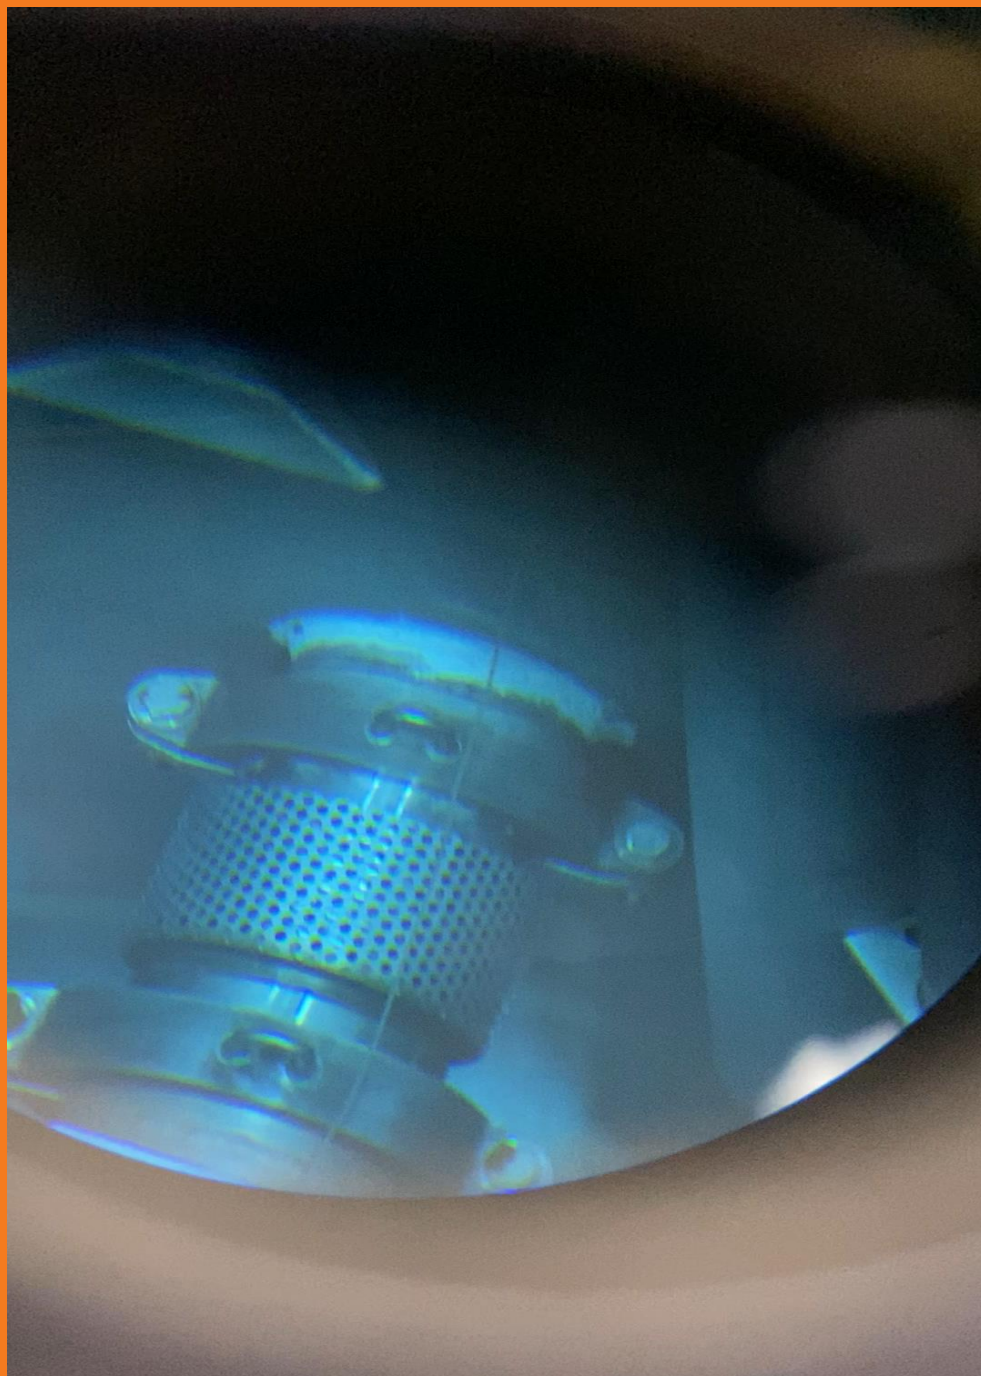
- We have to inject more epoxy in order to properly seal off leak (epoxy needs to inject into weephole)
- Designed new injection method involving a “paste pot” and retrofitting a plug we initially used as a seal plug for beam port #4 during the 2013 reflector replacement.
- Before injection, a pressure test was performed with the seal plug to determine if pressure could build up against reactor head pressure.
- At this point, we were able to determine the actual leak location!

Radial seal plug installed in front of first attempt and more epoxy was pneumatically injected to seal leak.

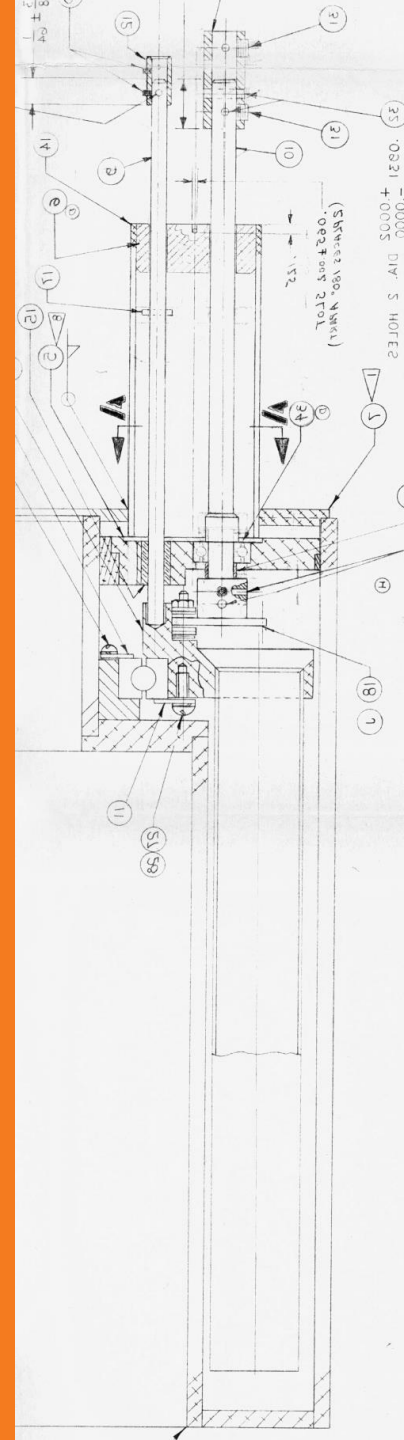
In the summer of 2022, the lazy susan rotating rack began experiencing various issues: sample tubes sticking to the bottom of the rack, and motor stoppages during operation. Both issues were attributed to the oiling regimen. For years, the staff used small amounts of WD-40 to oil the rack.

Over the years, the WD-40 began to ooze into the rack's tubes which caused TRIGA tubes to stick to the bottom. This caused multiple problems, such as a broken grapple tool, as well as broken TRIGA tubes upon withdrawal.

Staff performed an inspection with an endoscopic camera, found decent amount of debris. Built scrubbing tools using PEX and dryer vent brush. Built a makeshift vacuum with a HEPA filter and a Home Depot bucket (which failed) then a short metal bucket.
