# MIT Research Reactor

Big Impact of a Small Leak  
at the MIT Reactor

19 June 2023

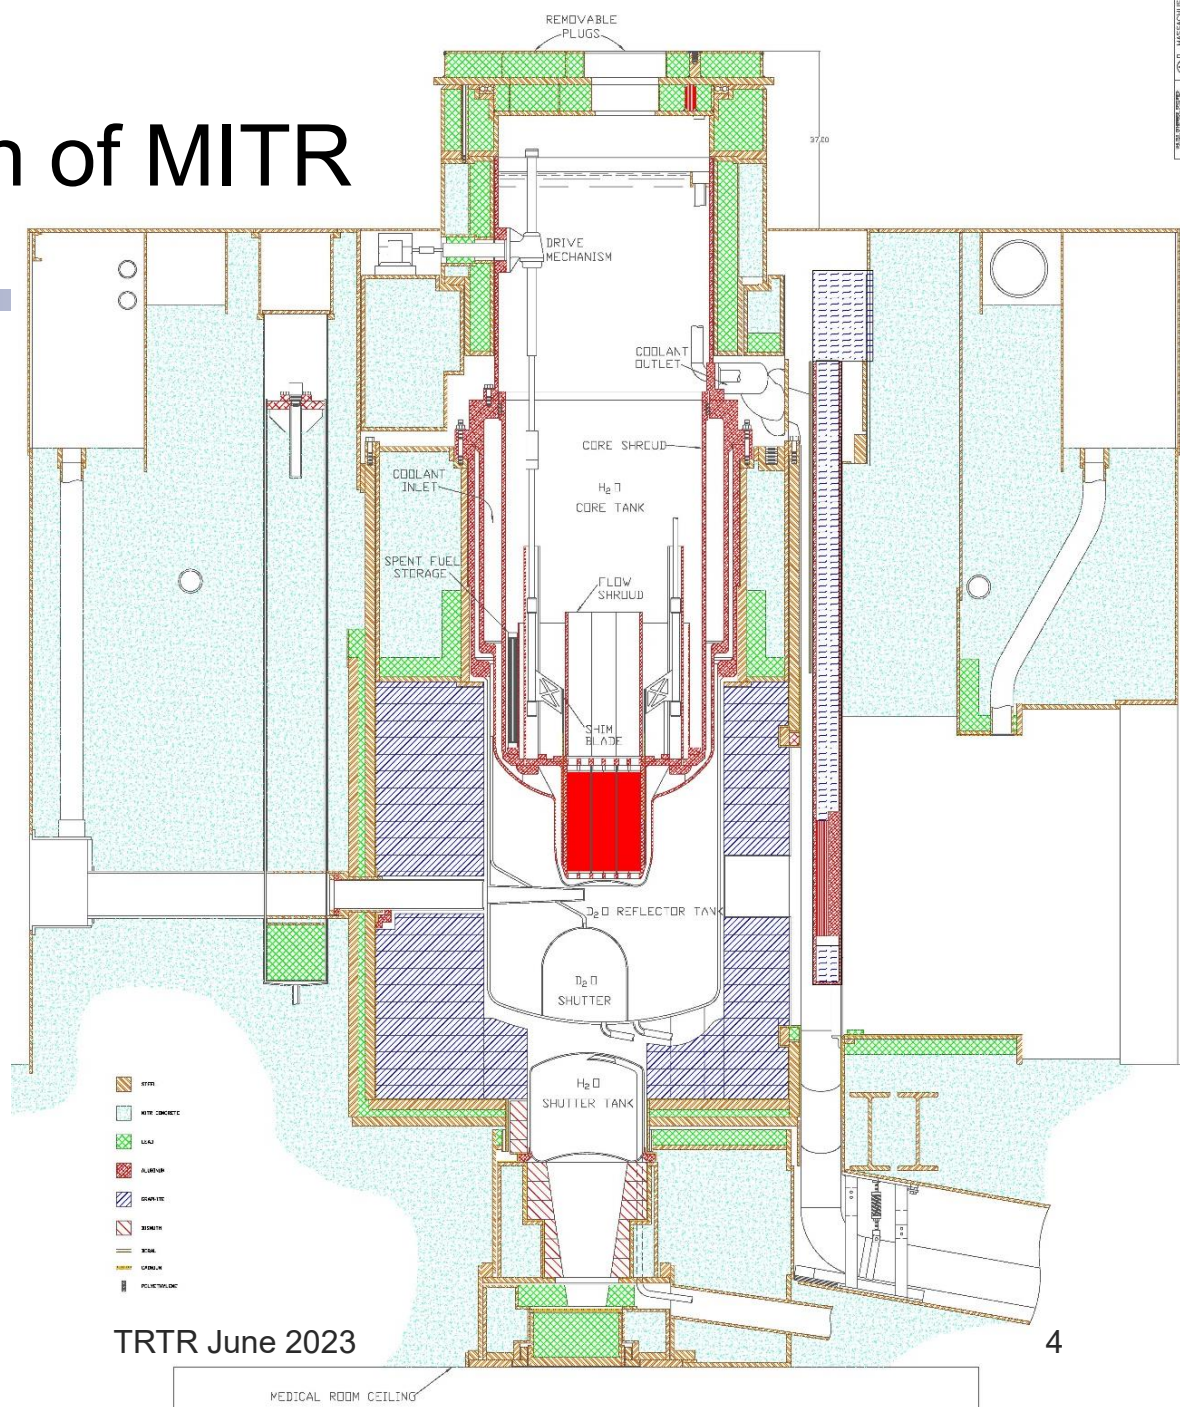
# Cross-Section of MITR

- Lowering the core tank water level below the primary coolant outlet pipe stopped the leak.
- Raising the core tank water level above the primary coolant outlet pipe restarted the leak.

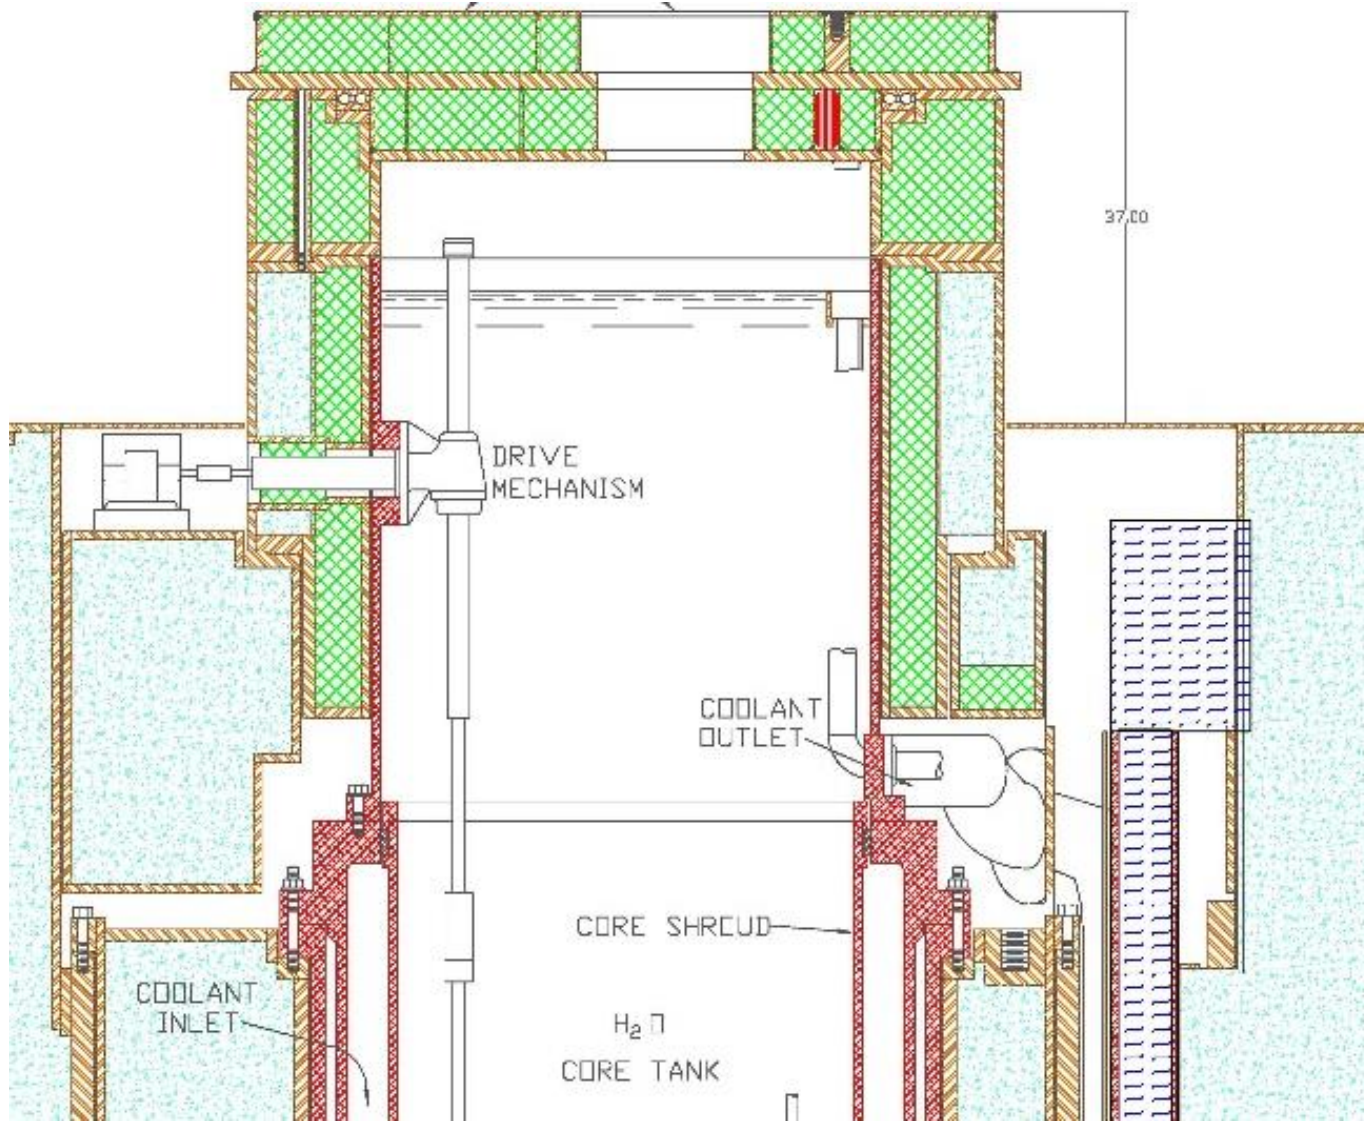
# [ Cross-Section of MITR (Upper Tank) ]

There were nine possible sources of primary water leakage at the level of the coolant outlet:

- Coolant outlet pipe/manifold
- Coolant inlet pipe/manifold
- Inlet differential pressure gages MP-6 and/or MP-6A
- Core tank overflow line/flange
- Core tank flange for core purge system piping
- Core tank level probes ML-3A and/or ML-3B
- Upper core tank gasket

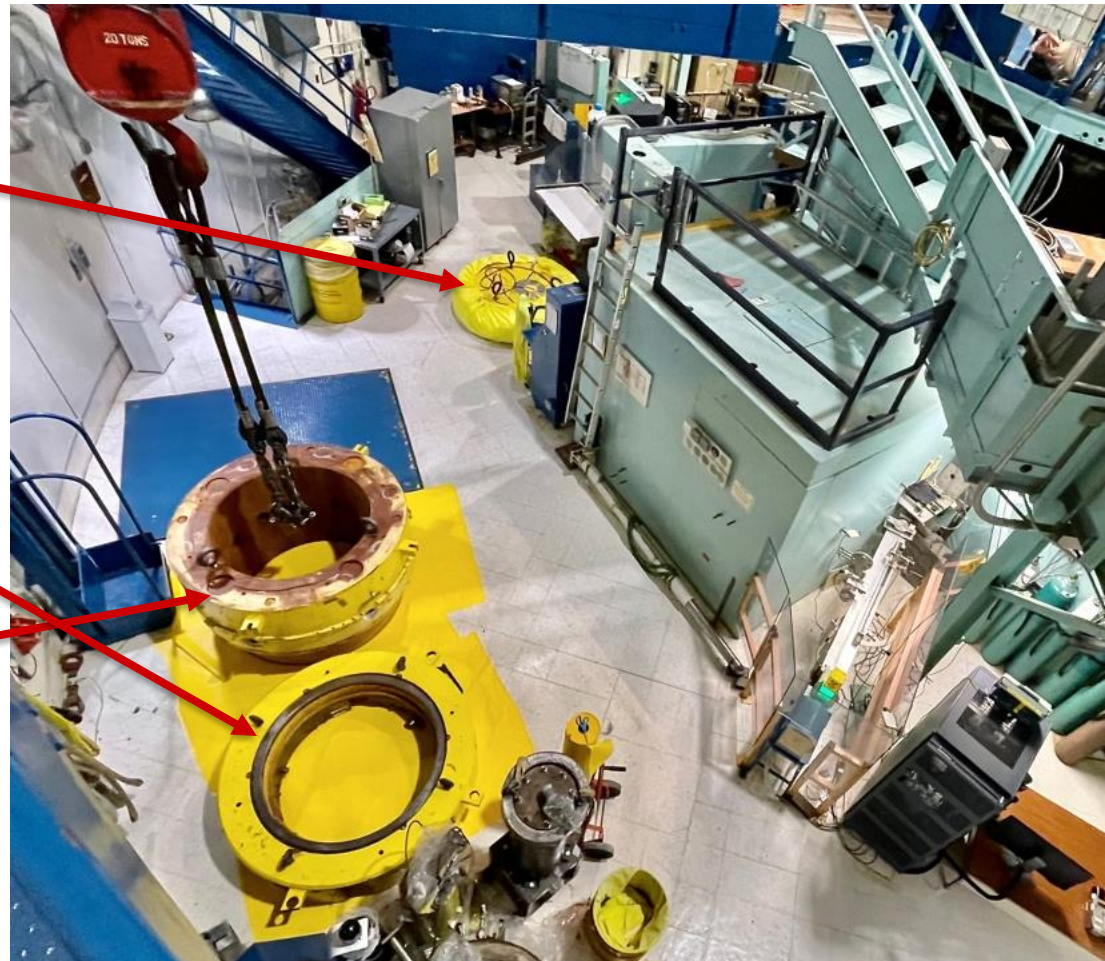
# Shielding Removal After Defueling

- 1) Top shield lid (+ protective bag)
- 2) Upper shield access ring
- 3) Upper shield ring
- 4) Upper annular ring is not yet removed in this photo

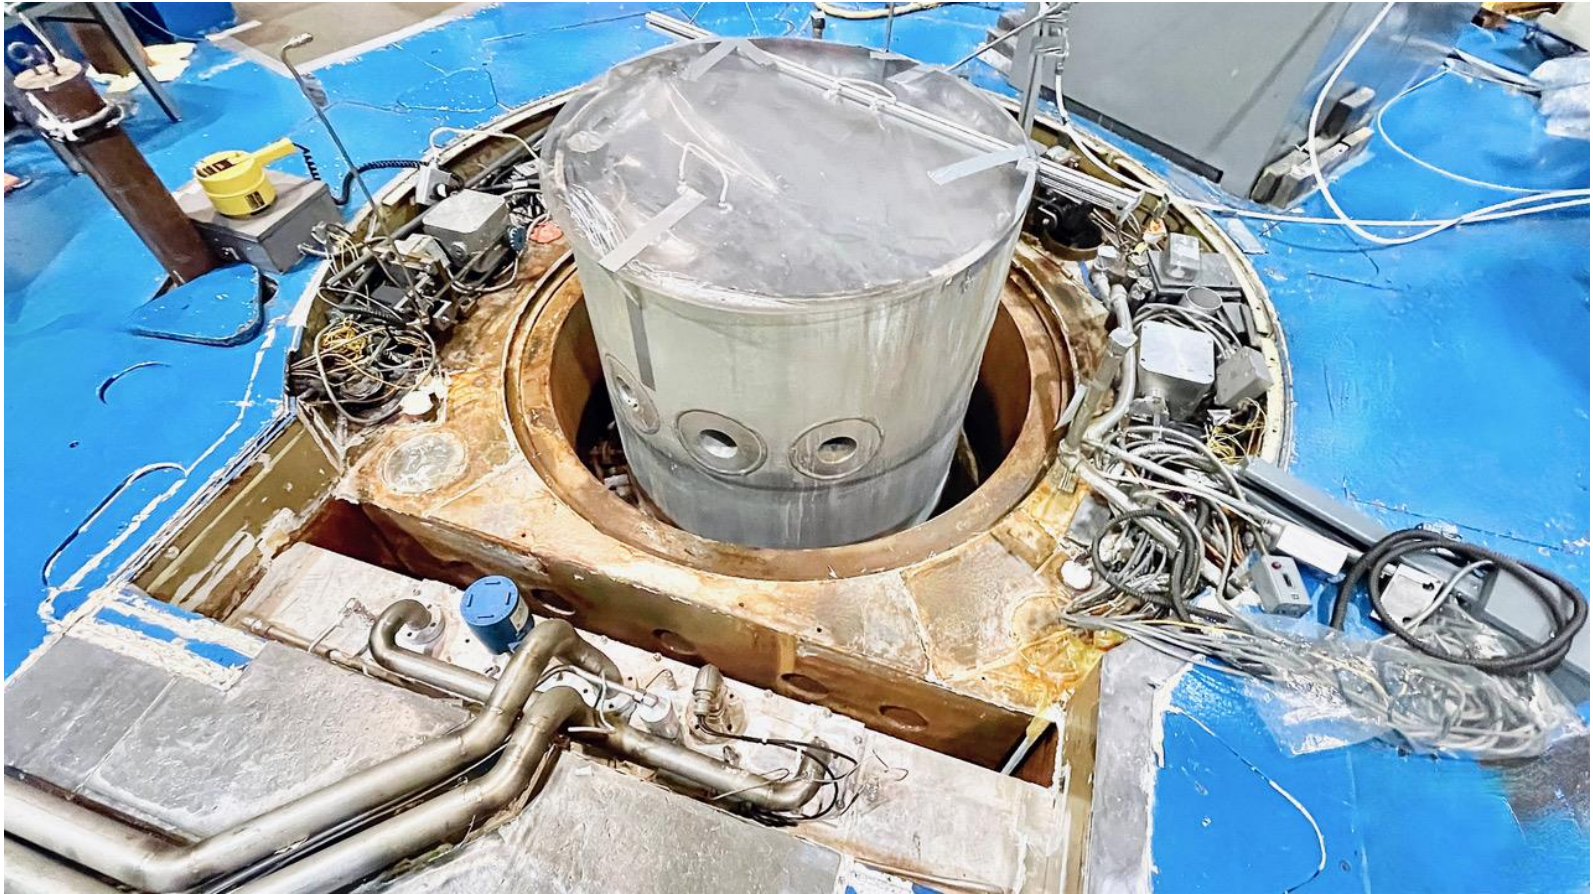
[ All the Control Blade Drives and Wiring had to be Removed... ]

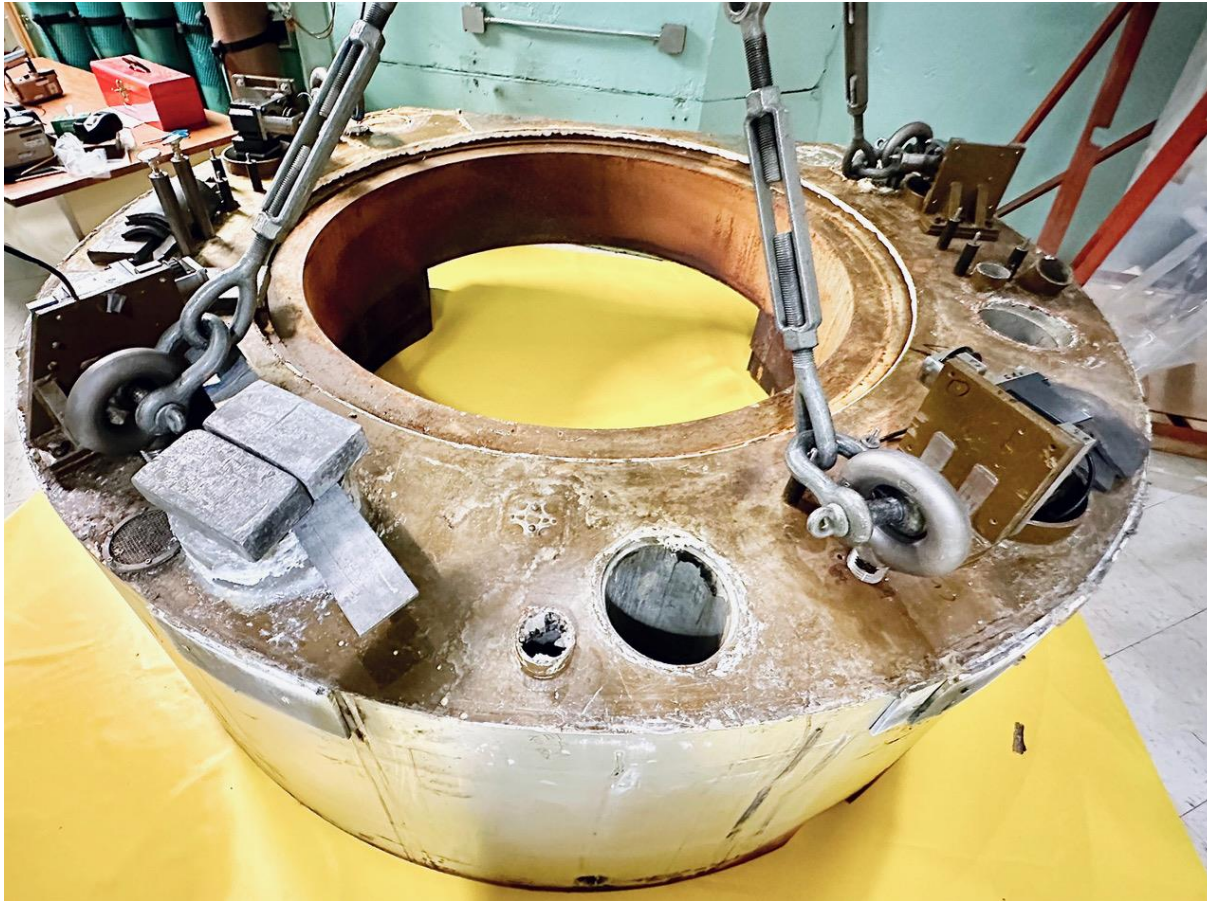
[ ...and then the Upper Annular Ring  
was Lifted Out using the Polar Crane ]

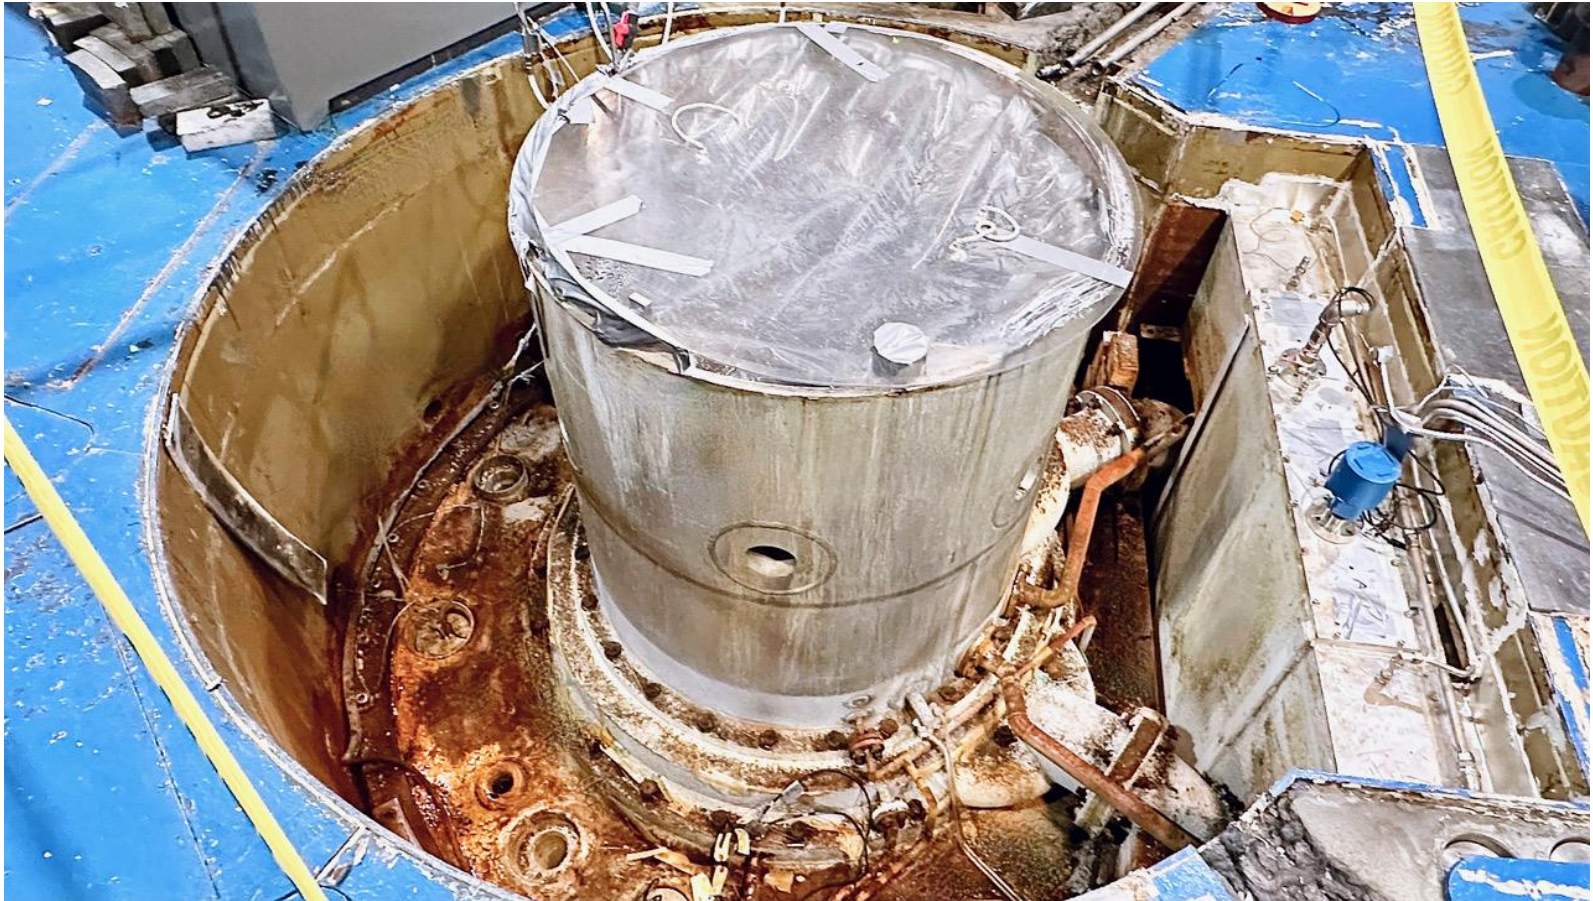
# Without the Upper Annular Ring...

- Corrosion to a 1/2" threaded aluminum pipe section for the MP-6A flow sensor
- Humid conditions prolonged in the area
- Iron rust covered the aluminum pipe!
- The rust acted as an oxygen reduction site, polarizing the aluminum above its corrosion potential, resulting in general localized corrosion.

- The leaking aluminum threaded pipe was replaced with a 316 stainless-steel threaded pipe.
- Other threaded piping in the area was similarly replaced as a preventive measure
- The piping area was cleared of iron rust.
- The inner and outer surfaces of the shield rings that sit above the piping area were carefully cleaned by grinding and sanding, and then coated with rust inhibitor.
- All gaskets in the area were inspected; some were replaced.
- Leak detectors added in many locations for early detection. Use of humidity sensors is being considered as well.
- Inspection tubes added for future use.
