POST IRRADIATION TESTING CAPABILITIES OF EXPERIMENTAL REACTOR COMPONENTS AT THE LECI FACILITY FOR SERVICE LIFE ASSESSMENT

P. GAVOILLE, K. COLAS, B. KAPUSTA

*CEA Saclay, Université Paris-Saclay, DEN, Service d'Etudes des Matériaux
Irradiés, F-91191, Gif-sur-Yvette, France*

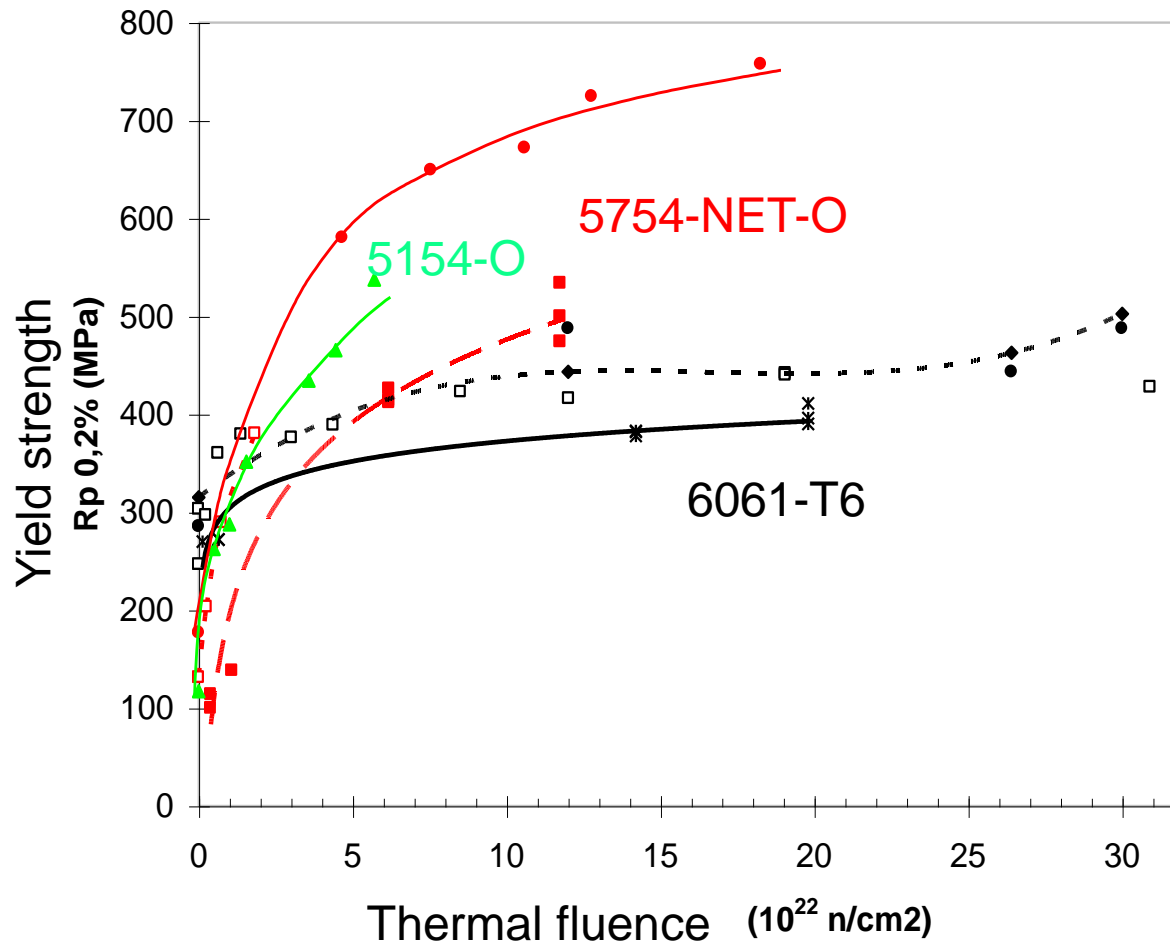
Example of hardening of aluminum alloys under irradiation as measured by tensile tests

- □ - 5754-O ; MELUSINE ; Fth/Fr=0,6
- 5754-NET-O ; OSIRIS ; Fth/Fr=1,1
- 5754-NET-O ; RHF ; Fth/Fr=200 à 250
- ▲ 5154-O ; HFR ; Fth/Fr=0,95
- ◆ 6061-T6 ; HFIR ; Fth/Fr=2,5 ; v=3E-5 s-1
- 6061-T6 ; HFIR ; Fth/Fr=2,5 ; v=3E-3 s-1
- 6061-T6 ; HFIR ; Fth/Fr=1,66
- × 6061-T6 ; BR2 ; Fth/Fr=2,25

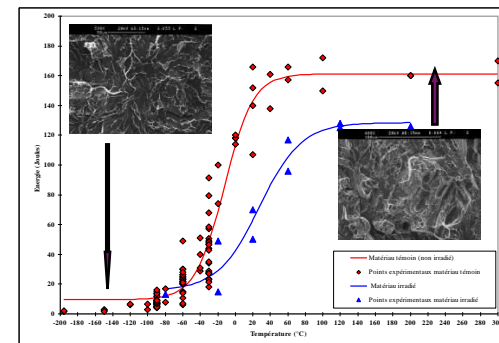
Ductile-Brittle transition (impact tests)

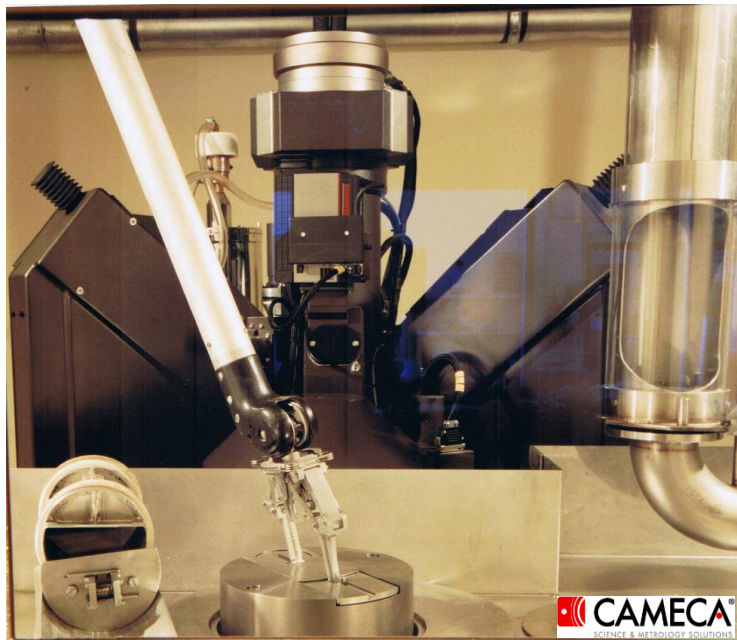
Nuclearized Electron Probe Micro-Analyzer

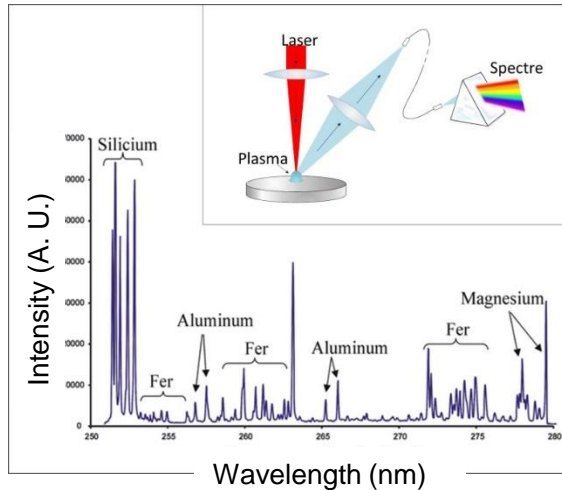
Nuclearized Laser-Induced Breakdown Spectrometer

- **LIBS technique:** measurement of Si content on centimeter size samples

- information on received dose (transmutation Al-Si)

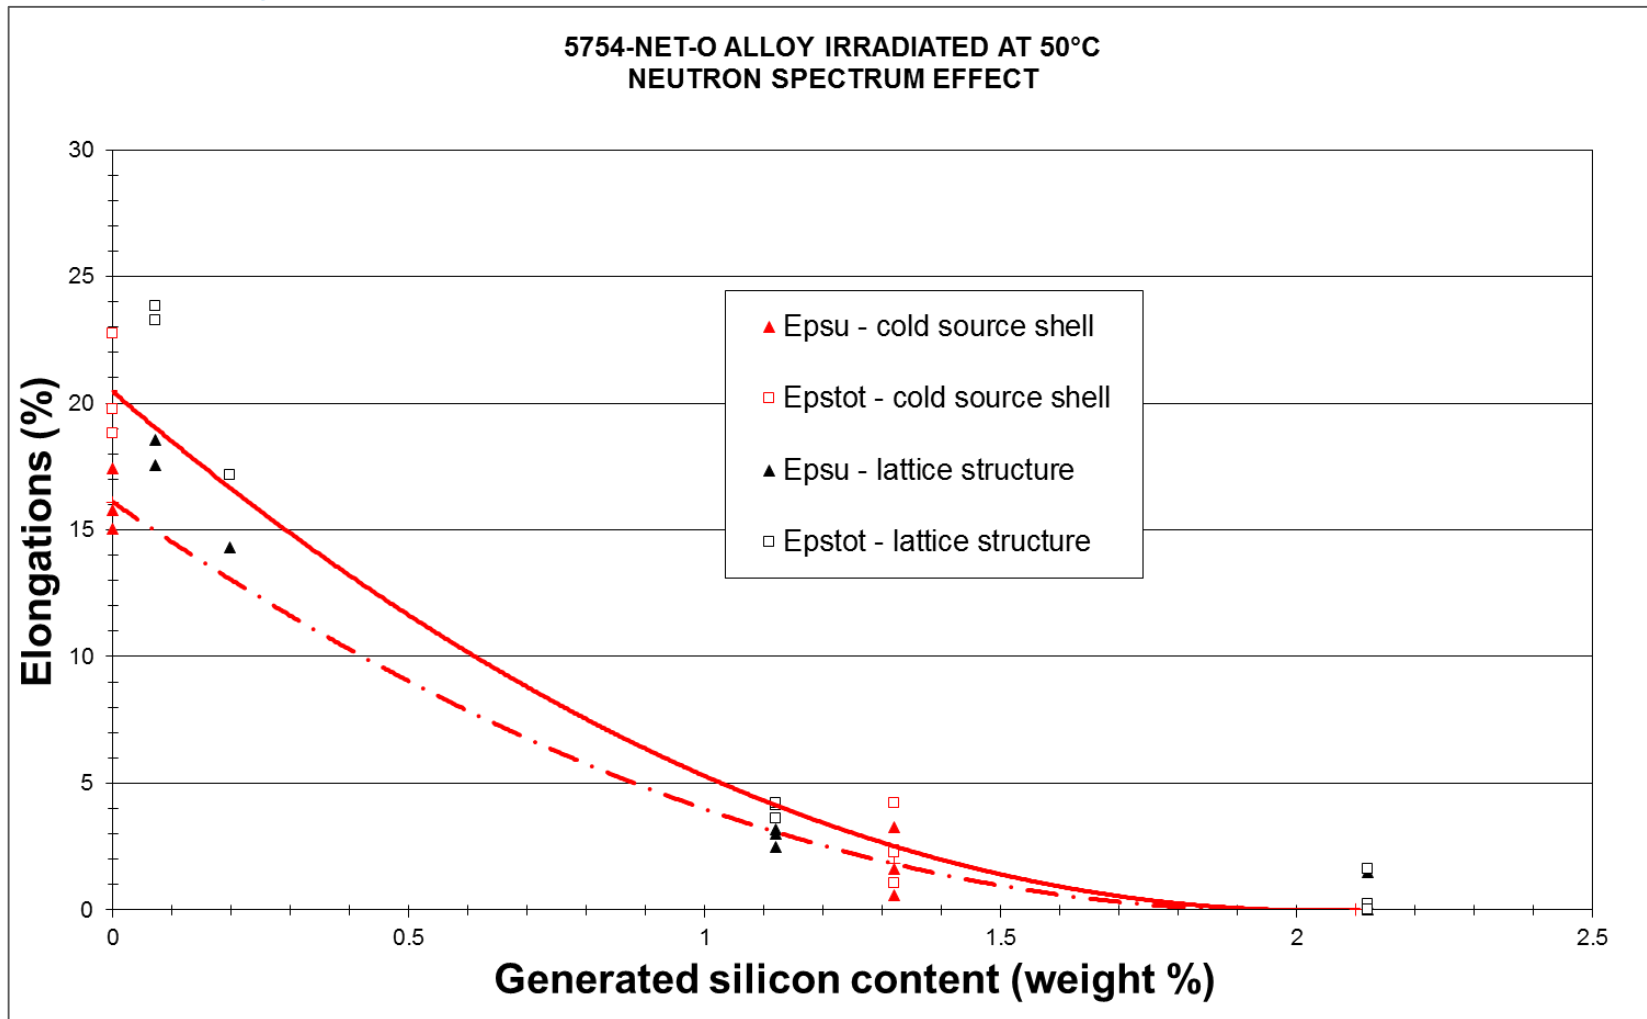
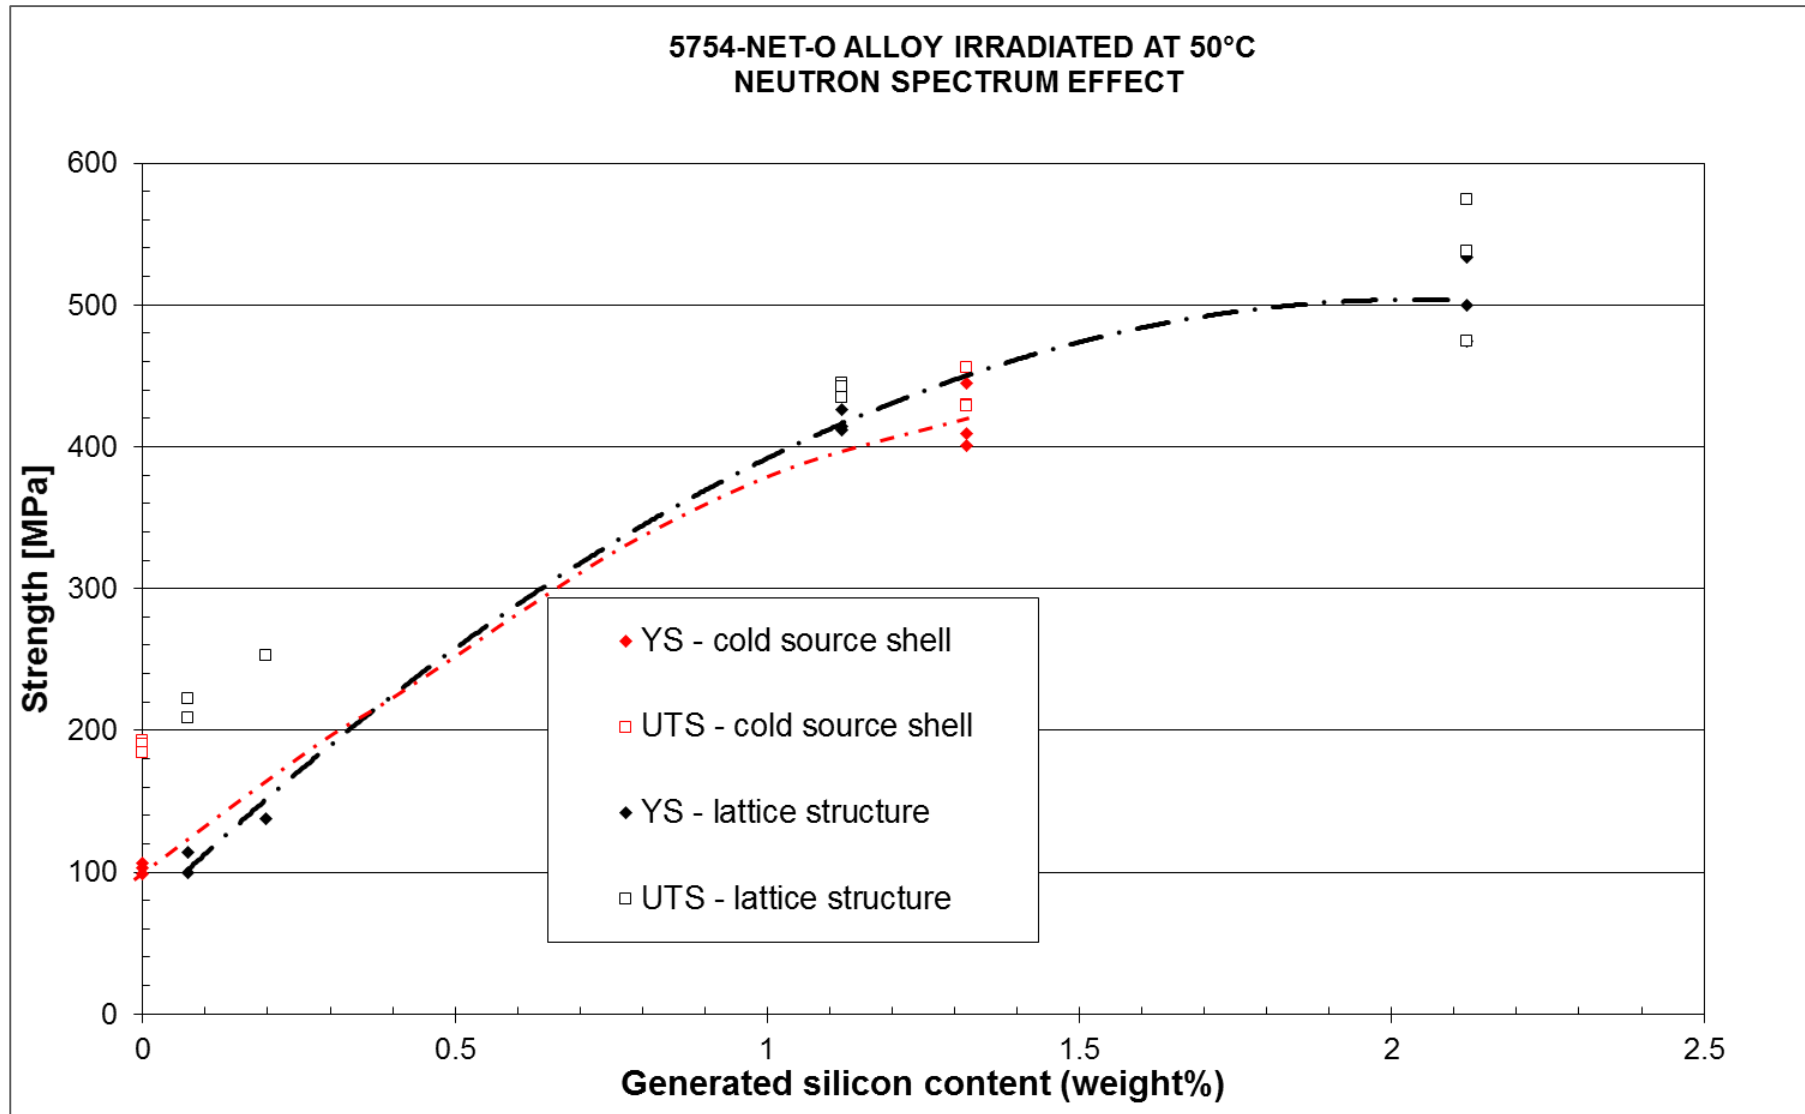
Generated Si content (from Al transmutation) is directly linked to embrittlement and hardening of the components of MTRs
