Present Status of Kyoto University Research Reactor, KUR

K. Nakajima¹

1) Research Reactor Institute, Kyoto University,
Asashiro-Nishi 2-1010, Kumatori-cho, Sennan-gun, Osaka Japan, 590-0494

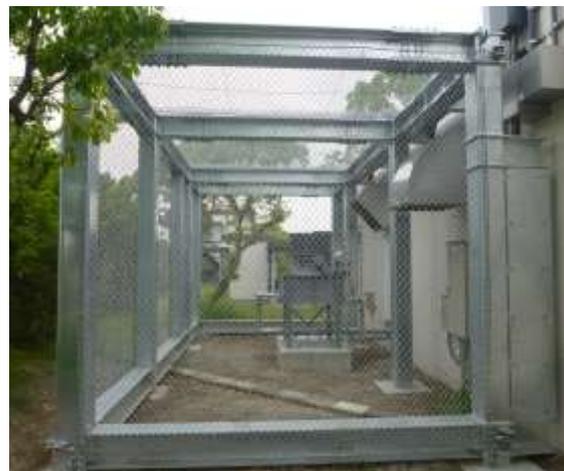
Fig.4 Safety Net for Cooling Tower of Diesel Generator against Tornado

The maximum wind speed of Tornado was determined as 92m/s according to the Guide of Tornado evaluation for NPPs. To protect the facility against the tornado, several facilities were modified to withstand the flying objects (see Fig.4), and some emergency actions will
