Technical Meeting on Research Reactor Ageing Management, Refurbishment and Modernization

EXPERIENCE OF TRR-1/M1 RESEARCH REACTOR FOR POOL REPAIRING

Thailand Institute of Nuclear Technology (Public Organization)
(TINT)

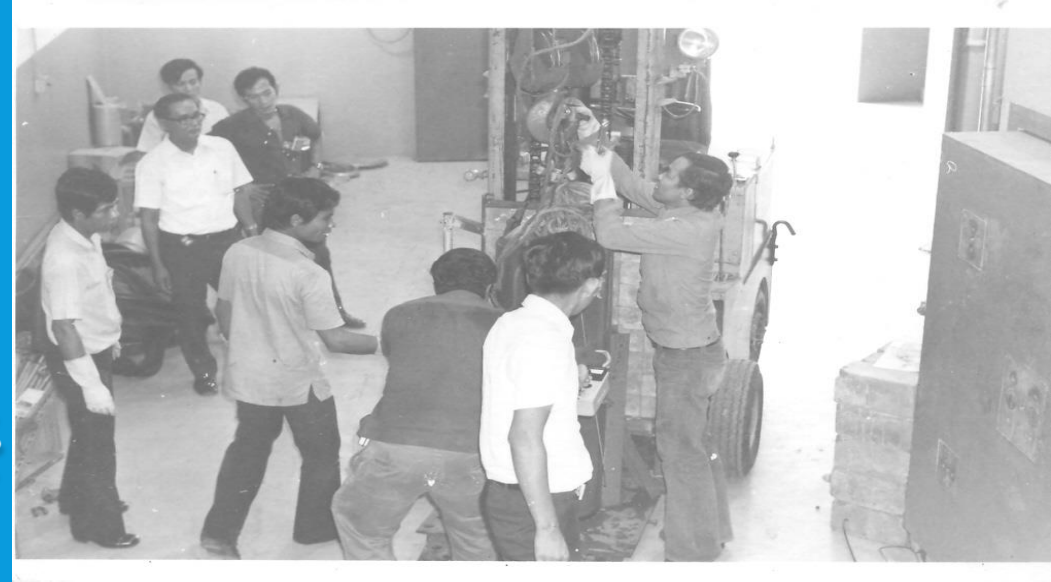
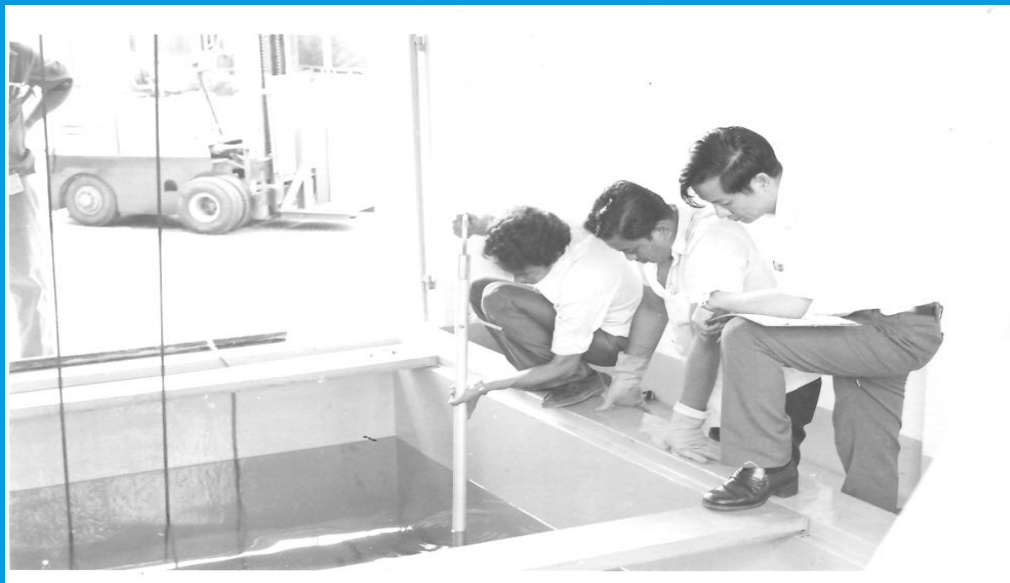
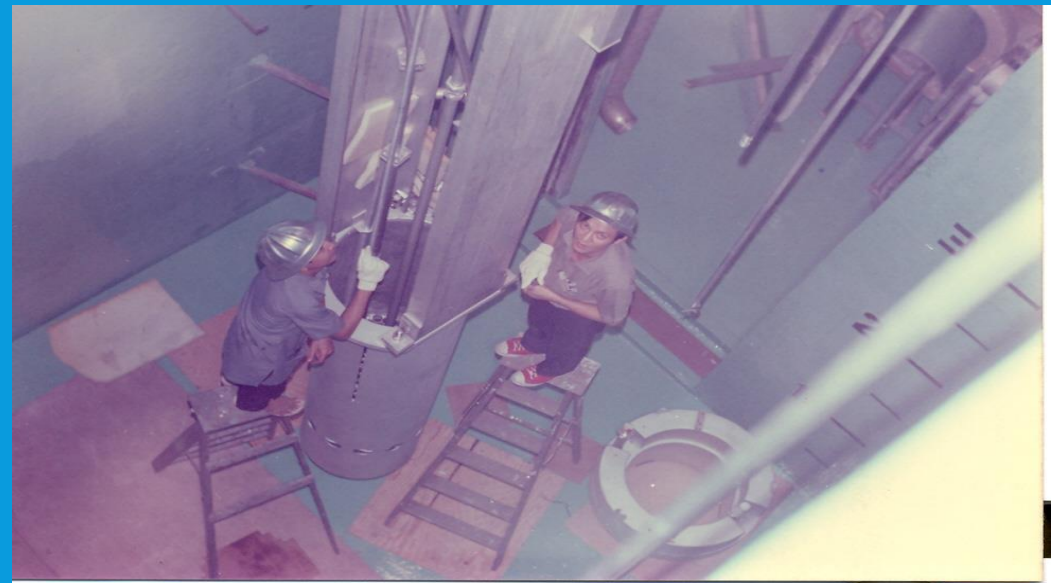
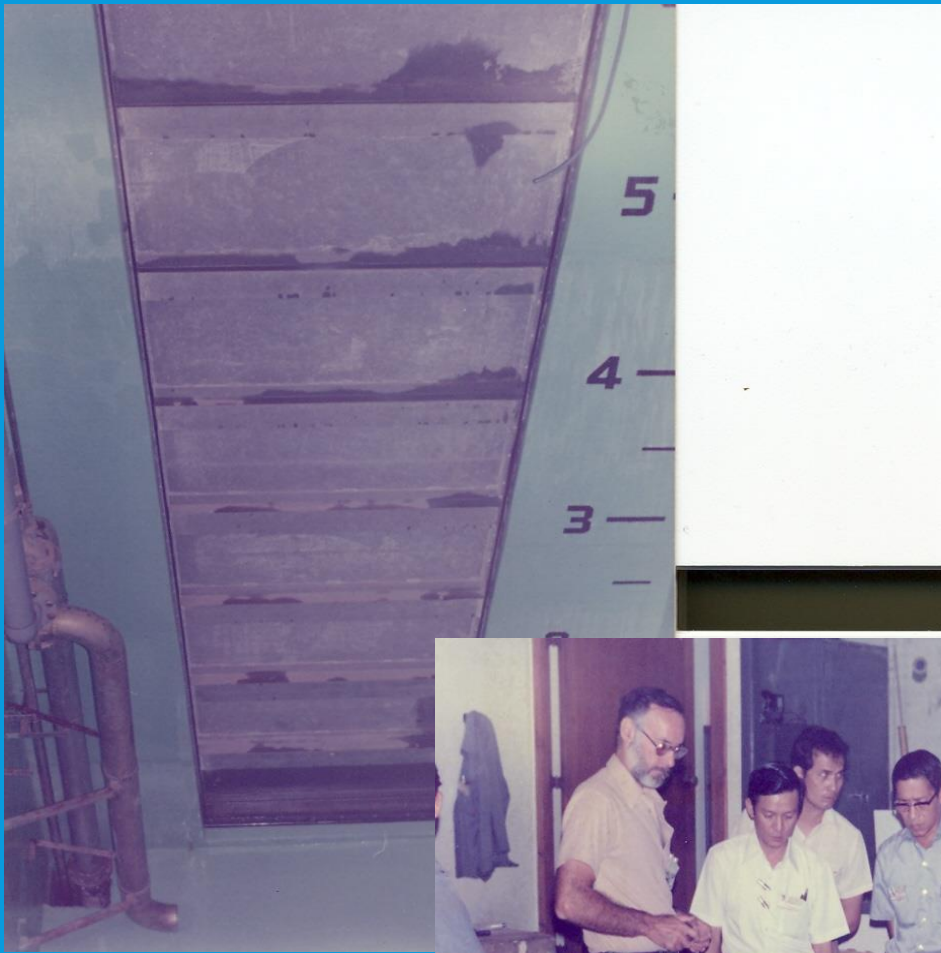
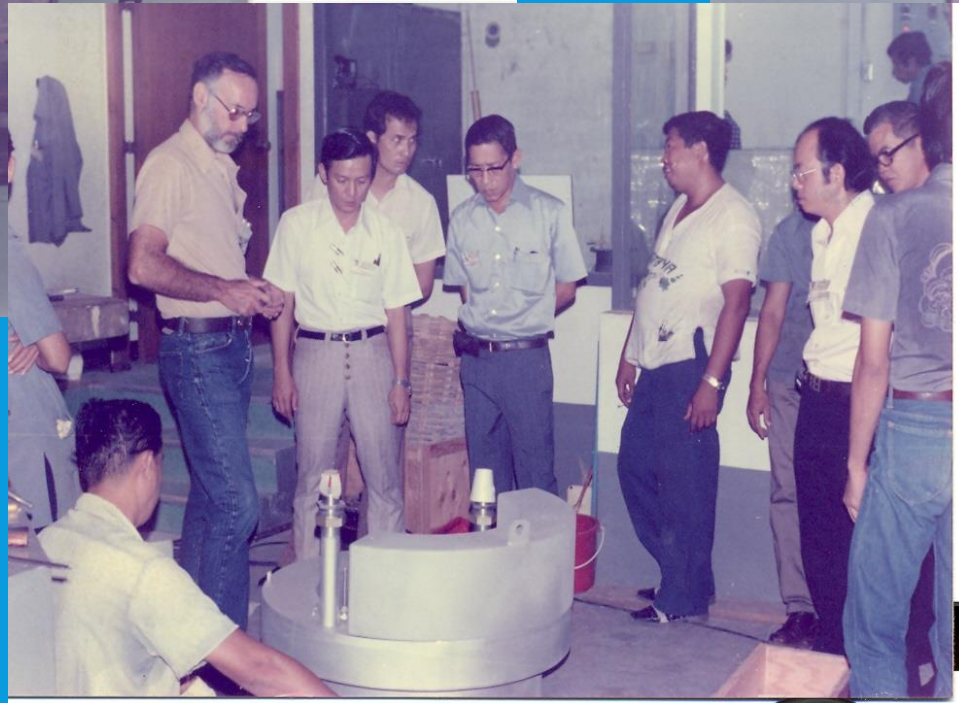
Repairing History

The reactor pool has been repaired and re-paint with the installation of TRR-1/M1 core (TRIGA Mark III) in 1975-1976

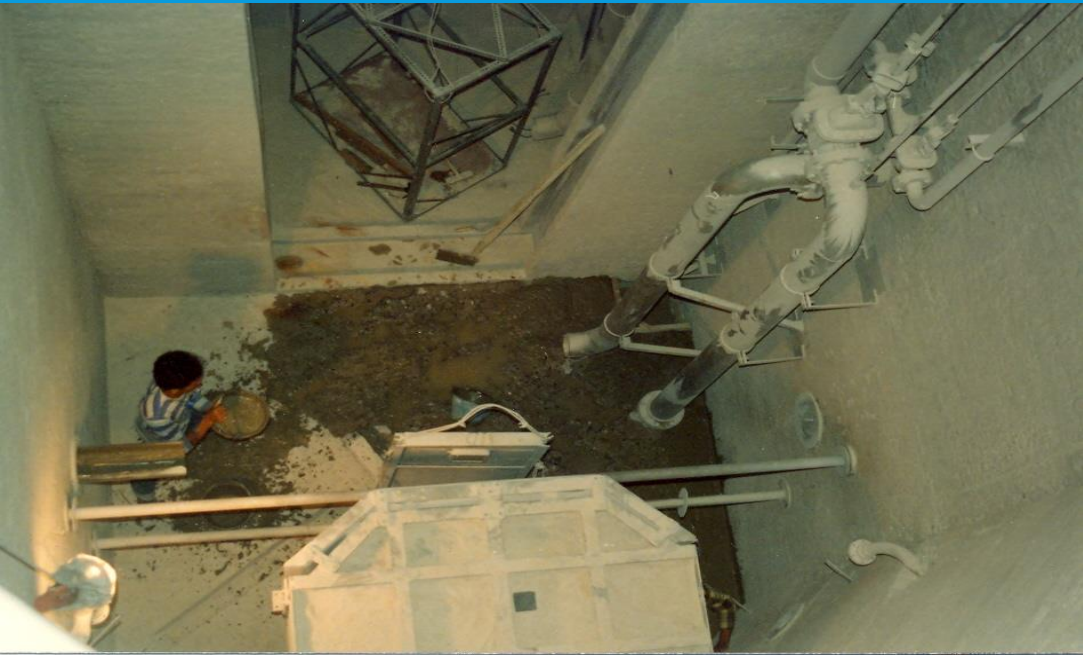
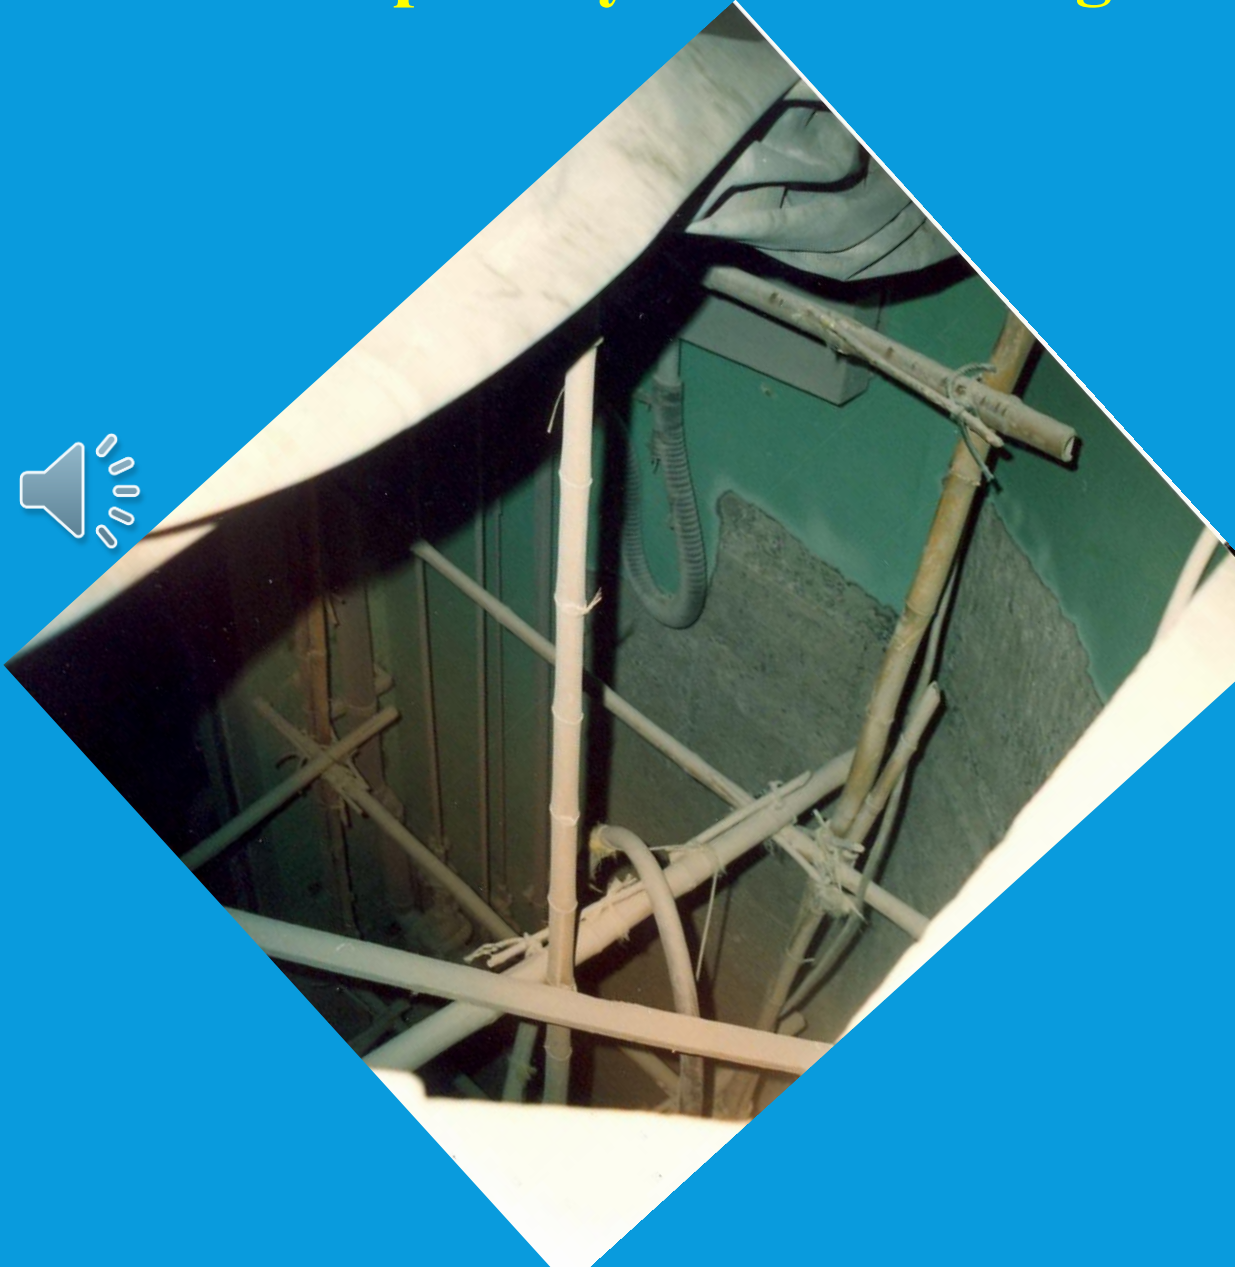
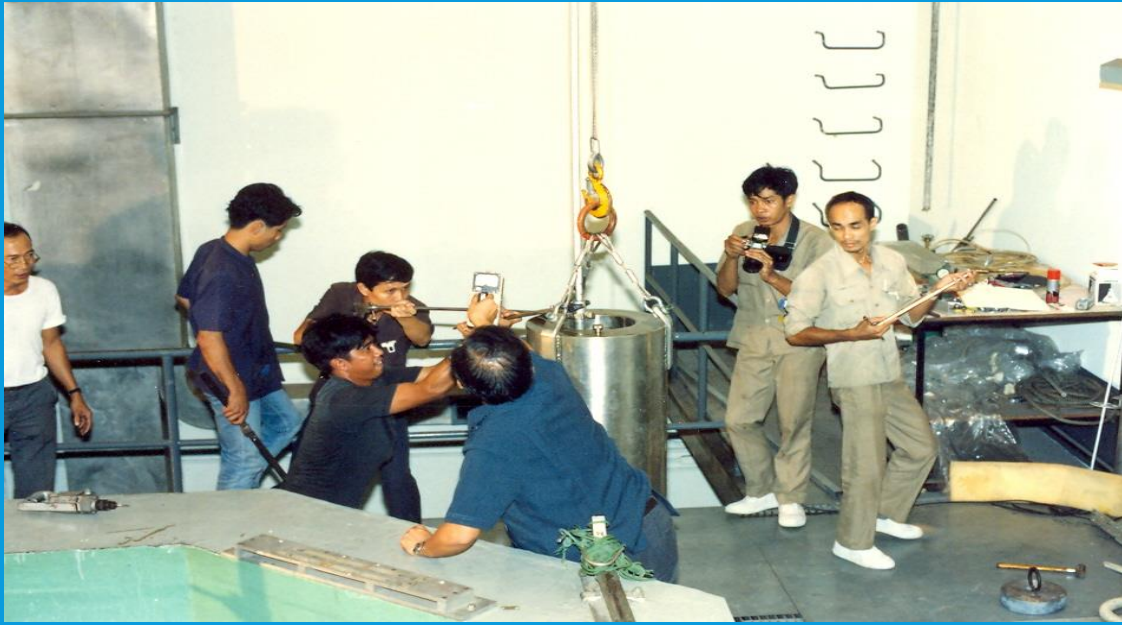
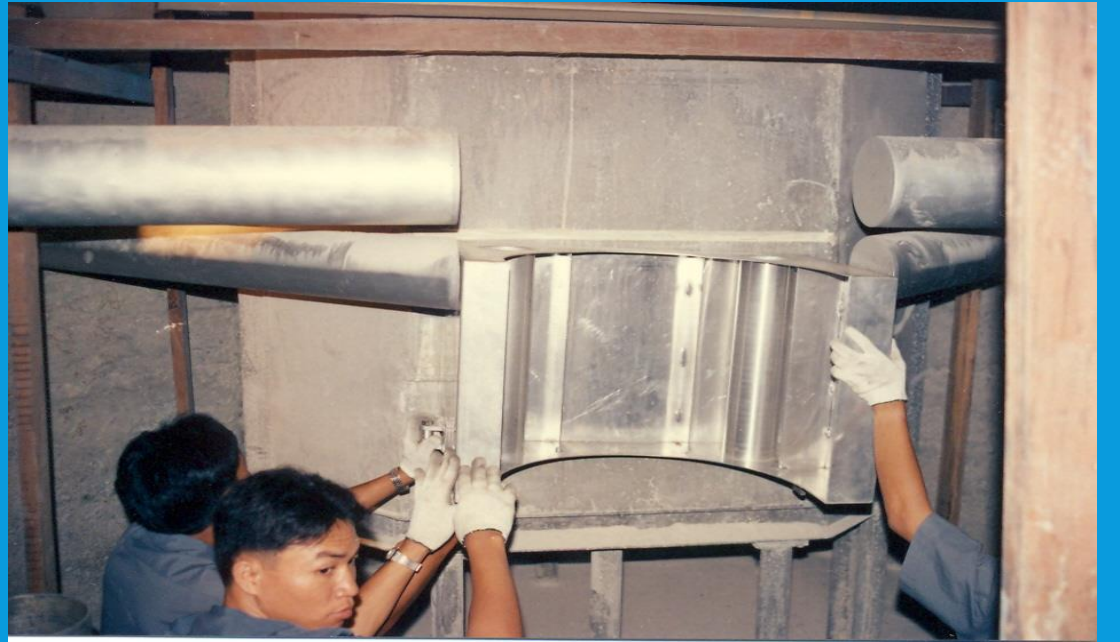
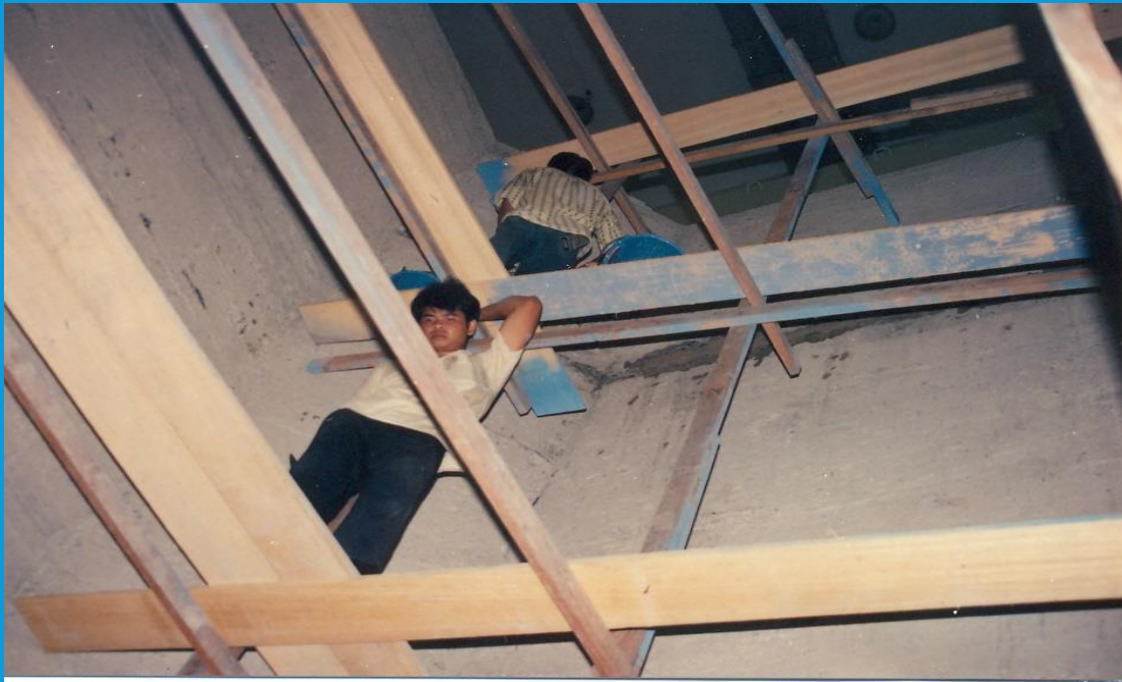
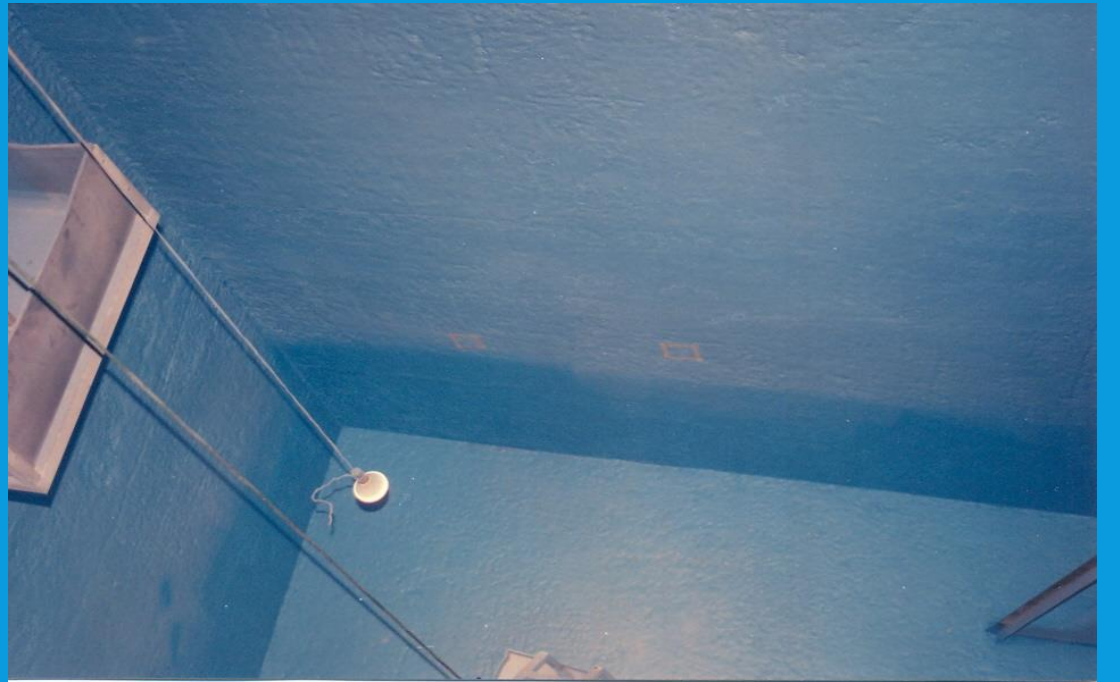
Pool Repairing 1991-1992 “Large-Small pool”

Repairing In 1991-1992, Both Big pool and Small pool by Sand Blasting

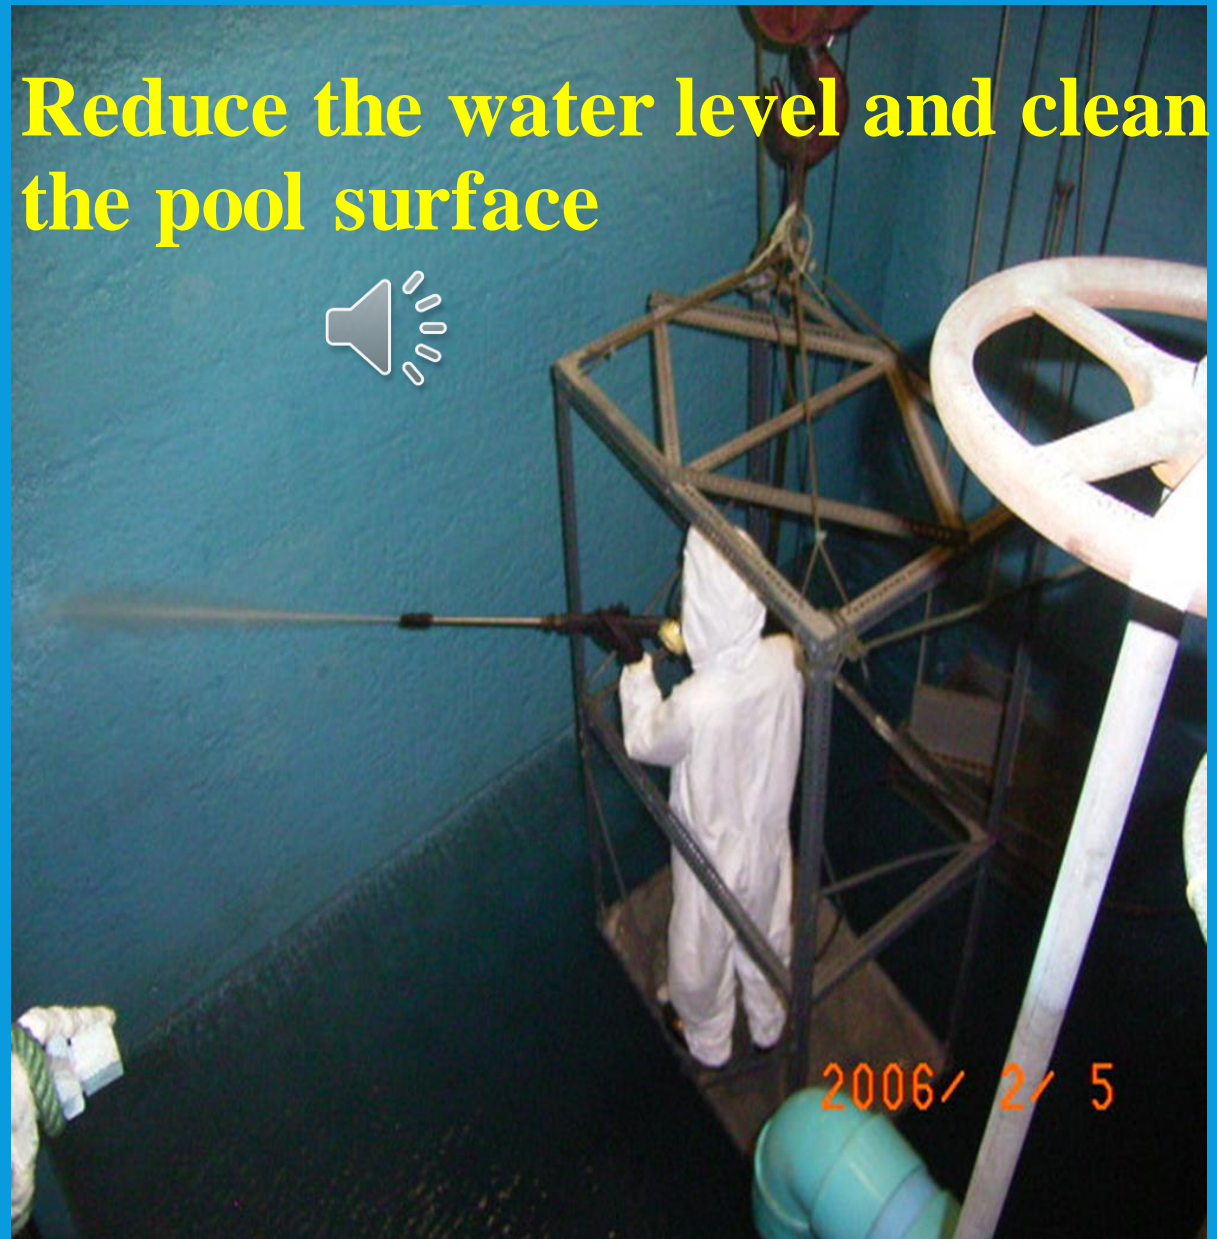
Reduce the water level and clean the pool surface

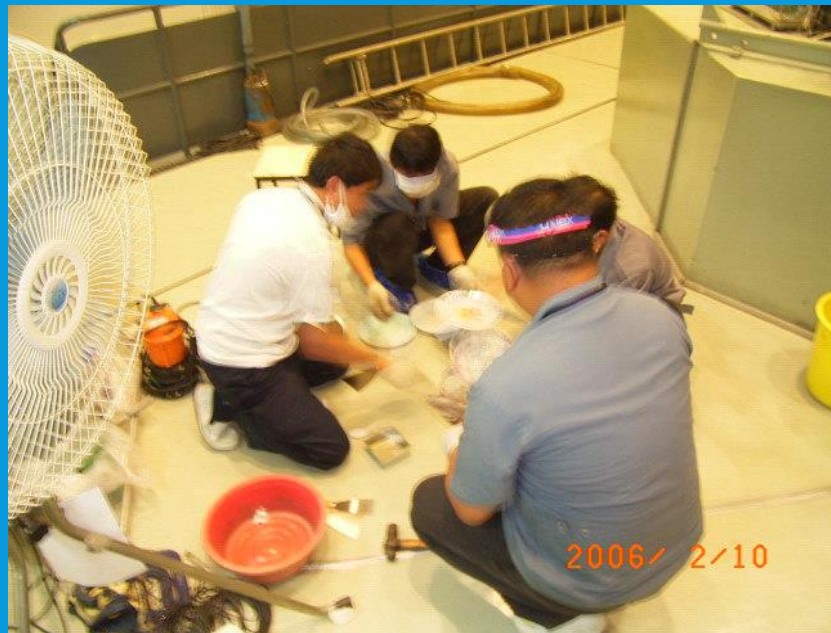
2006/ 2/10

Plugging with epoxy adhesive

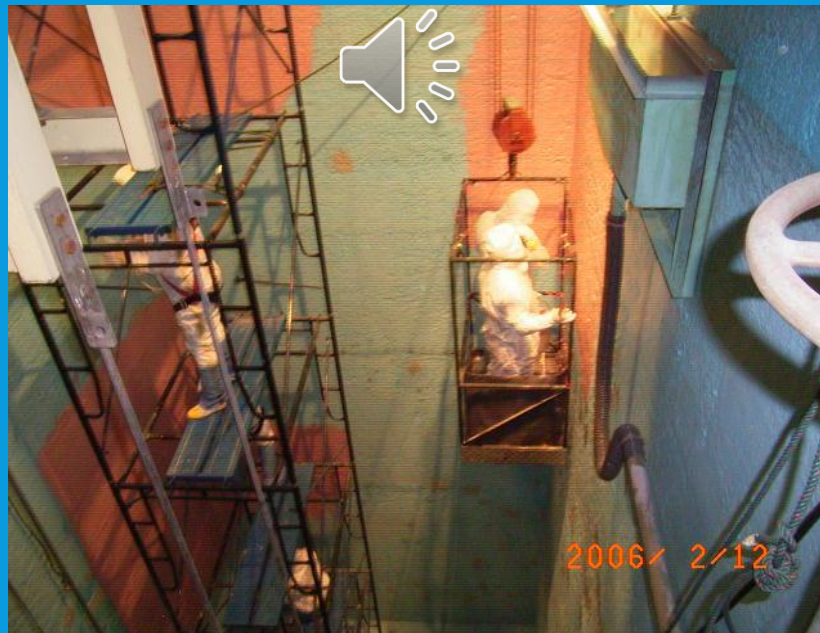
2006/ 2/12

Primer painting

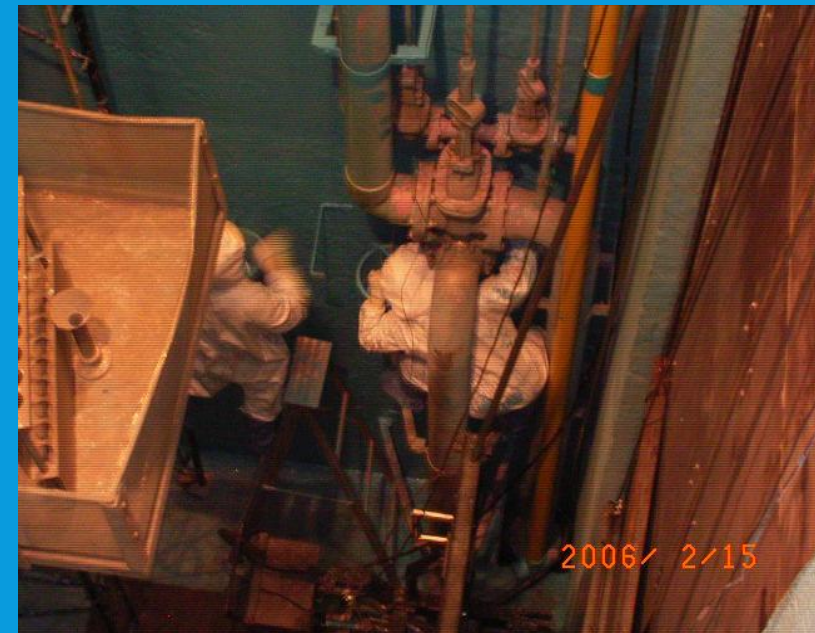
2006/ 2/15

Epoxy painting

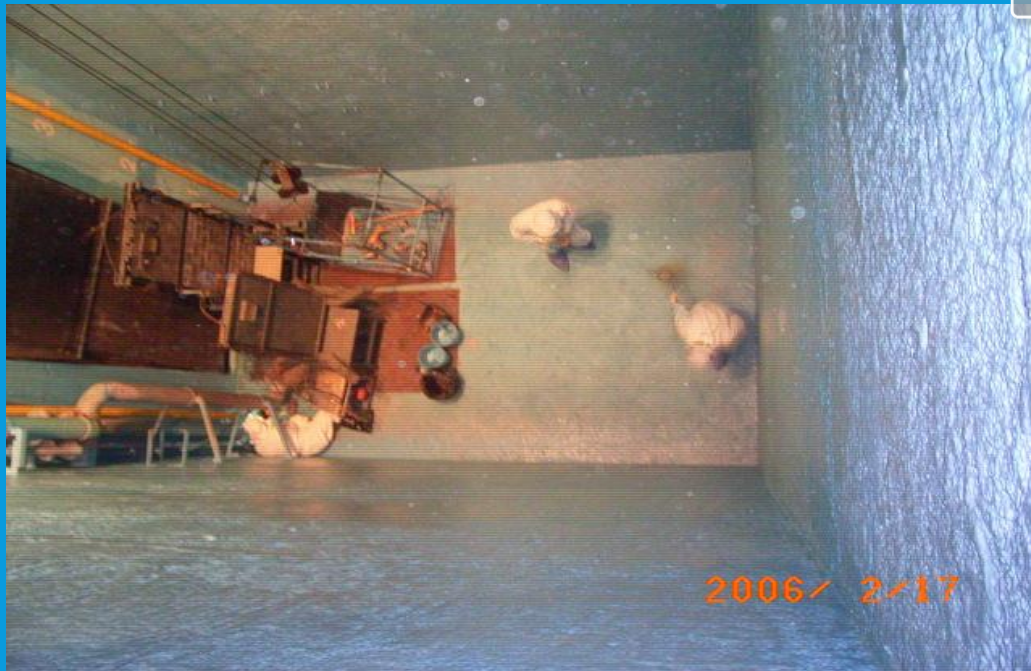
2006 / 2 / 17

Pool outer side repair

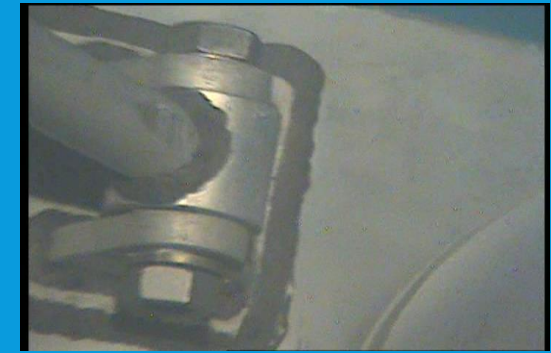
Top-North Location (#2)

all bolt-nut sets are in good physical condition except the bottom-south location which consists of rusty top washer. To minimize personnel contamination, the bottom-south location is the last of bolt-nut removal sequence.

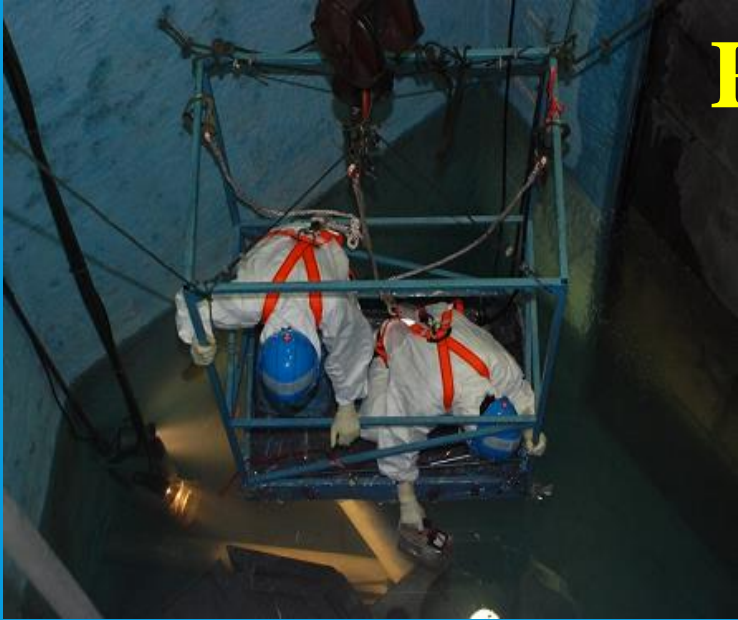
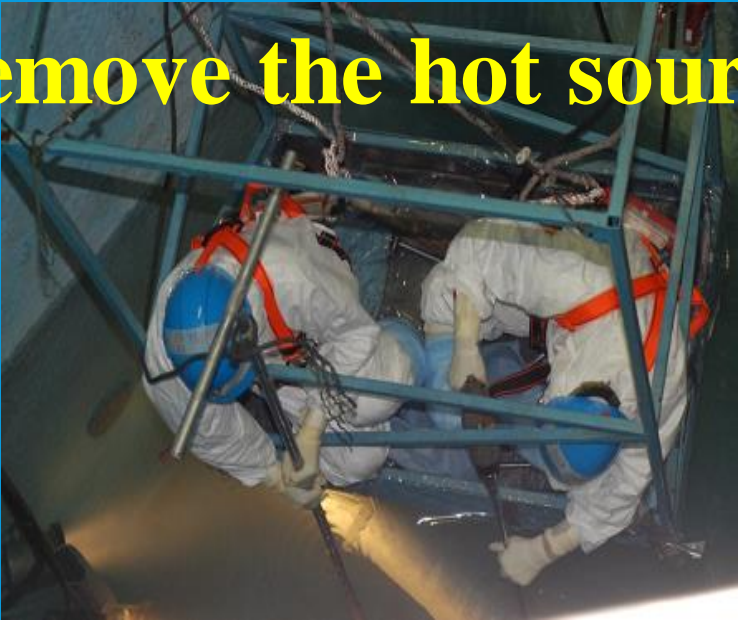
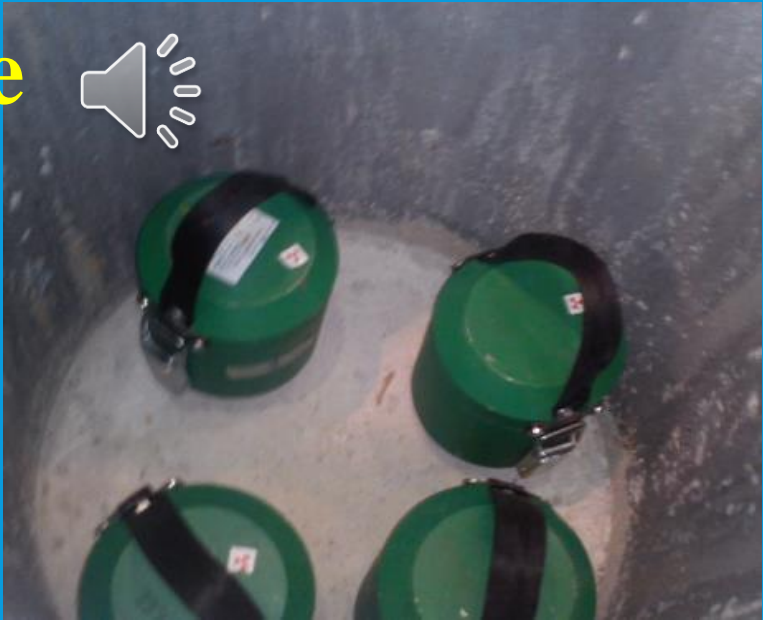
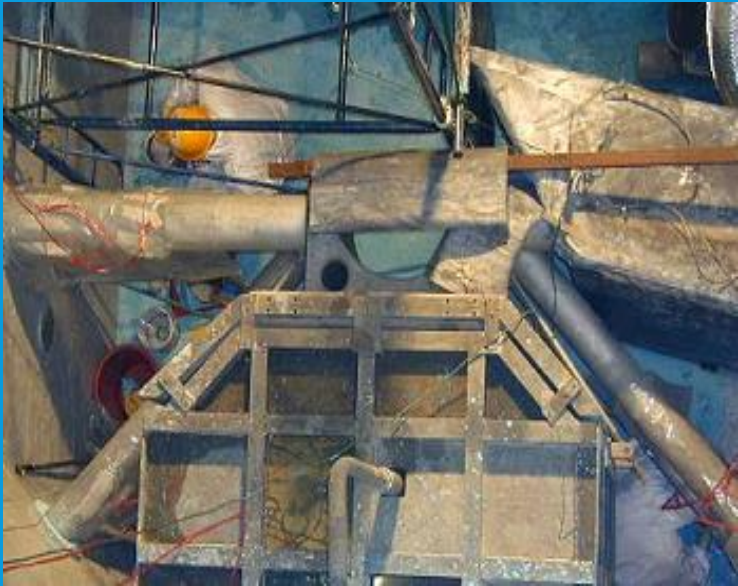
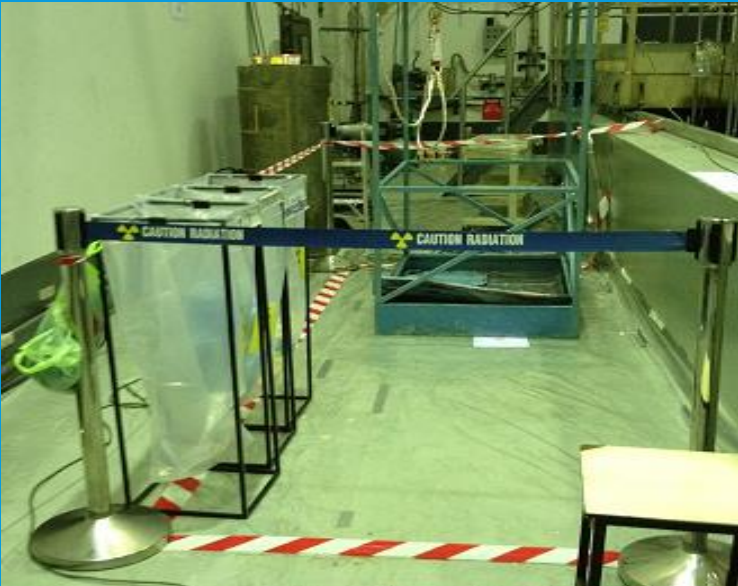
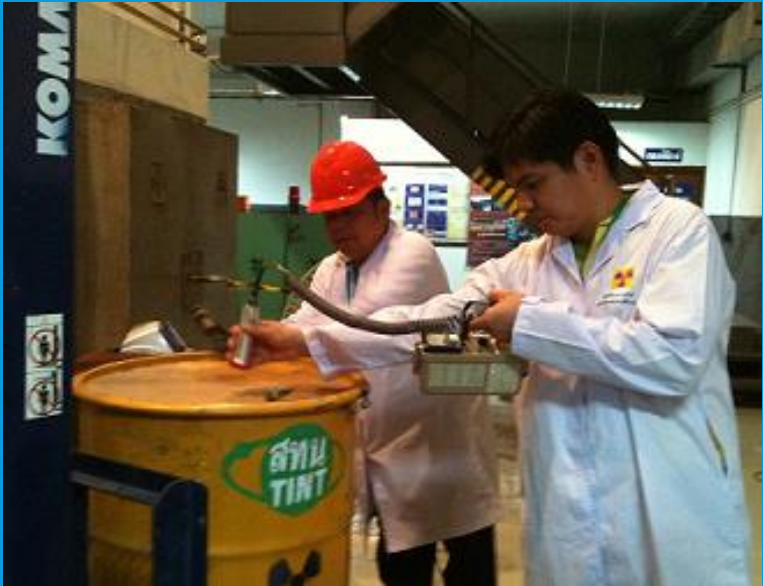
Remove the hot source

The measured dose rate shows high radiation field in the in-pool area. There are two main hotspots (as shown in red) which have radiation dose of approximately 20 R/hr. These hotspots are from the bolts and nuts which align the void tank and neutron beams in their designed positions. It is believed that the bolts and nuts are made from stainless steel
